Stone materials decay patterns of historical buildings in the Southeastern Anatolia climate: A case study of Mardin history İzzetpaşa Old Prison

Lale Karataş *¹

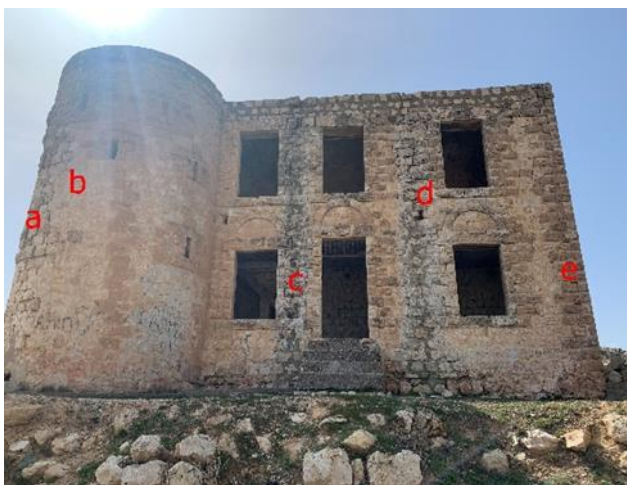
Figure 2. Stone deterioration on the south façade of the building
Joint discharge (a), Cement use (b, c),
Surface loss (d), Color change (e)

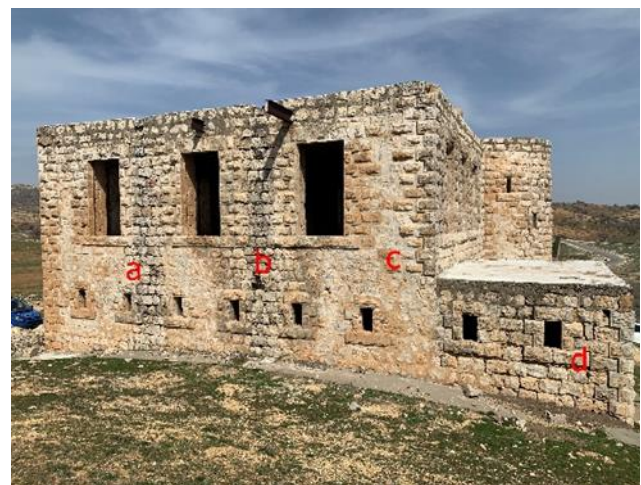
Figure 3. Stone deterioration on the eastern façade of the building
Joint discharge (a), Cement use (b, c),
Surface loss (d)

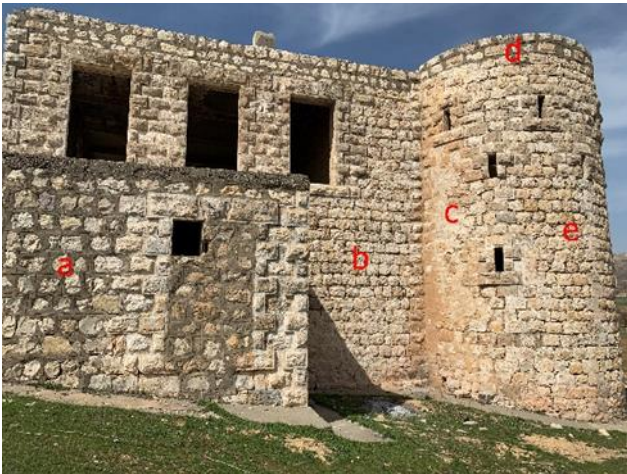
Figure 4. Stone deterioration on the north façade of the building

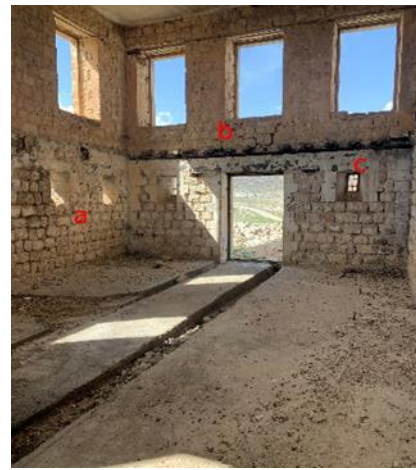
Figure 5. Stone deterioration in the interior of the building

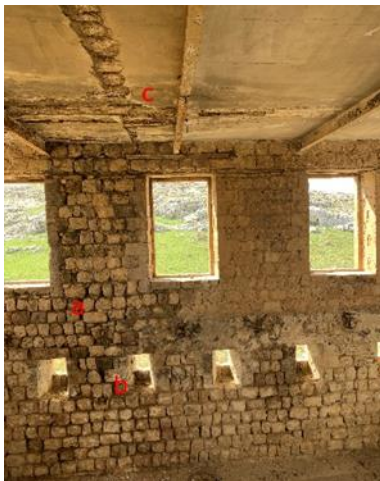
Figure 6. Joint discharge (a), Color Change (b),
Piece Loss (c)
