A systematic method for post-earthquake damage assessment: Case study of the Antep Castle, Türkiye

Cite this study: Karataş, L., Ateş, T., Alptekin, A., Dal, M., & Yakar, M. (2023). A systematic method for post-earthquake damage assessment: Case study of the Antep Castle, Türkiye. *Advanced Engineering Science*, 3, 62-71

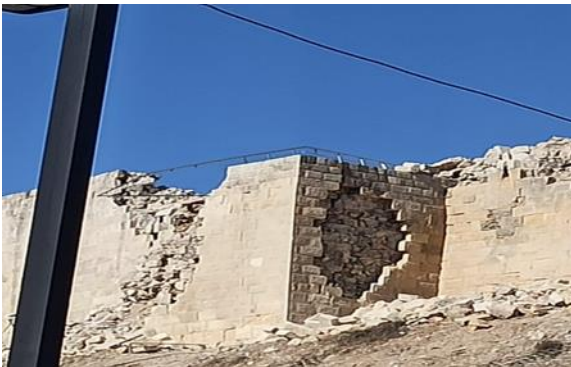
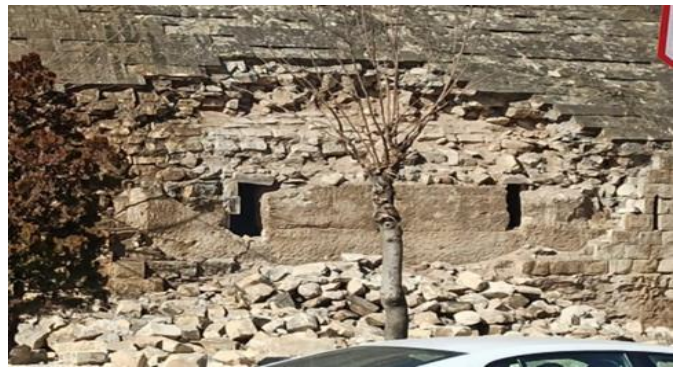
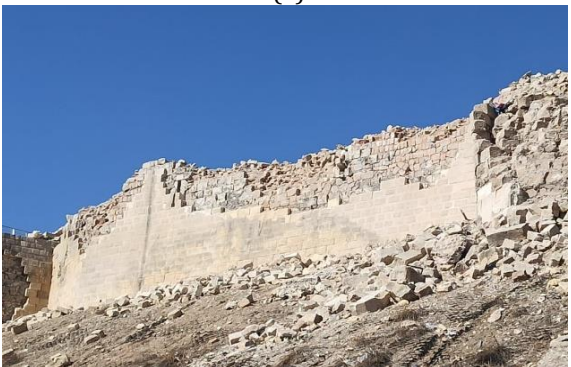
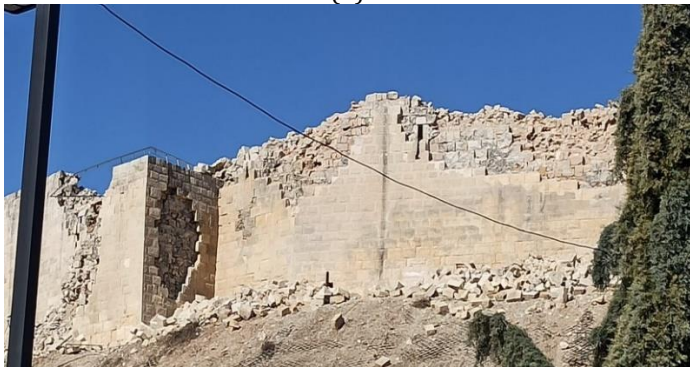
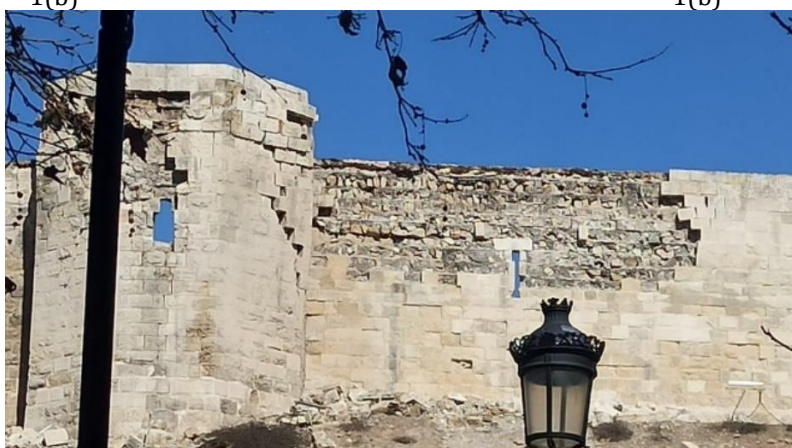
Figure 2. Types of (1a) and (1b) damage in the castle

crumbling of masonry (1a)

delamination of the cladding (1b)

1(b)

As a result of the observational analyzes on the damage typologies according to the characteristics of the building, it was determined that the most common damage after the earthquake in the 6000-year-old castle was caused by the shearing of the cut stones used on the front surfaces of the castle walls. The reason for such damages is the reactions of different types of materials used in the fortification walls against horizontal loads. Antep fortification walls are double paries walls. While the use of cut stone is seen on the front faces, the middle parts are filled with rubble stone. Since the responses of cut stone and rubble stone to horizontal loads during an earthquake are different, it is frequently seen that the cut stones on the front faces of the walls are separated from the rubble stones and poured. In particular, the type of masonry, which is closely linked to the local resources available in the region, seems to strongly influence the damage mechanisms. This finding supports the conclusion that Coisson et al. [14] determined that the construction technique is related to the crumbling and delamination of the wall.

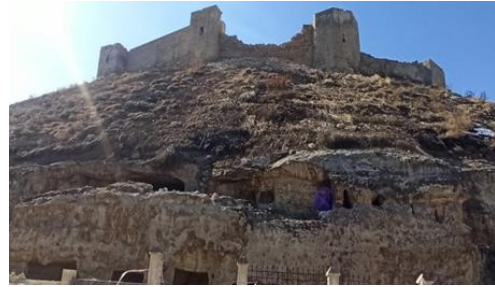
cracks caused by the different dynamic behavior between tower and wall (2a),

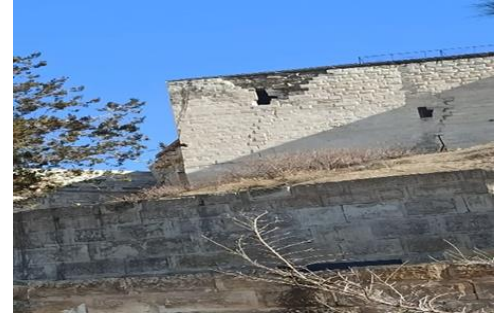
plane shear cracks (2b)

In addition, merlons were damaged in the building elements, and frequent cutting damages were detected on the walls. The cracks in the main walls of the castle and widespread damages on the upper parts of the merlons were directed by the partial collapse of the upper part of the walls. When we examine the destruction mechanisms, we see that the fortification walls generally spill from the upper parts and experience separation problems. Also, it is possible to notice that the building, which was completely destroyed due to the collapse of the walls, is in a dilapidated condition. In addition, the damages that occur frequently on the floor are described in general terms and it is not clear whether this is due to the rotation or deterioration of the walls. However, data collected on this seismic event is still limited and more research is needed.

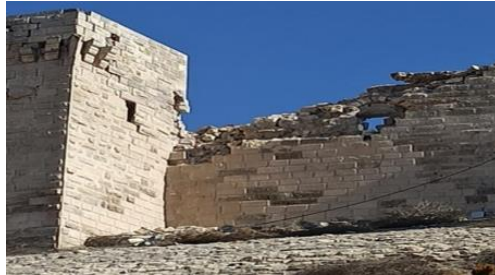
out of plane overturning (2c)

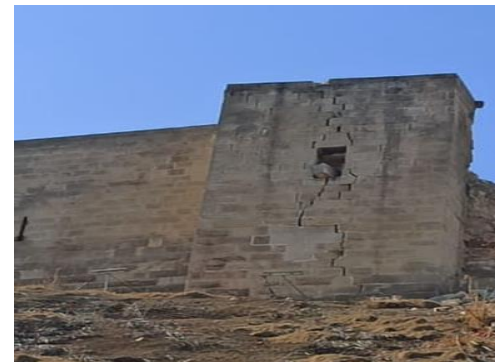
shear cracks in the main body of the tower (3a)

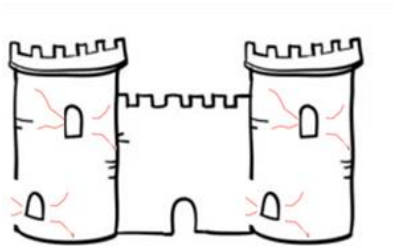
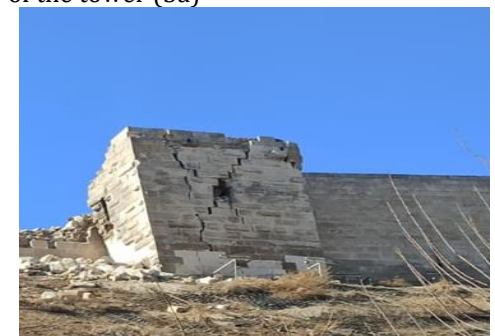
with possible torsional effects if the tower is asymmetrically connected to the walls, shear cracks in the upper part of the tower (3b)

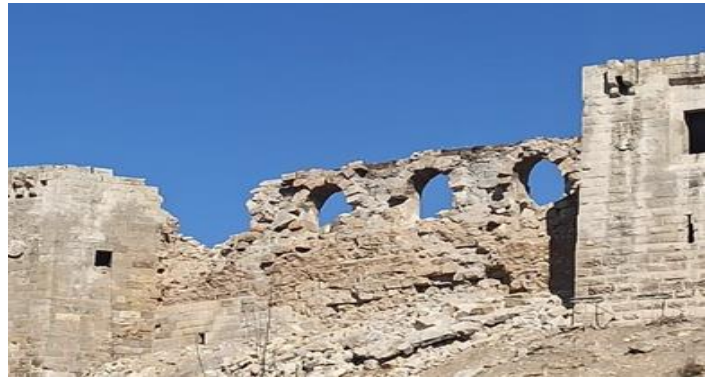
4a

flexural or shear cracks (4a)

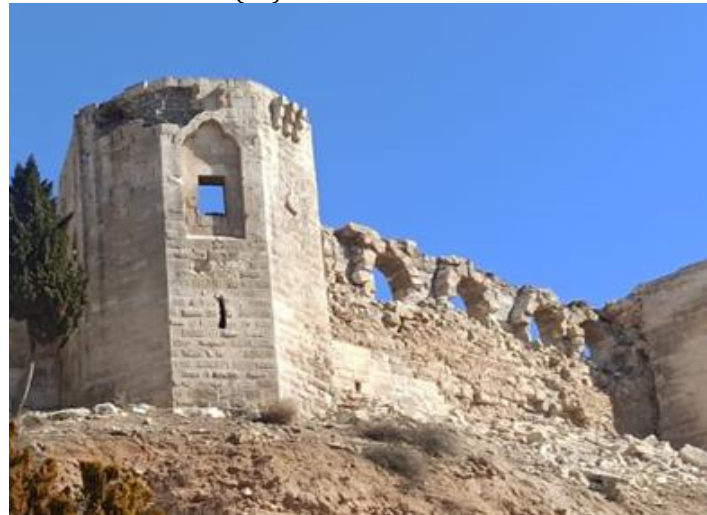
4b

overturning (4b)

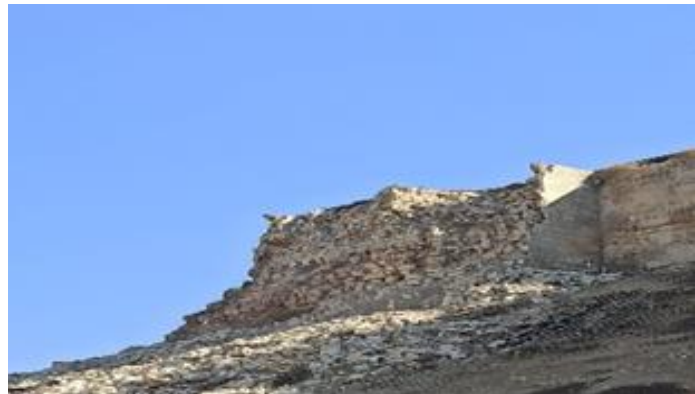
5a

fall of the foundation rock or settlements of the soil (5a)

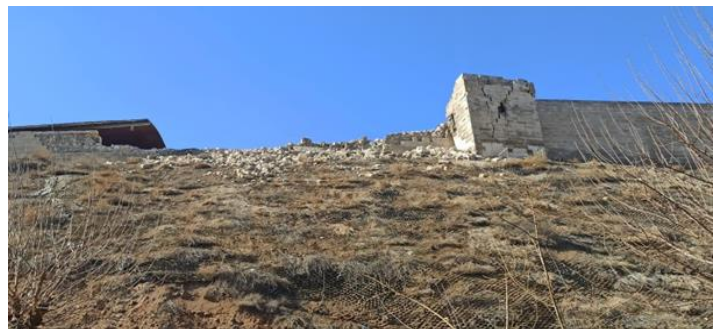
5b

overturning of walls caused by the dynamic thrust of the earth (5b)
