Advanced Engineering Days

Stone material damage detection in restoration using terrestrial laser scanning (LiDAR): The case study of Karacabey Government Mansion in Bursa, Türkiye

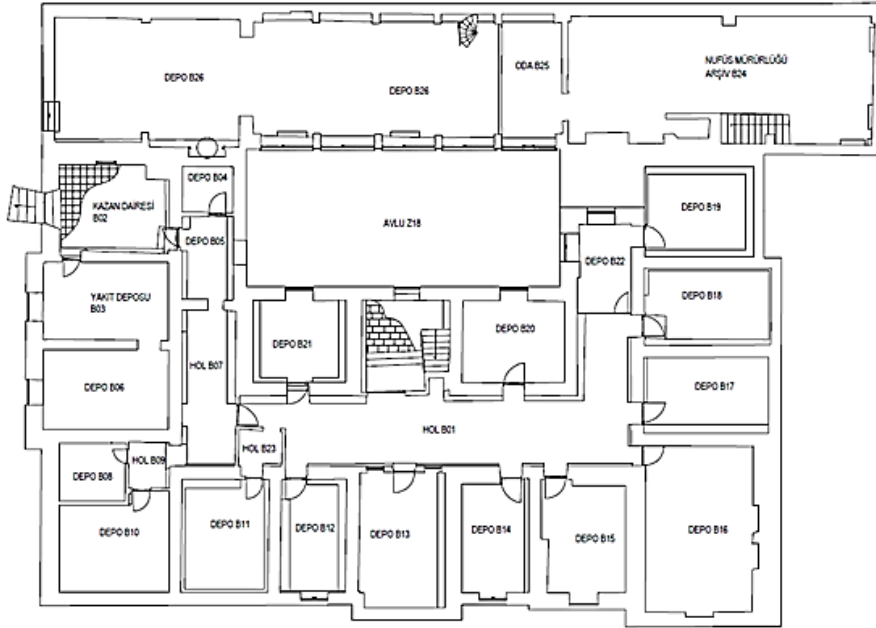
Figure 3. Basement floor plan analytical survey drawing

The structure was originally built in a "U" plan type. However, due to the later addition of the Population Directorate, it can be described as a square-planned structure with a courtyard. In the current condition, the basement floor exhibits spaces belonging to the southern structure group (Population Directorate Archive B24, Room B25, Storage B26) (Figure 3).

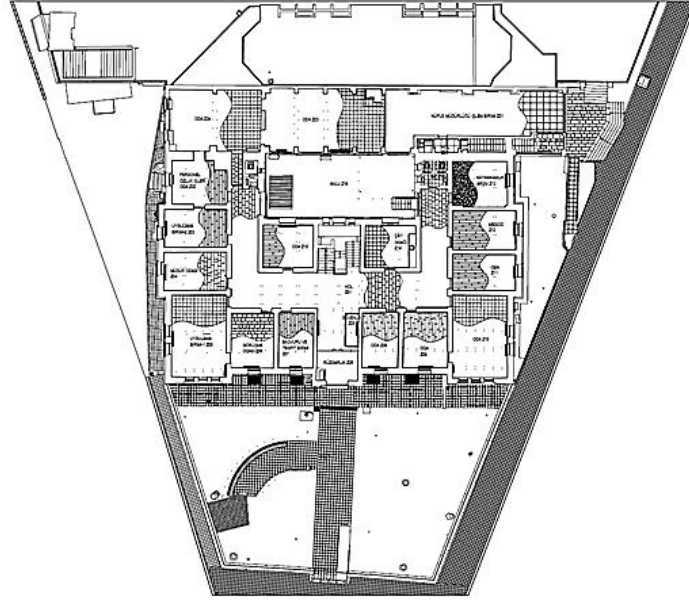
Figure 4. Ground floor analytical survey drawing

The southern section of the ground floor is dedicated to a group of spaces, including rooms Z20, Z21, Z22, Z23, Z24, and Z27. These areas belong to the population directorate. The rooms of the population directorate are arranged in an east-west direction, with interconnected passages between them. The connection between the population directorate and the main building is established through two door openings on the north wall of room Z24, leading to room Z02 (Personnel Affairs) and the Z01 hall.

As seen in the photograph, the spaces in this area of the building are arranged around the Z01 Hall. The floor of the hall is covered with ceramic tiles, while the walls and ceiling are plastered. To the east of the hall, rooms Z02, Z03, Z04, and Z05 are located, while rooms Z13, Z12, Z11, and Z10 are situated to the west. On the north side of the hall, rooms Z05, Z06, Z07, Z26, Z08, Z09 can be found, while rooms Z14 and Z15 are positioned on the south side. The north side of the Z01 hall houses various units, including application units Z05, interview room Z06, application and identification unit Z07, windbreak, Z26, room Z08, room Z09, and room Z10. The floor, walls, and ceiling of the hall are adorned with ceramic tiles and plaster.

Moving westward from the Z01 Hall, one can find district governor's archive- Z13, prayer room- Z12, and room- Z11. The floor, walls, and ceiling of this area of the hall are also finished with ceramic tiles and plaster. On the south wall of the hall, there is a tea room with rooms Z15 and Z14. Additionally, there are reinforced concrete stairs in the central axis of the hall, providing access to the upper and lower floors (Figure 4).

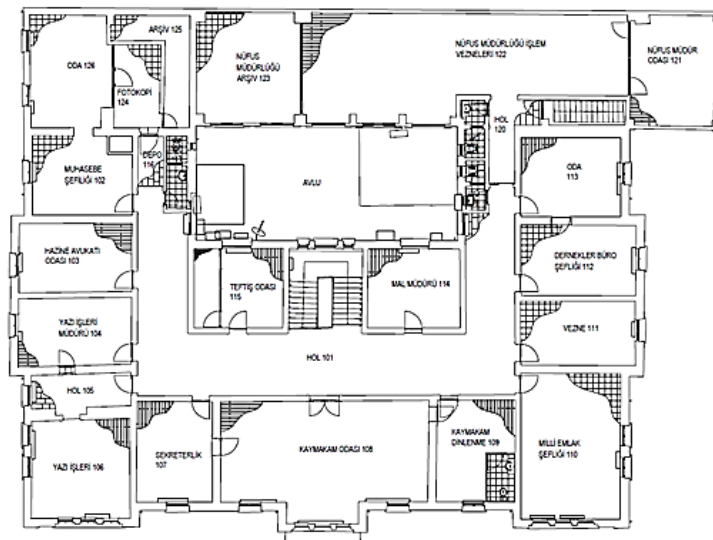
Figure 5. First floor plan analytical survey drawing

The first floor plan of the building is almost symmetrical to the ground floor plan. On the first floor, there are rooms belonging to the southern section of the building, including room -126, photocopy room -124, archive room-125, population registry archive- 123, population registry transaction counters -122, and population registry director's office- 121. These rooms, like on the ground and basement floors, belong to the population registry department. The rooms belonging to the Population Registry Department are arranged in an east-west direction, and the transitions between spaces are facilitated through connecting rooms.

Room 126 and photocopy room 124 have openings on their northern walls, providing access to the main building (accounting office -102 and storage room- 116). The connection between the ground floor and the first floor is established through concrete stairs, with the creation of the central space, room -120, towards the south. The rooms belonging to the Population Registry Department are arranged from east to west in the floor plan. No significant deterioration is observed in these rooms. The walls are plastered, the ceilings are suspended ceilings or plastered, and the floors are either ceramic or parquet.

The main space of the building follows the 'U' scheme and consists of rooms placed around the courtyard and room-101. On the south wall of the central space, there are room -115, the furnishing room, and room 114. on the south wall of hol -120, there are room -107 (secretary's office), room -108 (governor's office), and room -109 (governor's resting room) (Figure 5).
