Stone alterations in Şehidiye Madrasah

Abstract

In this study, the alterations on the facades of Şehidiye Madrasah in Mardin were analyzed. The alterations occurring on the stone surface were analyzed and their causes were determined. The study covers the alterations on the south, east and west facades of the building [8]. The changes in the structure were classified and analyzed as physical, chemical, biological and anthropogenic changes [9].

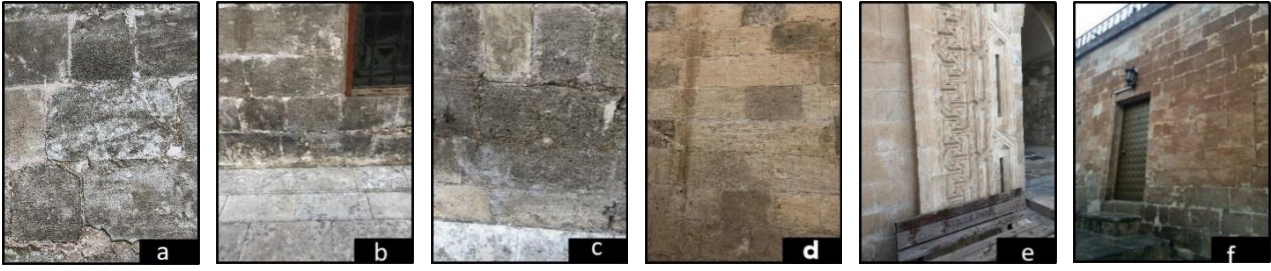
Figure 1. Physical alterations at Şehidiye Madrasah (November 2019)

The physical alteration of the structure is shown in Figure 2. Physical alteration types such as capillary cracks, joint failure, fragment rupture and surface abrasion were observed. Due to the climatic conditions of Mardin province, the structure was exposed to thermal shock and capillary cracks occurred in the limestone which constitutes the main material of the structure (Figure 2a). Joint failure (Figure 2b, Figure 2c) and fragmentation

(Figure 2d, Figure 2e) were observed. Dust grains carried by the wind caused surface abrasions (Figure 2f) on the façade of the building over time.

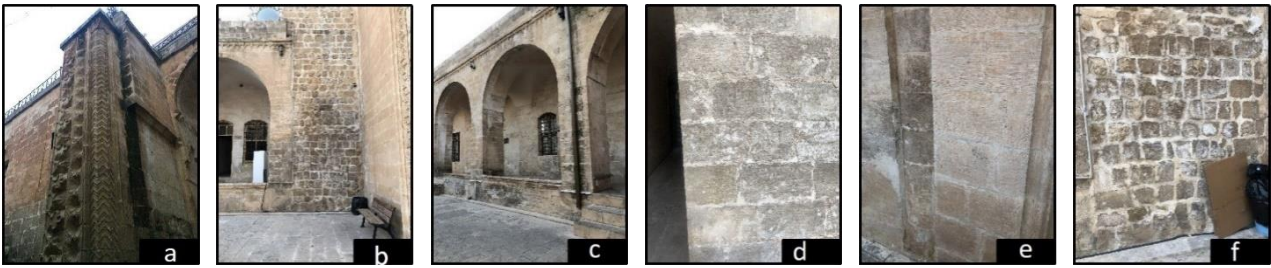
Figure 2. Chemical alterations at Şehidiye Madrasah (November 2019)

The limestone, which constitutes the main material of the Şehidiye Madrasah, has undergone chemical alteration over time due to internal or external factors. These alterations are given in Figure 2. Discolouration is observed on the main portal providing access to the building (Figure 2a). It is also possible to observe discolouration on the façade facing the inner courtyard of the building, where the women's masjid is also located (Figure 2b). In the Şehidiye Madrasah, it was observed that salting of limestone occurred as a result of interaction with air (Figure 2d and Figure 2e). It is also possible to see bacterial formations on the limestone (Figure 2c and Figure 2f).

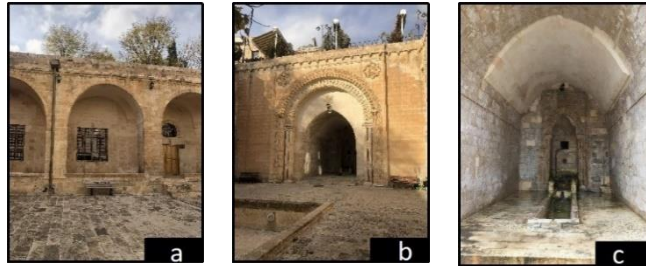
Figure 3. Biological alterations at Şehidiye Madrasah (November 2019)

Organic substances on stone surfaces cause alterations. These are called biological alterations. Algae formation, plant formation, biological accumulation is among the types of biological alteration [15, 16]. The biological alteration of the Şehidiye Madrasah is shown in Figure 3. Plant growth was observed on the façade of the women's masjid (Figure 3a) and the façade of the selsebil (Figure 3b), and moss growth was observed in areas that interact with water (Figure 3c).

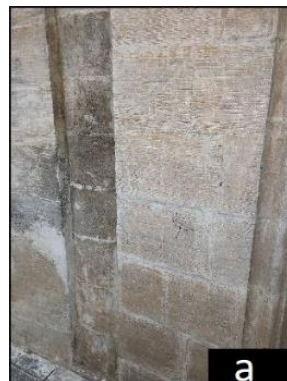
Figure 4. Anthropogenic alterations at Şehidiye Madrasah (November 2019)

In Şehidiye Madrasah, anthropogenic alterations were observed on the north-facing courtyard façade of the building as a result of sharp tools (Figure 4).
