Stone alterations in Zinciriye Madrasah

Abstract

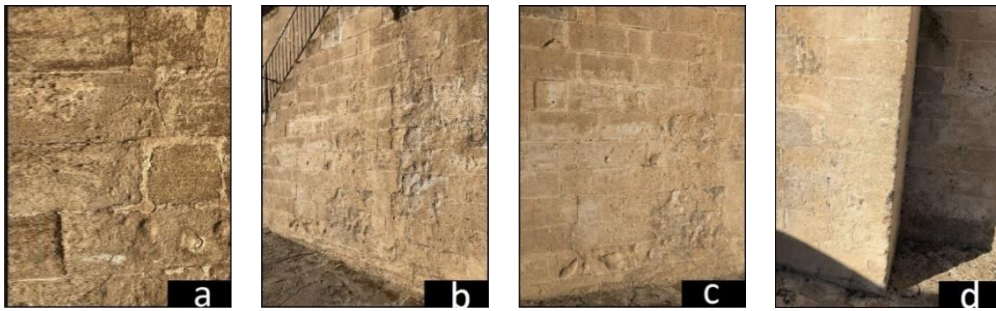
The physical alterations caused by environmental and climatic effects are shown in Figure 1. Capillary cracks (Figure 1a), joint losses (Figure 1b), surface loss (Figure 1c) and fragment losses (Figure 1d) were observed on the facades of the building. These observed degradations negatively affect minerals that increase strength and facilitate physical decomposition [12].

Figure 1. Physical alterations at Zinciriye Madrasah (November 2019)

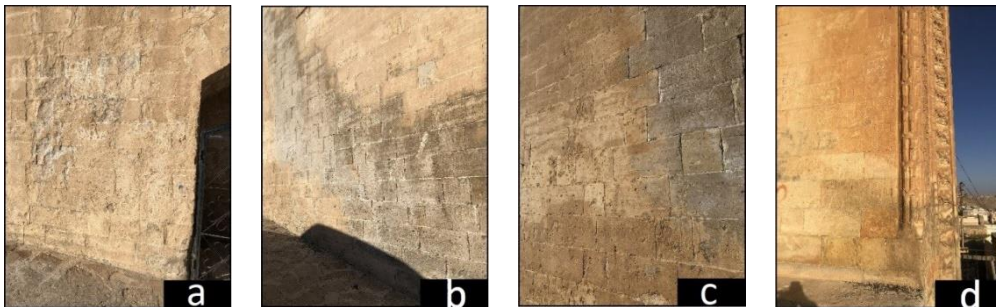
Chemical changes are the type of deterioration that occurs on the surface of the stone as a result of atmospheric events. Salination and colour changes in the structure due to climatic factors are shown in Figure 2. Salination caused by the dissolution and evaporation of salts in limestone under the influence of humidity and temperature (Figure 2a and 2b) and discolouration caused by the interaction of minerals in the stone (Figure 2c and 2d) were observed.

Figure 2. Chemical alterations at Zinciriye Madrasah (November 2019)

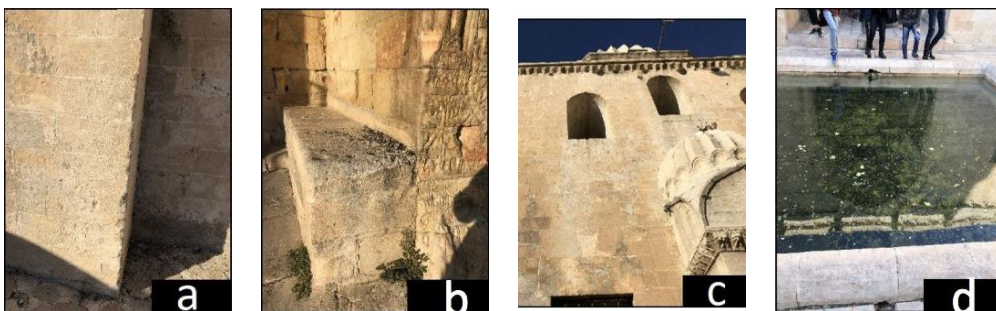
Biological changes in the structure are shown in Figure 3. Plant formations are observed as a result of the interaction of the seeds that settle in the capillary cracks with water [13]. Flowering was observed on the south façade of the building (Figure 3a, 3b and 3c) and mossing was observed in the inner courtyard of the building (Figure 3d).

Figure 3. Biological alterations at Zinciriye Madrasah (November 2019)

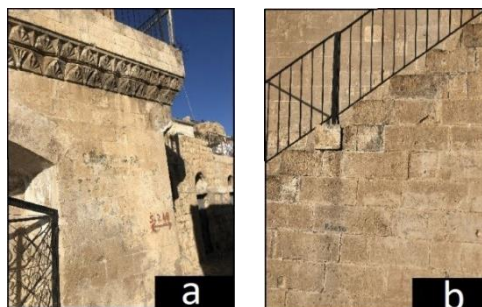
Anthropogenic alterations in the building are shown in Figure 4. The use of paint on the south façade (Figure 4a) and misuse of stone on the staircase (Figure 4b) were observed.

Figure 4. Anthropogenic alterations at Zinciriye Madrasah (November 2019)
