## Investigation of the existing situation of the Surp Ağpırig (Déra Spî) Monastery

Enes Arkan\*<sup>1</sup>

, Fatih Avcil<sup>2</sup>

<sup>1</sup>Bitlis Eren University, Engineering-Architecture Faculty, Civil Engineering Department, Bitlis, Turkey, earkan@beu.edu.tr; favcil@beu.edu.tr

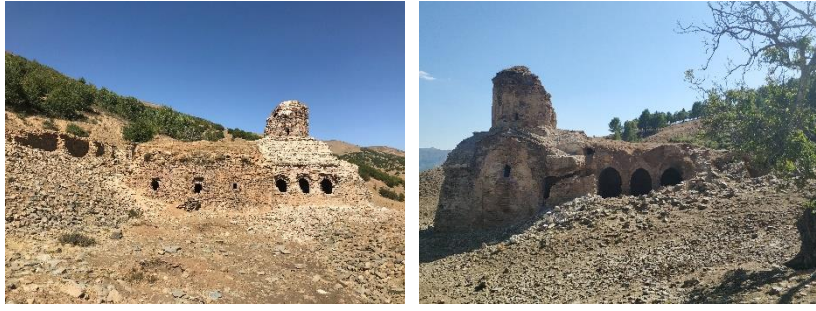
Figure 1. General view of the monastery (photo by author)

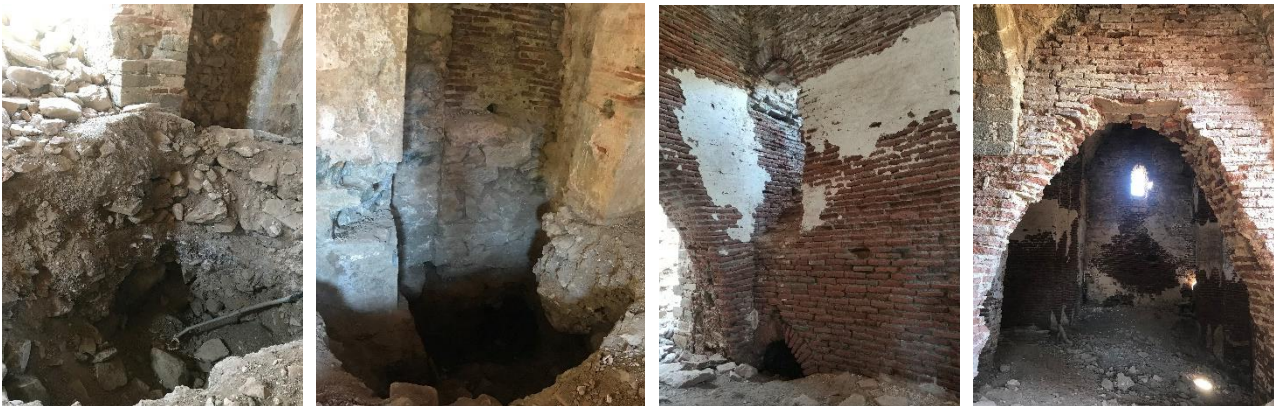
Deep pits were dug by treasure hunters in many parts of the monastery floor and this caused emptying on the ground. As can be seen in Figure 3, the interior walls, rooms and arches of the monastery were partially or completely destroyed. Due to these mortars and stones accumulated in the building, the ground floor level has risen and the entrances to some rooms have been closed. This has caused the historical structure to move away from its originality.

Figure 3. Pits in the ground and damaged walls (photo by author)

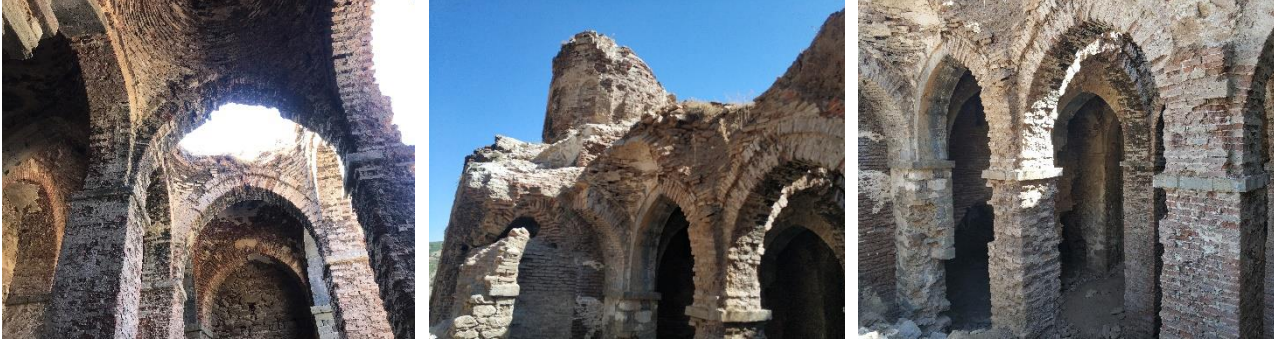
The mortars on the dome and arches have eroded and largely disappeared. Therefore, some domes and arches were partially or completely destroyed. It was observed that columns in the historical building were heavily damaged and some parts were destroyed. Images of collapsed domes, arches and columns are given in Figure 4. It also poses a great danger to those who enter such a damaged monastery.

**Figure 4.** Damaged domes, arches and columns (photo by author)

- 4) The damaged parts of the building should be rebuilt and restored by choosing materials suitable for the historical structure instead of segregated materials.
