Advanced Engineering Days

Material deteriorations occurring on the facades of the Mor Sergios Bakhos Church

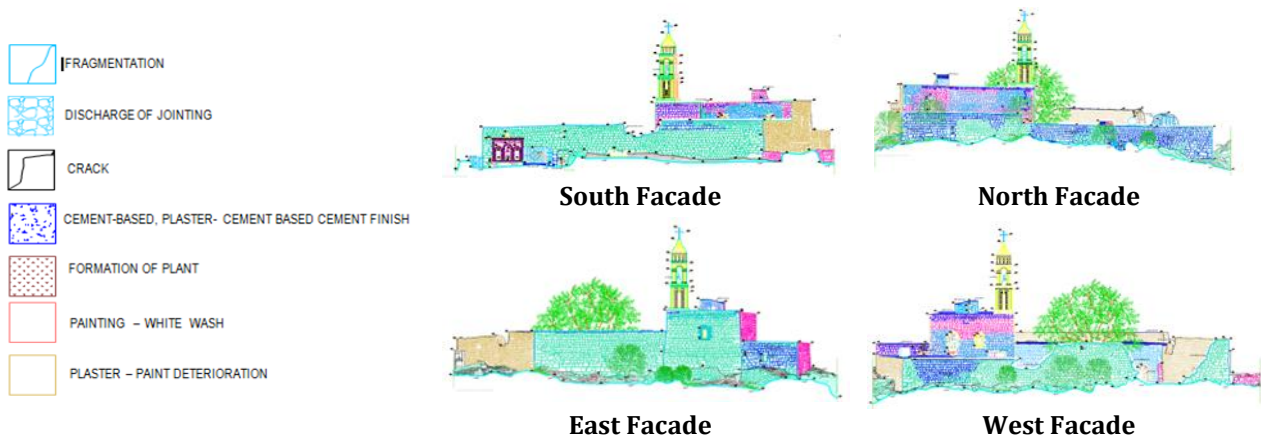
Figure 2. Mapping of material deteriorations on the facades

Facade drawings of the building were achieved with the help of the scaled orthophotographs obtained from the point cloud. Material deteriorations were processed on the facade drawings obtained and the damage maps of the building were obtained. According to these maps, the problems of fragmentation, discharge of jointing, cracks, use of cement, formation of plants, plaster deterioration are seen on the **south facade**. Problems of discharge of jointing, cracks, use of cement, formation of plants, and plaster deterioration are seen on the **north facade**. Problems of fragmentation, discharge of jointing, cracks, use of cement, formation of plants, and plaster deterioration are seen on the **east facade**. Problems of fragmentation, discharge of jointing, cracks, use of cement, formation of plants, and plaster deterioration are seen on the **west facade** (“Fig. 2”).
