## Advanced Engineering Days

### Investigation of Molla Hari (Halil) Süleyman Paşa Mosque's material deteriorations

Cite this study: Karataş, L., Alptekin, A., & Yakar, M. (2022). Investigation of Molla Hari (Halil) Süleyman Paşa Mosque's material deteriorations. 4<sup>th</sup> Advanced Engineering Days, 55-57

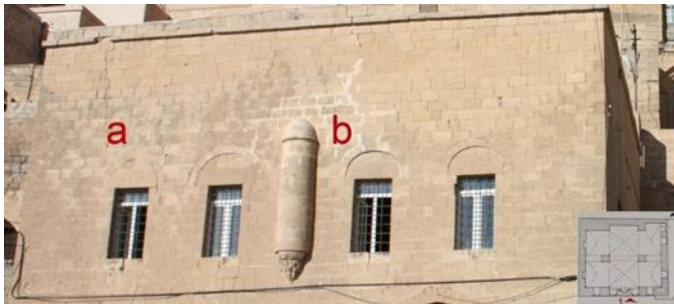
Use of face stone is seen on the structure. Discharge of jointing, colour change, and faulty repairs caused by the use of cement are the types of the material deterioration existing on the walls of the building, material deterioration is not seen on the flat flooring. Material loss in the plaster exists on the vaults [5].

(a) Discharge of jointing, Colour change

**Figure 2.** Deteriorations on façade nr. 1

As a result of the investigations conducted within the scope of the study, it was concluded that the building must be subjected to a general maintenance and repair process as soon as possible. Preventing damage to the current structure must be essential in the selection of the materials and methods to be applied in cleaning, strengthening and conservation. For this, the necessary analyses must be conducted on the original materials before the application.

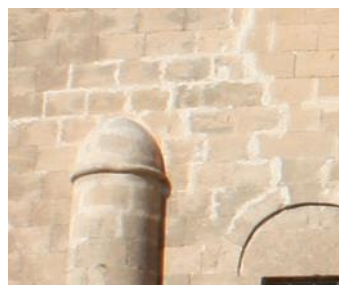
(b) Use of cement

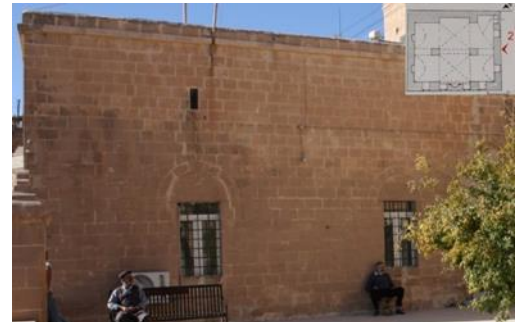
**Figure 3.** Colour change, use of cement on the wall of façade nr. 2

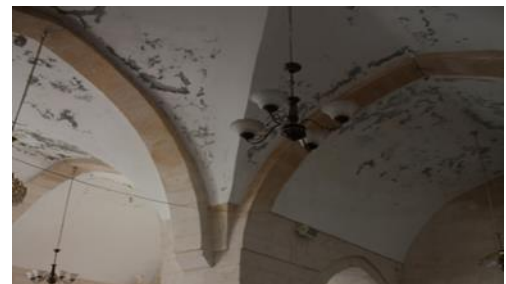
**Figure 4.** Material loss in the plaster on vaults
