Advanced Engineering Days

Documentation of Mardin Kadife Ertem Mansion's architectural characteristics

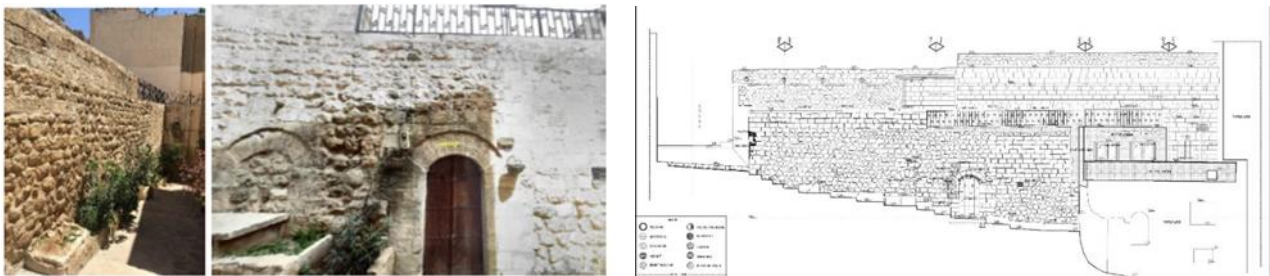
Figure 5. South frontage

The south façade of the building maintains its original status. One original wooden door, which leads to the roof of the building, is present on the south facade of the building. Jerry-built painted attachment, which was built later, is seen on the right side of the facade. Iron railings are present on the roof of the jerry-built attachment. Blackening is present on some parts of the façade. Illuminations and window boxes are present on the right and left side of the entrance door (Fig. 5).

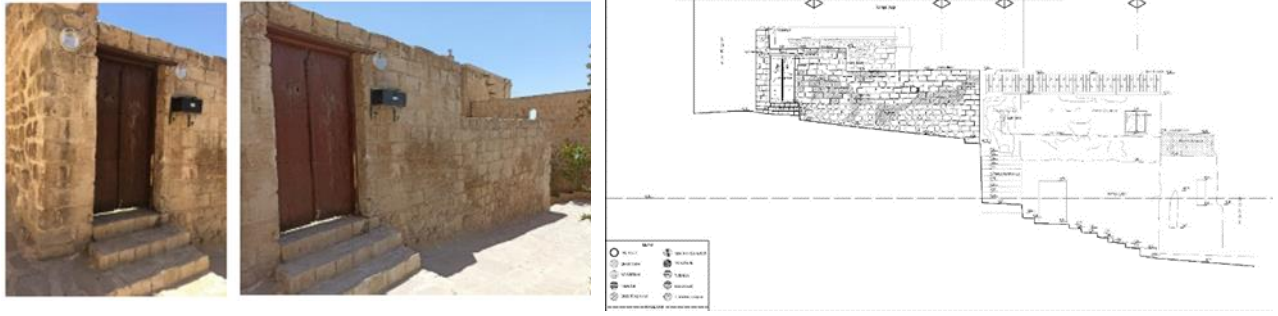
Figure 6. West frontage

One original wooden door, which leads to the roof of the building, is present on the west facade of the building. The facade wall is consisted of face and rubble stone. Iron railings are present on the roof of the jerry-built attachment. Blackening is present on some parts of the façade. Illuminations and window boxes are present on the right and left side of the entrance door (Fig. 6).
