Advanced Engineering Days

Stone material problems in Mardin historical İzzetpaşa Old Prison

Lale Karataş¹, Aydın Alptekin², Murat Yakar³

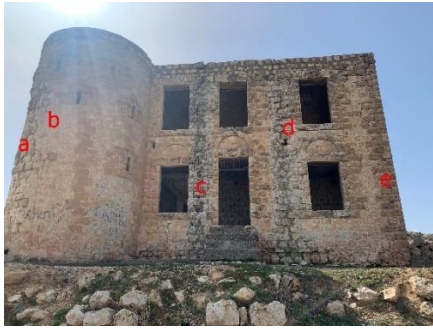
Figure 2. Stone deterioration on the south façade of the building

Joint discharge (a), Cement use (b, c), Surface loss (d), Color change (e)

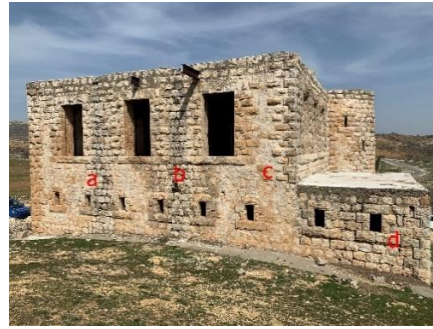
Figure 3. Stone deterioration on the east façade of the building

Joint discharge (a), Cement use (b, c), Surface loss (d)

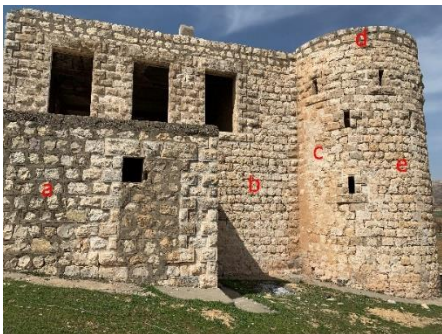
Figure 4. Stone deterioration on the northern façade of the building

Cement Usage(a,c,d), Surface Loss(b), Surface Loss(c), Joint Discharge(e)
