Mardin TCDD Şenyurt historical station building material characterization and conservation suggestions

Cite this study: Karataş, L., Ateş, T., Alptekin, A., & Yakar, M. (2023). Mardin TCDD Şenyurt historical station building material characterization and conservation suggestions. *Engineering Applications*, 2 (1), 84-93

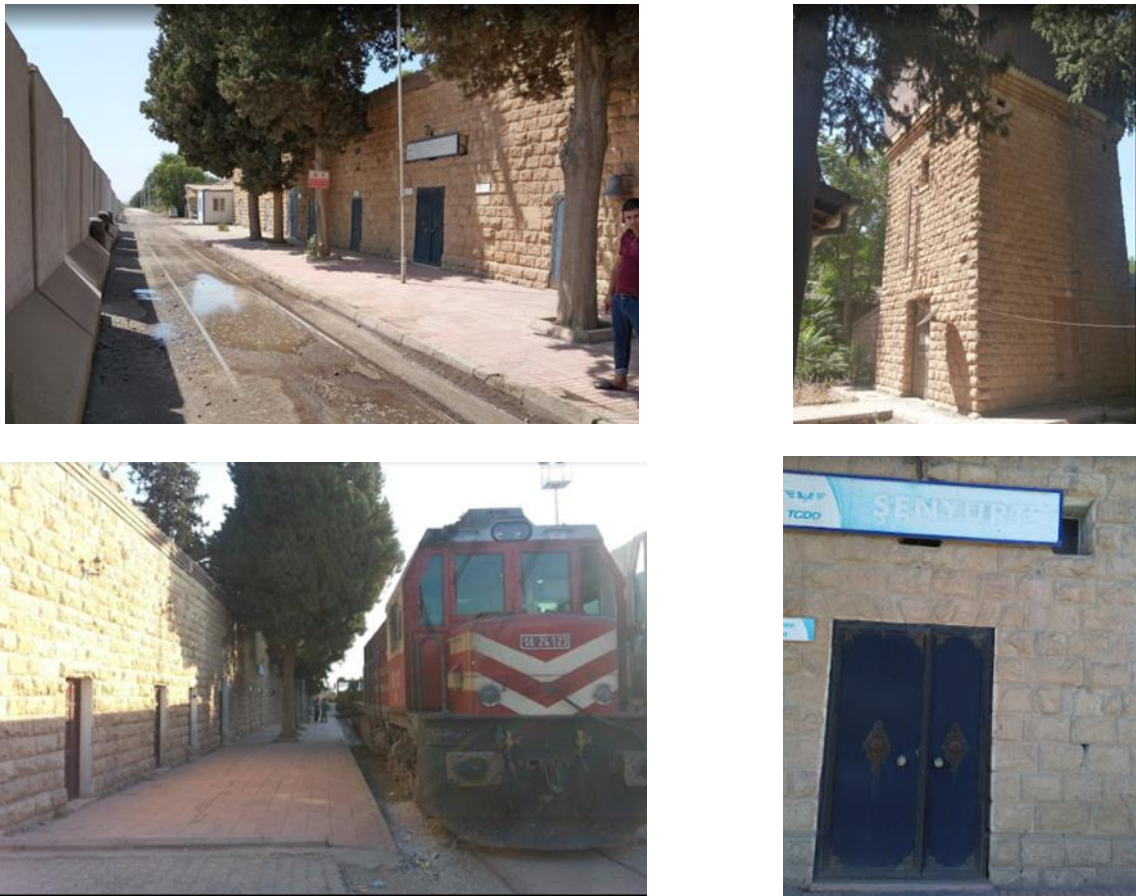
Located in the Kızıltepe district of Şenyurt, Şenyurt station building is surrounded by 3 meters high walls on all four sides. There is a water press and a tower in the courtyard of the building. The building has been in this area for over a hundred years. The building shows a wide variety of material deterioration and needs an urgent restoration intervention (Figure 2).

Figure 2. Images from Şenyurt Station Historical Station Building

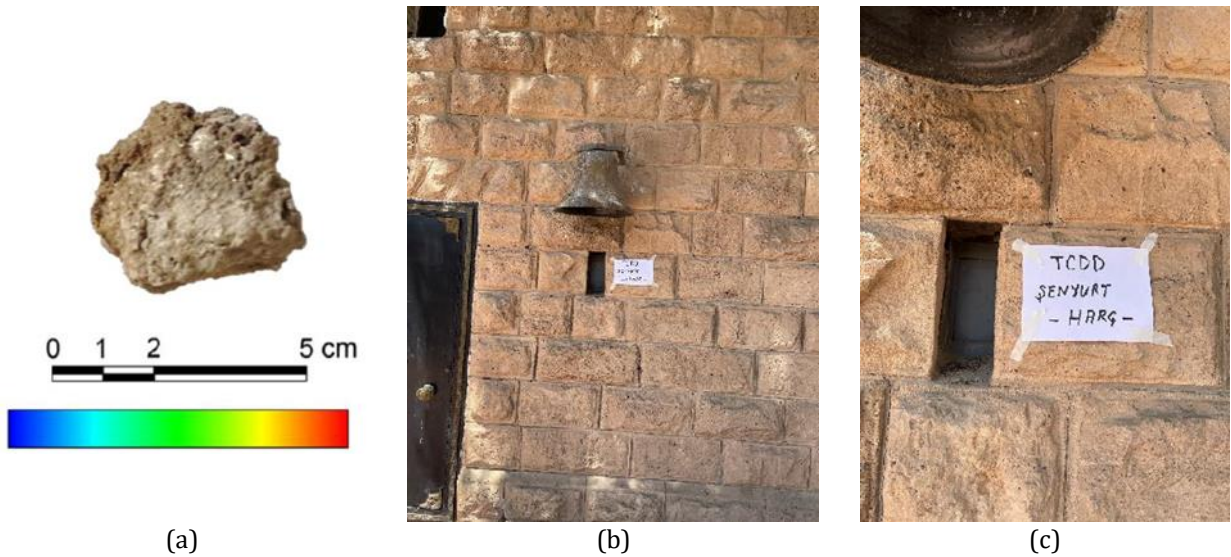
Figure 3. Sample 1 3a) General view 3b) General Location 3c) Detail Location

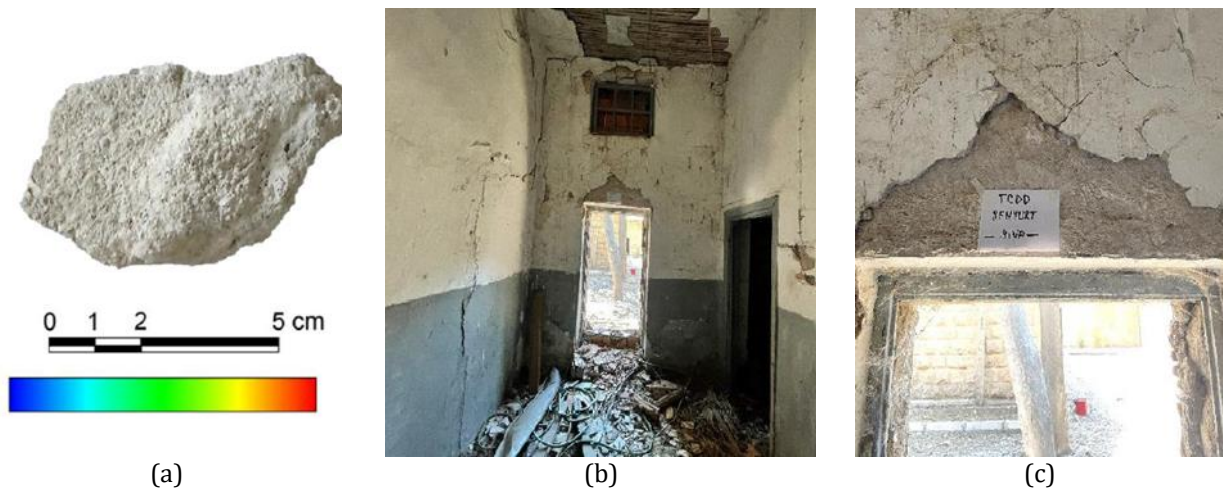
Figure 4. Sample 2 4a) General view 4b) General Location 4c) Detail Location

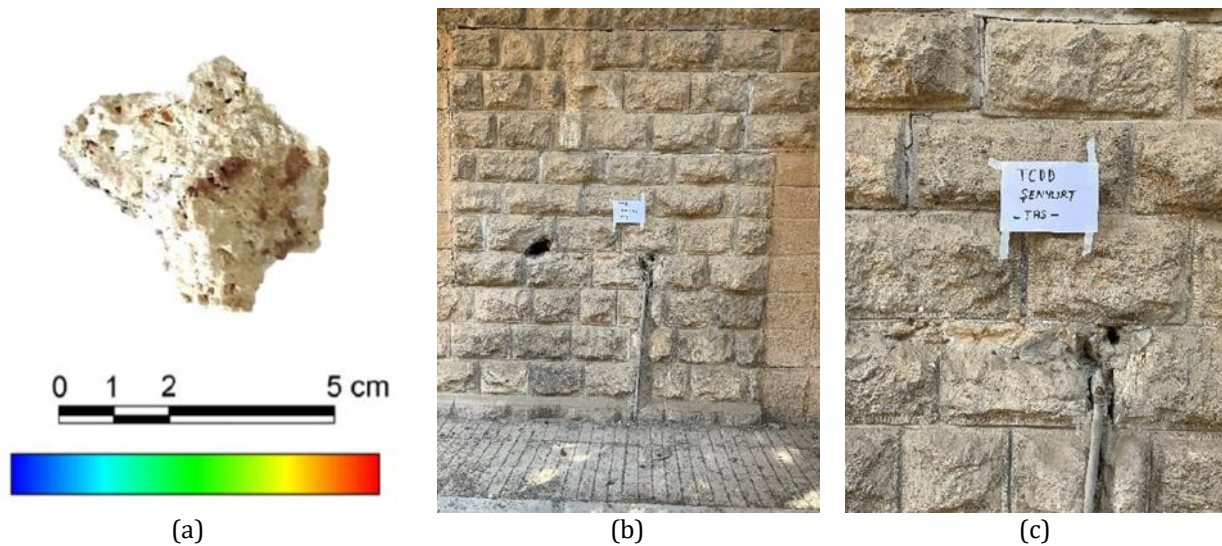
Figure 5. Sample 3 **5a)** General view **5b)** General Location **5c)** Detail Location

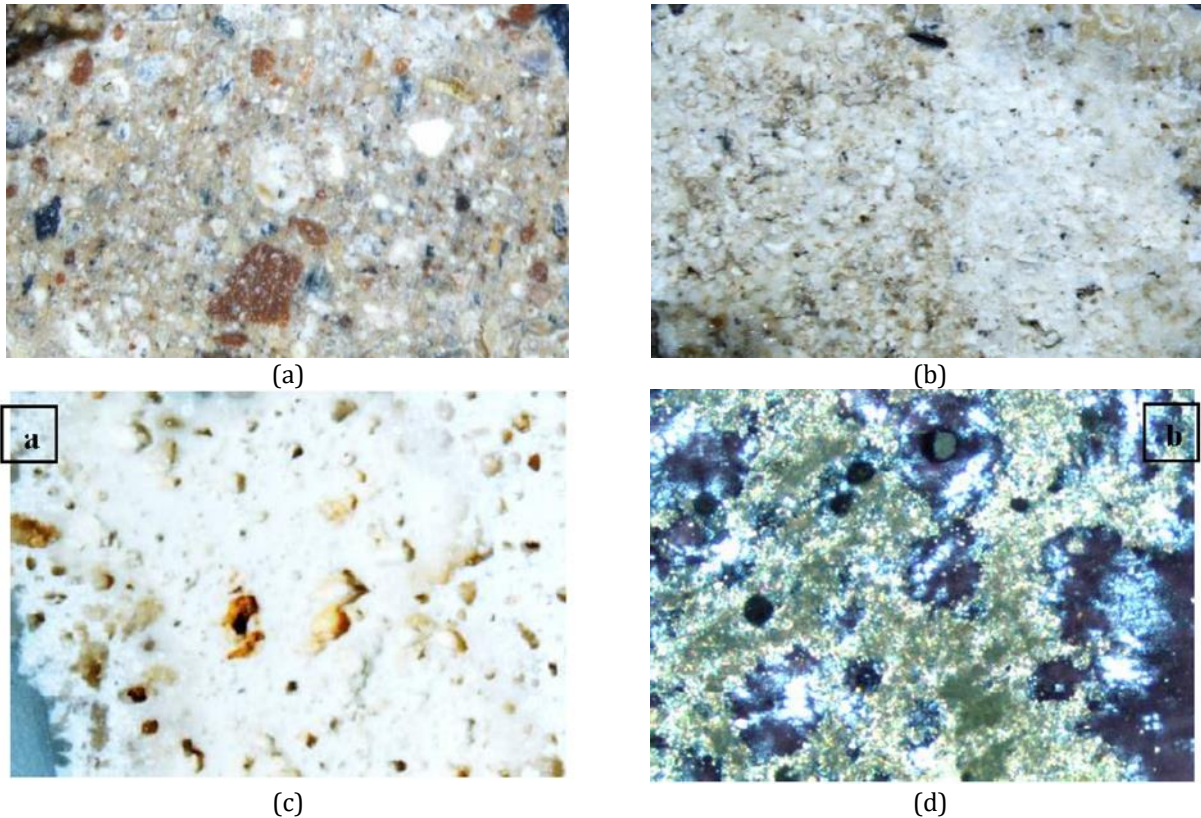
Figure 6. Stereo Microscope/ Polarizing Microscope Images of Samples

For petrography analysis, firstly the samples were epoxied, then coarse and thin sections were prepared for the necessary ones, polarizing microscope (double nicol) mineral contents were examined from the thin sections prepared, and the general tissue properties were examined under the stereo microscope from the shiny thick sections. In the petrographic analysis, the binder type of mortar and plaster type materials, aggregate size and properties, and the general mineral and texture properties of natural stones and their types are given. Sample 1, which was examined under a stereo microscope, resulted in the analysis results; The aggregates of the sample, whose binder is 150-200 doses of Portland cement with approximately 10% lime added, were determined as quartz sea sand with 2 mm sieve size. Sample 2 examined under a stereo microscope; It has been determined that the aggregates of the sample, whose binder is approximately 50 doses of Portland added lime, are sand in 1 mm sieve size. Sample 3 examined under a Stereo Microscope and Polarizing Microscope; It was determined as cream-beige colored, spary-micritic limestone with abundant voids and organic impurities, which is thought to belong to the quarries in the region (Figure 6).

- a) Sample 1/Stereo Microscope General Tissue
- b) Sample 1/Stereo Microscope General Tissue
- c) Sample 3/Stereo Microscope General Tissue
- d) Sample 3/Polarizing Microscope General Tissue

According to the results obtained from petrographic analysis; Sample 1 examined under a stereo microscope; The aggregates of the sample, whose binder is 150-200 doses of Portland cement with approximately 10% lime added, were determined as quartz sea sand with 2 mm sieve size. Example 2 examined under a stereo microscope; It has been determined that the aggregates of the sample, whose binder is approximately 50 doses of Portland added lime, are sand in 1 mm sieve size. Sample 3 examined under a stereo microscope and polarizing microscope; It has been identified as cream-beige colored spiro-micritic limestone with abundant voids and organic impurities, which is thought to belong to the quarries in the region. The results of these analyzes confirm that the minerals that make up the rocks and the texture formed by these minerals, the weathering and weathering of the minerals can be determined by petrographic analysis.

According to the results obtained from petrographic analysis; Example 1 examined under a stereo microscope; The aggregates of the sample, whose binder is 150-200 doses of Portland cement with approximately 10% lime added, were determined as quartz sea sand with 2 mm sieve size. Example 2 examined under a stereo microscope; It has been determined that the aggregates of the sample, whose binder is approximately 50 doses of Portland added lime, are sand in 1 mm sieve size. Sample 3 examined under a stereo microscope and polarizing microscope; It has been identified as cream-beige colored spiro-micritic limestone with abundant voids and organic impurities, which is thought to belong to the quarries in the region. In this context, it is necessary to use mortar, plaster and stones, which have properties similar to the original material specified in the building, during the restoration phase.
