Advanced Geomatics

Determination of Stone Material Deteriorations on the Facades with the Combination of Terrestrial Laser Scanning and Photogrammetric Methods: Case Study of Historical Burdur Station Premises

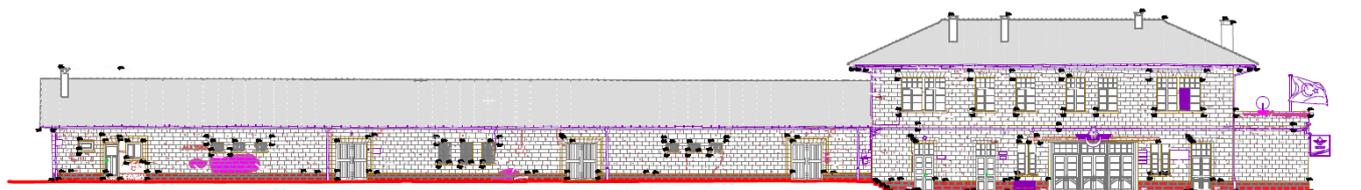
Figure 9. The north frontage

Deteriorations and deformations such as intervention with reinforced concrete plaster, surface contamination, and material losses were observed on the cut stone surfaces, on the north frontage. Besides, jerry-built attachments such as the electric cables, speakers, and signboard are also present on the facade (“Fig. 9”).

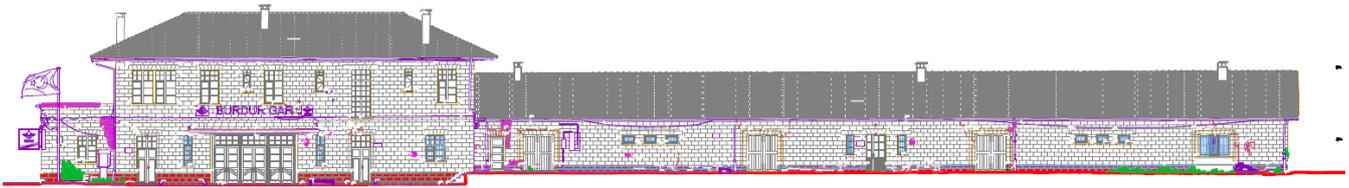
Figure 10. The south frontage

Deteriorations such as formation of plants, surface contamination, material losses on the window sills are seen on cut stone surfaces constituting the south frontage.

Besides, there are numerous jerry-built attachments are present on the facade (“Fig. 10”).

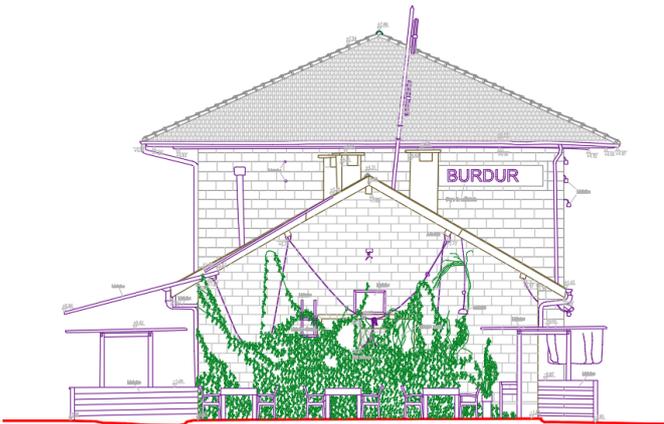
Figure 11. The east frontage

Majority of the east frontage is covered with ivy plant, and it is seen that the front of the facade is utilized as a cafe. Jerry-built attachments and deteriorations such as the surface contamination were observed (“Fig. 11”).

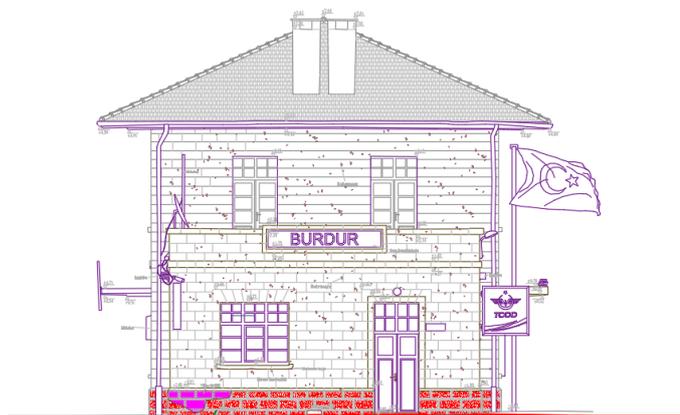
Figure 12. The west frontage

It is seen that intervention has been made on the sign plate within the rectangular frame created by cut stones with paint on the west frontage. Deformation and surface contamination, and various jerry-built attachments such as cables and antenna are seen on the surface of the cut stone facade (“Fig. 12”).
