### Documentation of stone material deterioration on the facades of historical masonry buildings by terrestrial laser scanning: A case study of a Mansion in Mardin

Lale Karataş<sup>\*1</sup>, Aydın Alptekin<sup>2</sup>, Murat Yakar<sup>3</sup>

The rich architectural heritage of our Turkey is also manifested in stone monuments. The building, which is the subject of the study, is located in the Şar Neighborhood of the Artuklu district of Mardin Province which has the characteristics of historical buildings in the region with its construction technique, plan features and materials. As in many buildings in the region as construction material, there is an intense use of stone

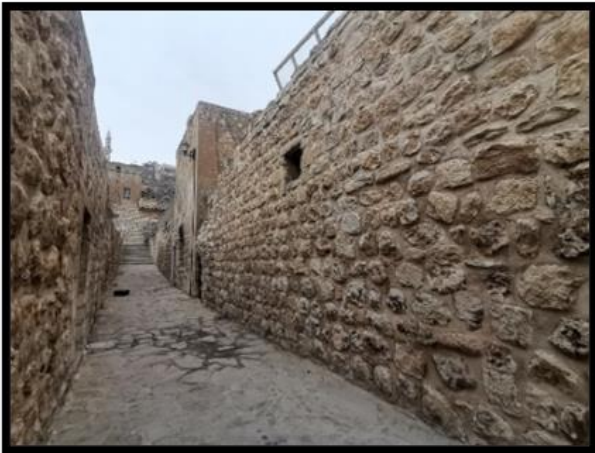
Figure 9. Western Front

The western façade of the building is the side entrance façade and has a total length of 23 m. The building facade height is 3.51 m at the lowest and 9.45 m at the highest. The façade wall of the building was built with rubble stone and faceted stone (Figure 9).

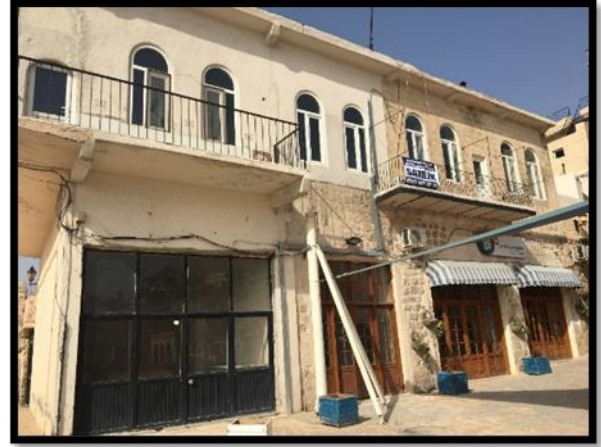
Figure 10. Eastern Front

The eastern façade of the building is the entrance façade of spaces such as workshops and shops. Its total length is 17 m and the facade height is 9.10 m. The facade wall is covered with stone and rubble stone, and some of it is plastered with cement-based mortar (Figure 10).
