Intercontinental Geoinformation Days

Monitoring the stability of highway cut slopes utilizing drone photogrammetry

Six cut slopes varying in size on Kastamonu-Karabük intercity road were investigated for slope failure in this study.

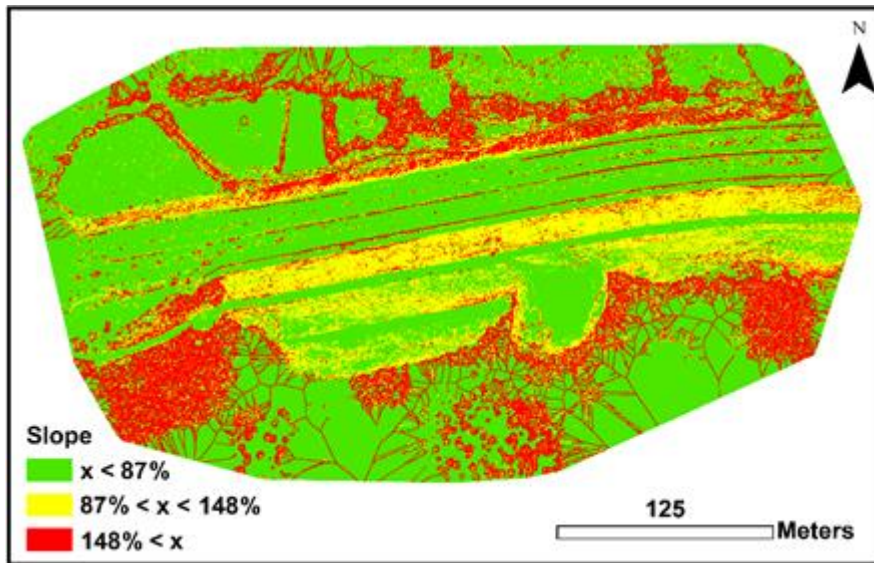
surfaces. In majority of the studies conducted to assess the slope stability, the term, factor of safety, (FS), is rather important in better understanding and definition (Duncan et al. 2014). When FS is explained in terms of the slope gradient intervals; “stable”, “critical range” and “fail certain”, can be grouped as followed: $< 87\%$, $87\% < x < 148\%$ and $148\% < x$, respectively (Zakaria et al. 2018) (Figure 2).

Figure 2. Site 2 slope classification resulting from 0.09 m DSM
