Detection and documentation of stone material deterioration in historical masonry structures using UAV photogrammetry: A case study of Mersin Aba Mausoleum

Lale Karataş¹, Aydın Alptekin², Murat Yakar³

Cite this study: Karataş, L., Alptekin, A., & Yakar, M. (2022). Detection and documentation of stone material deterioration in historical masonry structures using UAV photogrammetry: A case study of Mersin Aba Mausoleum. *Advanced UAV*, 2 (2), 51-64

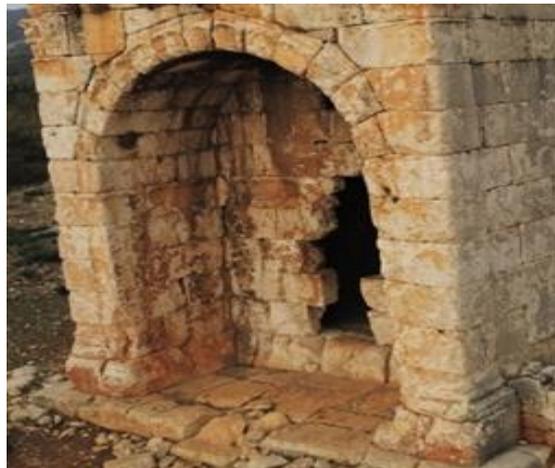
Figure 3. Scaling and discoloration of the feet

In masonry structures, the only carriers are legs and columns. There are two pillars used in the building. The problems seen in the feet that make up the structure are in the form of scaling and color change caused by the effect of rain.

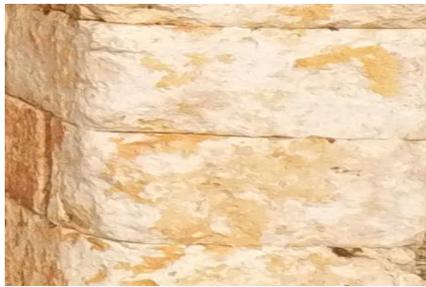
It has been determined that the structural body wall forming the south façade of the building is in the form of exfoliation, joint discharge, surface loss, surface pollution caused by human effects, crusting and fragmentation caused by the effect of rain (Figure 6).

exfoliation (a)

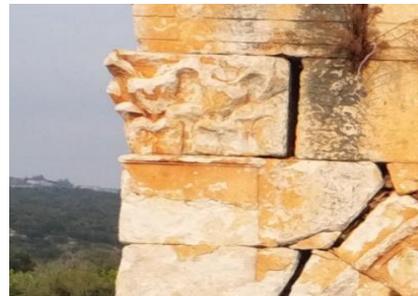
Joint discharge (b)

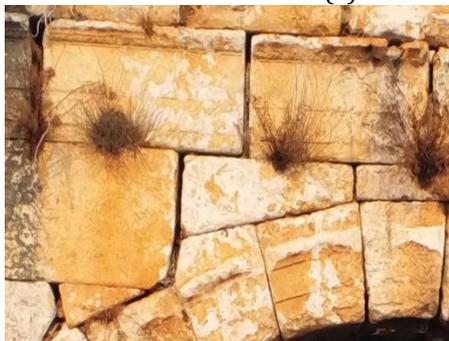
Plant (c)

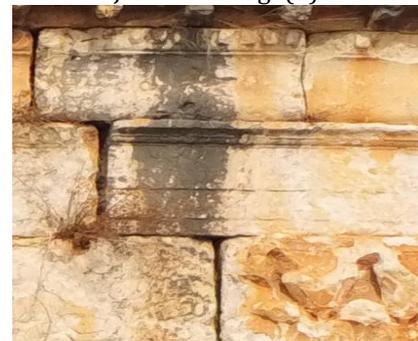
Surface contamination (d)

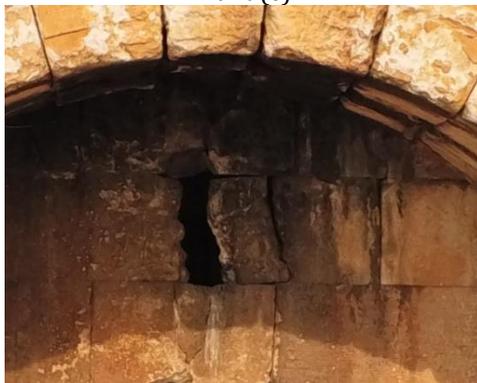
Soil crust (e)

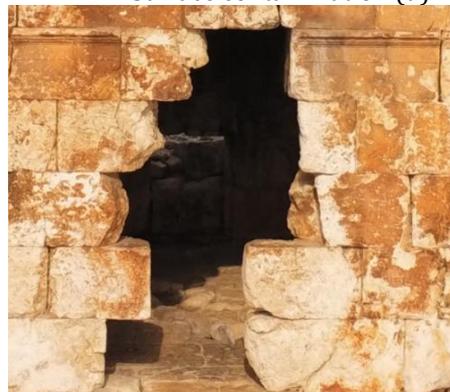
Chunking (f)

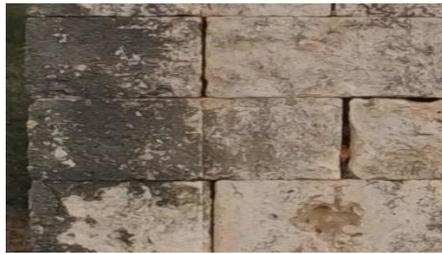
On the eastern façade of the building, surface pollution caused by human-induced effects, joint discharge, plant formation, gap hole formation, surface loss and color change can be seen as a result of the effect of rain water on the stone. In addition, there are serious cracks in the wall that divide the stone components into two. This graph shows a high probability of impact triggered by lateral thrusts or seating issues (Figure 7).

(a) Surface contamination

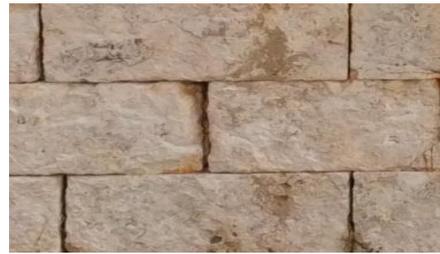
(b) Joint discharge

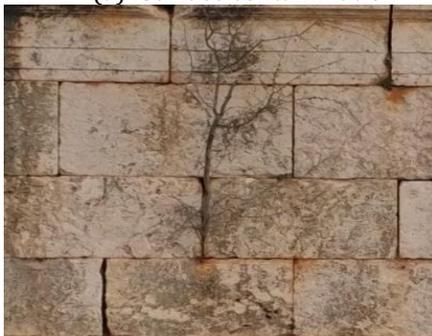
(c) Plant

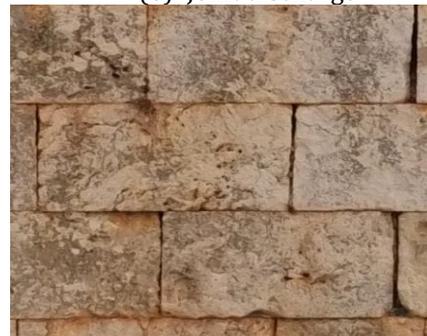
(d) Void-hole Formation

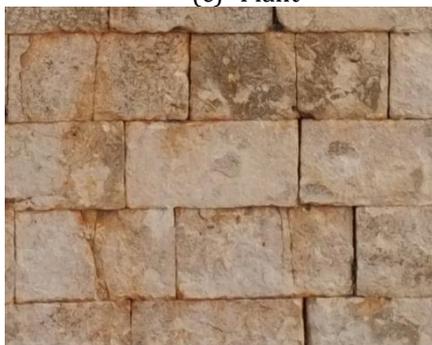
(e) fracture

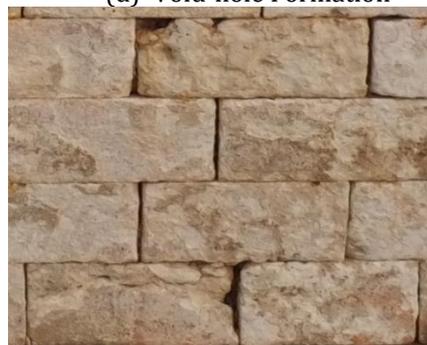
(f) Surface loss

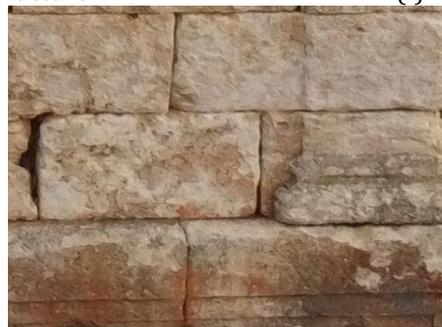
(g) Color change

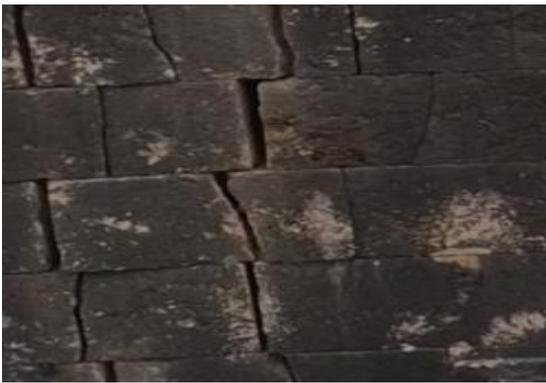
On the northern body wall of the building, there are serious cracks triggered by human-induced surface pollution, fragment rupture, joint discharge caused by rain, and lateral pressures or settlement problems (Figure 8).

(a) Surface contamination

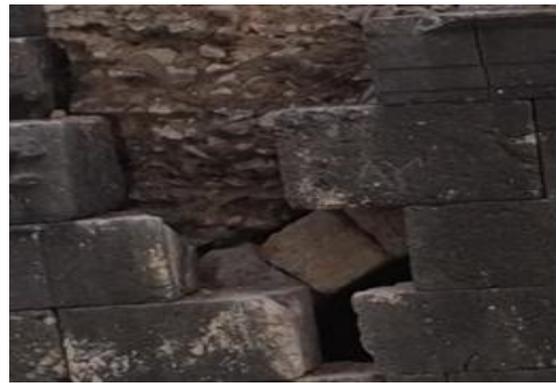
(C) fragment rupture

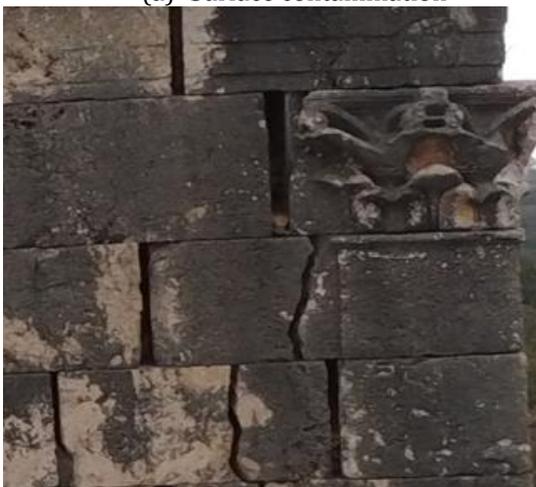
(b) Fracture

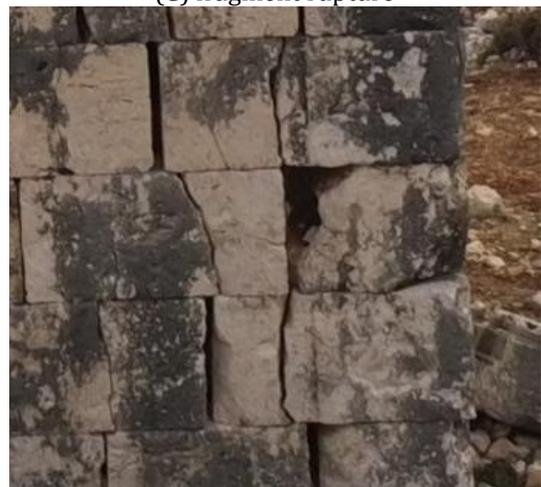
(d) Joint Discharge

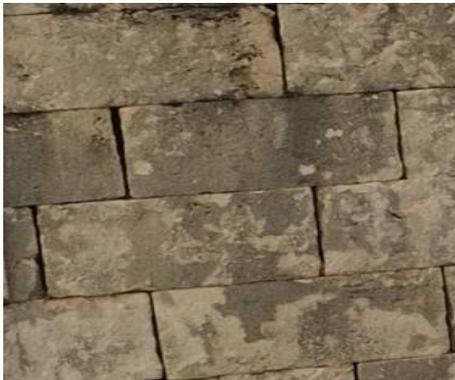
On the eastern façade of the building, joint discharge, fragmentation, surface pollution, exfoliation and loss of surface stone material problems are observed (Figure 9).

(a) Joint Discharge

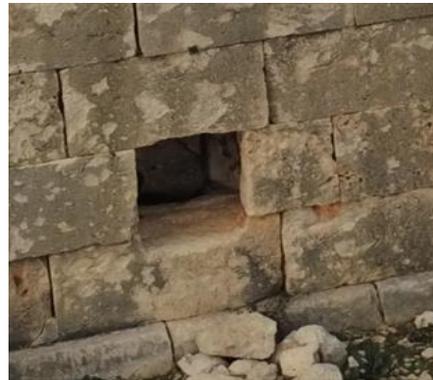
(b) fragment rupture

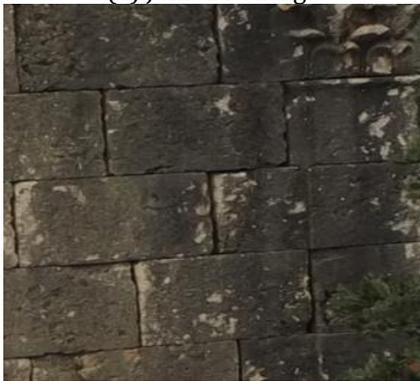
(c) Surface contamination

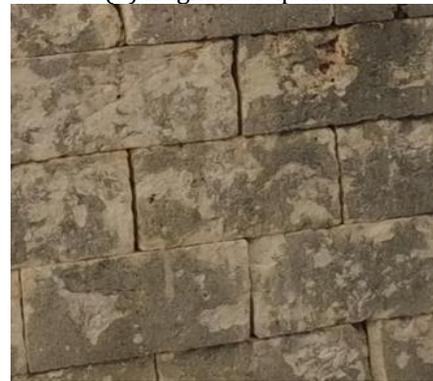
(d) exfoliation

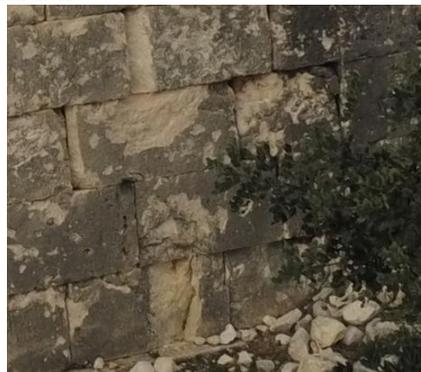
(e) surface loss

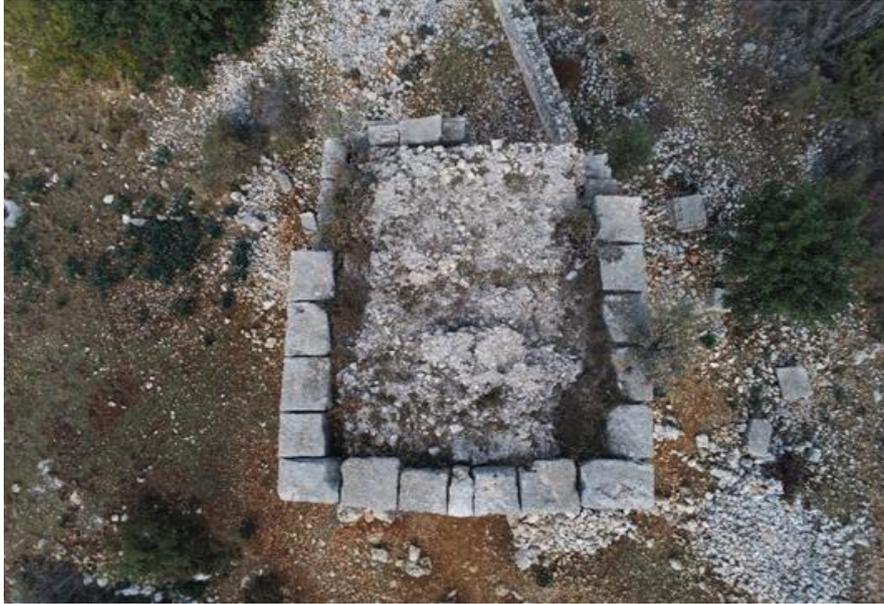
In masonry structures, horizontal carriers are floors. Plant formations originating from the effect of water can be seen on the flat floor seen in the building (Figure 10).

Figure 8. Plant formation seen on the floor

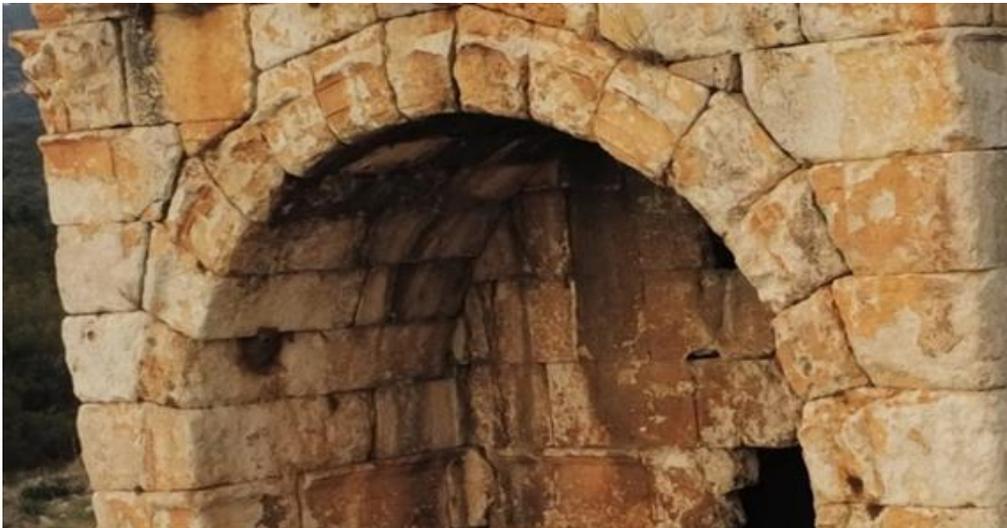
The structural elements that make up the wall spaces in masonry structures are arches. The discoloration of the arches as a result of the joint discharge of the rain and the effect of the sun can be seen (Figure 11).

Figure 9. Joint discharge and discoloration in the arch

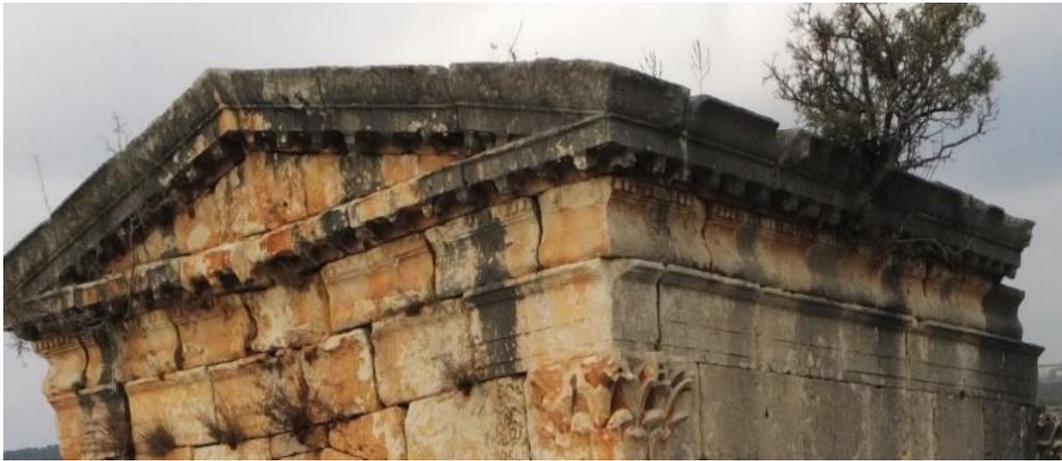
Building elements that make up auxiliary elements in masonry structures are moldings, ornaments and muqarnas. Surface pollution caused by human influence is observed in the wipes. Moisture-based plant formations were observed in places. On the other hand, it was determined that there were color changes in the decorations due to the effect of the sun (Figure 12).

Surface pollution in wipes, Plant formation

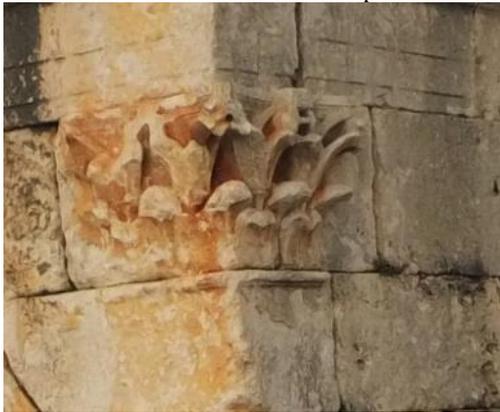
Color change in ornament

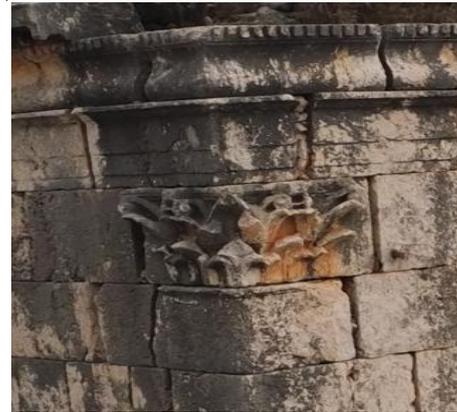
Surface pollution in decoration
