## Integration of 2D mapping, photogrammetry and virtual reality in documentation of material deterioration of stone buildings: Case of Mardin Şeyh Çabuk Mosque

Cite this study: Karatas, L. (2022). Integration of 2D mapping, photogrammetry and virtual reality in documentation of material deterioration of stone buildings: Case of Mardin Şeyh Çabuk Mosque. *Advanced Engineering Science*, 2, 135-146

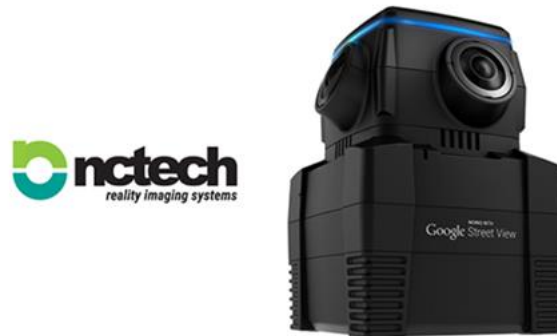
Initially, 360 degree panoramic images of the buildings were taken with NCTech iris360<sup>o</sup> Model Panoramic Imaging by visiting the building, in order to create the 3D environments (Figure 4).

Figure 4. NCTech iris360<sup>o</sup> Model

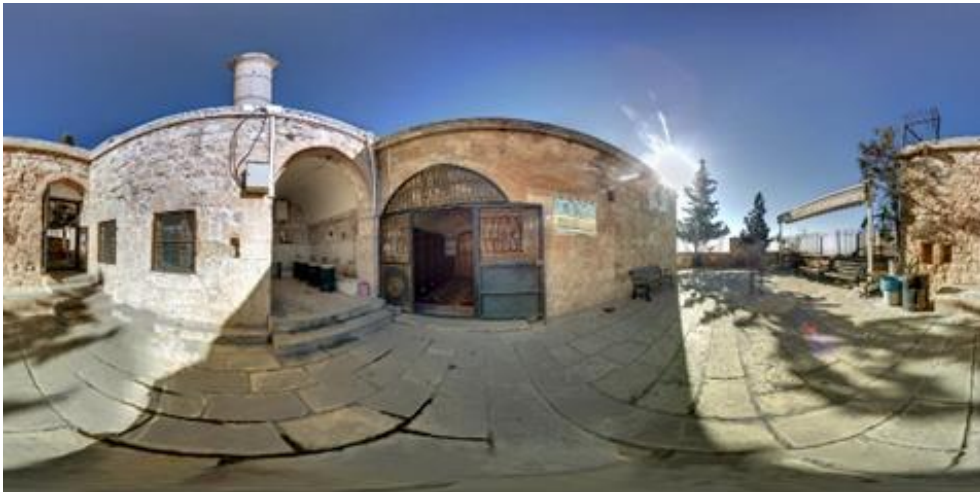
The panoramic images obtained shall be used in 3D virtual environment on Mozilla Hubs, which is an open source platform in internet environment (Figure 5).

**Figure 5.** 360 degree panoramic image of Mardin Şeyh Çabuk Mosque taken by NCTech iris360° Model Panoramic Imaging Device
