Advanced Engineering Days

Cultural landscape elements of Pire (Şeyh) Merdan first degree archaeological site, Mardin

Lale Karataş^{*1}, Aydın Alptekin², Murat Yakar³

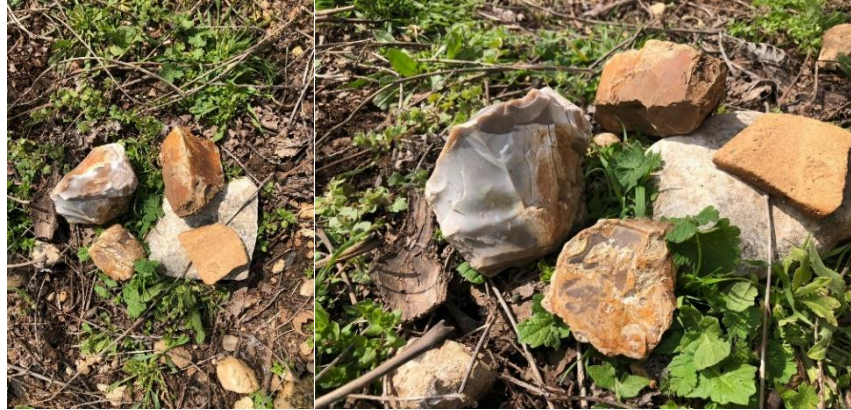
It has been reported by the local population that there is a significant presence of flint stones, some of which are worked, on the dominant hill approximately 1 km walking distance southeast of the Pire Merdan site. It is estimated that the flint stones and nodules identified on the surface in the Pire Merdan settlement area were brought from this location. The most significant evidence of carrying traces of different cultures has been identified through surface examinations. Although the flint stones and tools identified on the surface near the location used as a pool may not be densely concentrated, they can be dated back to the prehistoric period (Figure 1).

Figure 1. The stones presumed to belong to the prehistoric period

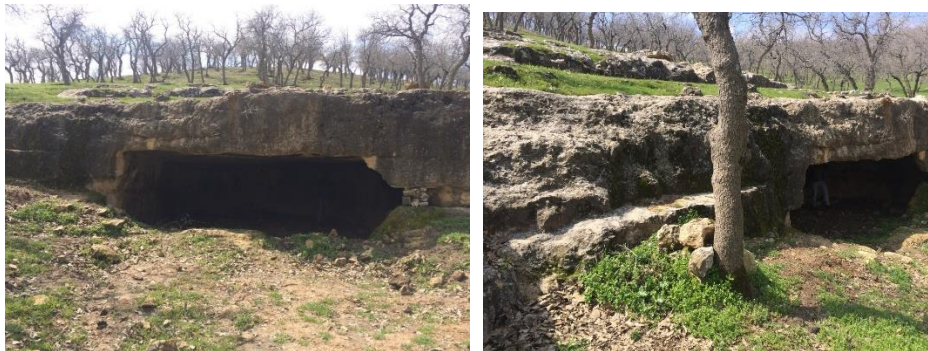
Approximately 130 meters northeast of the section where the pool is located and about 70 meters southwest of the Pire Merdan Tomb, there is a rectangular-shaped cave structure carved into the main rock. The entrance to the cave structure is accessed through a 5-meter-long and 2-meter-high opening. Inside the cave structure, the inner part is carved into the main rock. The ceiling and walls are smoothly carved, and there are decorative arches, presumed to be embossed lintels, on the inner walls. These lintels are believed to be decorative elements that continue at the same level along the walls. At the end of the cave, there is a chimney-like architectural feature in the center of the ceiling. This suggests that it may have been used as a healing center or a place of worship during that period. The roof part of the cave is flat, and the chimney feature is covered with molded and processed stone (Figure 2, 3).

Figure 2. The exterior view of the cave structure

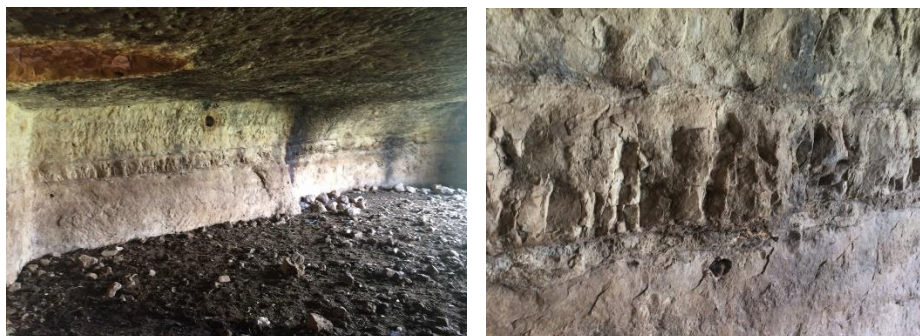
Figure 3. Interior detail photos of the cave structure

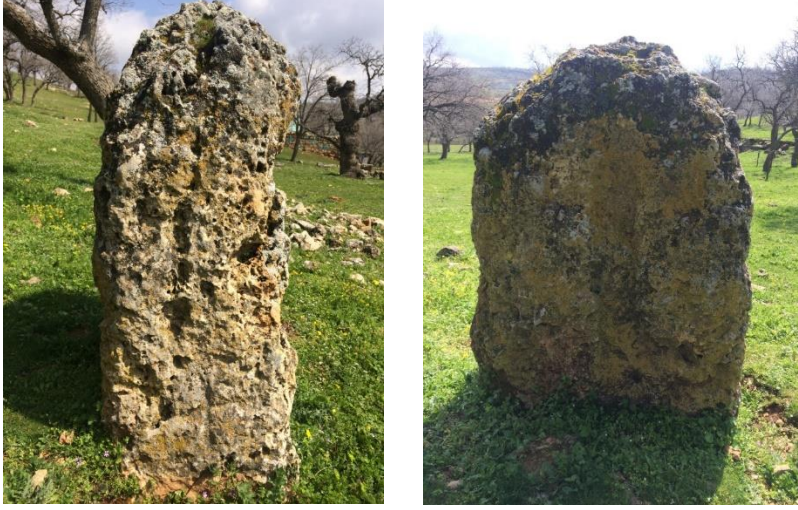
Approximately 60 meters northwest of the cave structure, there are rectangular-shaped architectural remains that are presumed to belong to the Roman period. Some of the stones have been worked, indicating their association with the architectural structure in the area. Adjacent to the architectural remains, there is a damaged monolithic stone in the form of an obelisk, which is believed to be part of the same structure (Figure 4).

Figure 4. The stone structure in the form of an obelisk

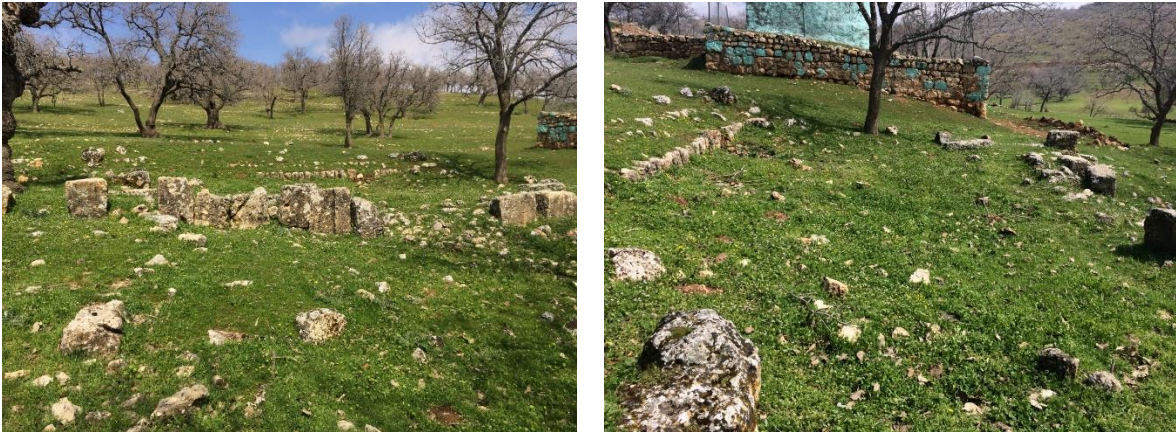
There is an approximate distance of 10 meters between these architectural remains and the tomb. The remains are located in the western section of the tomb structure (Figure 5).

Figure 5. Archaeological architectural remains

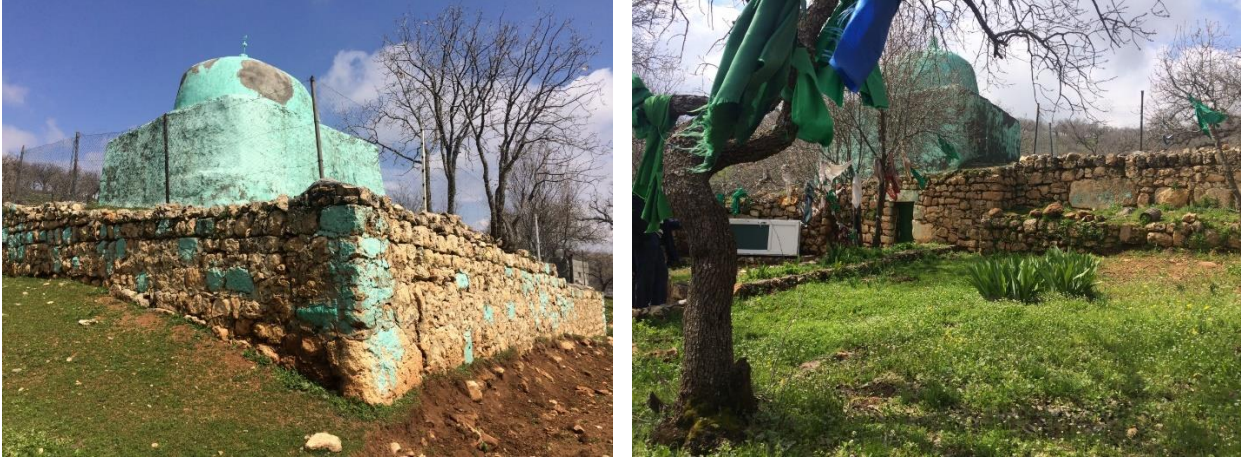
The tomb, located at the center of the site, is one of the most impressive architectural elements of the Pire Merdan Sacred Area. The tomb structure is oriented in a north-south direction and has a square-like plan with an open courtyard. It is constructed with rubble stone materials. The top of the structure is covered with a stone dome that is rounded downwards and tapers towards the top like a cone. The main entrance to the structure is provided through an iron gate with lintel-like forms located on the eastern facade. Above the gate, there is a square-shaped window at the top. Inside the space, in the southern section, there is the tomb sarcophagus belonging to Sheikh Merdan, extending east-west. The interior space is plastered with lime mortar and painted with white lime wash. The entrance to the tomb courtyard is through the lintel-shaped gate on the east side. The northeastern part of the courtyard is elevated in a terrace-like manner and used as a garden with trees. South of the gate entrance, there is a small area built with brick material. The external facades of the structure are made of concrete and painted with a synthetic green color. According to information obtained from the local villagers, it is mentioned that Pire Merdan is one of the twelve disciples of Sultan-Şeyhmus (Sheikh Mussa Ezzuli), who holds great importance in the region (Figure 6, 7).

Figure 6. Exterior details of the tomb structure

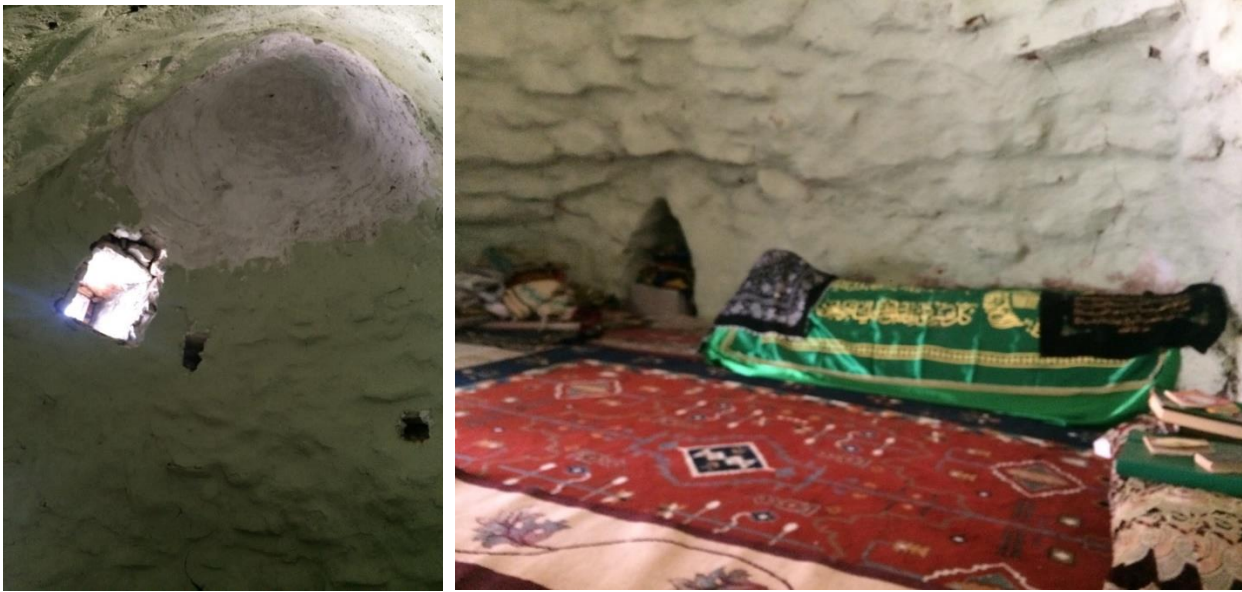
Figure 7. Interior details of the tomb structure
