Stone alterations in Hatuniye Madrasah

Cite this study: Dal, N., Ergin, Ş., Biçen Çelik, A., & Ay, İ. (2023). Stone alterations in Hatuniye Madrasah. *Advanced Engineering Days*, 7, 77-80

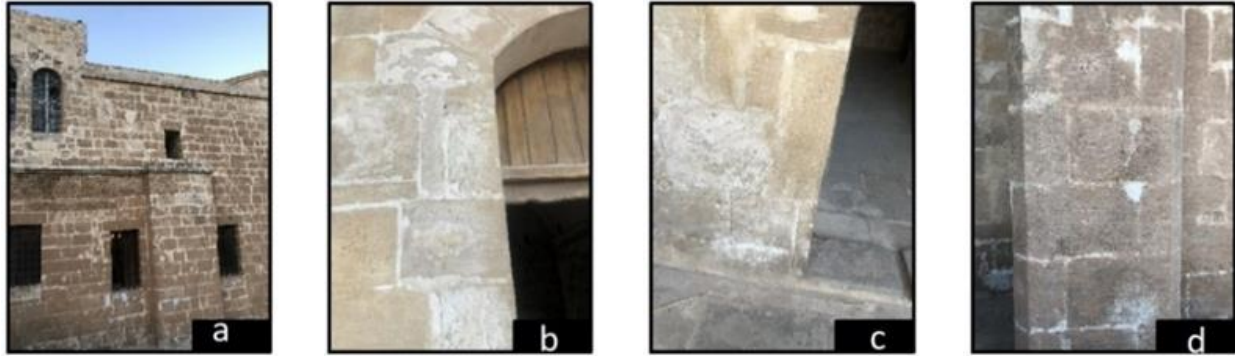
Figure 1. Physical alterations at Hatuniye Madrasah (November, 2019)

The limestone, which is the main material of the building, has been subjected to physical alterations such as fragment breakage, joint discharge (Figure 1a), capillary crack (Figure 1b) and abrasions due to the effect of dust carried by wind (Figure 1c and 1d).

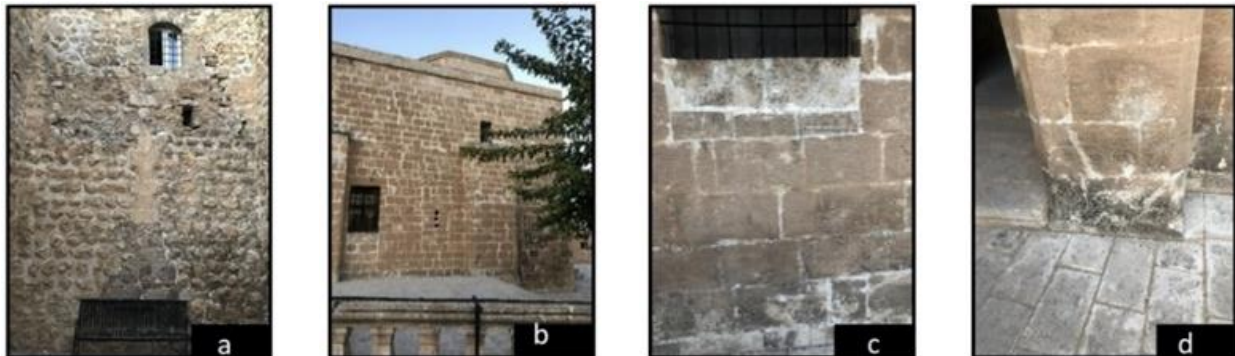
Figure 2. Chemical alterations at Hatuniye Madrasah (November, 2019)

Chemical alteration types such as salination, discoloration and bacterial growth were observed in Hatuniye Madrasah. Discoloration was observed on the inner courtyard façade (Figure 2a) and the main façade (Figure 2b). Salination (Figure 2c) and bacterial growth (Figure 2d) were also observed.

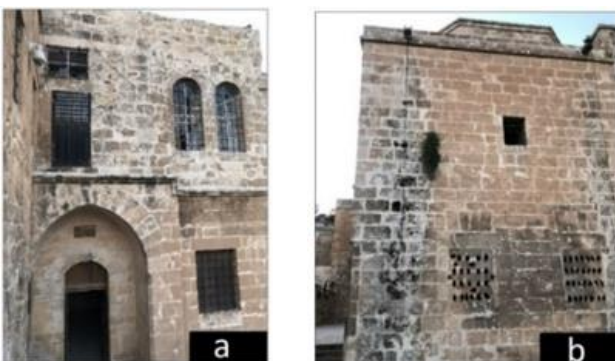
Figure 3. Biological alterations at Hatuniye Madrasah (November, 2019)

Plant formation is encountered as biological alteration in Hatuniye Madrasah. The plant formations on the south and east facades of the building are shown in Figure 3.

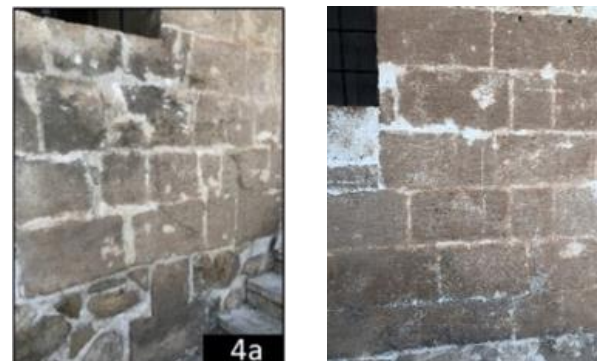
Figure 4. Anthropogenic alterations at Hatuniye Madrasah (November, 2019)

Alterations were observed in Hatuniye Madrasah due to the use of sharp tools as a result of anthropogenic effects (Figure 4).
