## Advanced Engineering Days

### Investigation of stone deterioration in Gaziantep Historical Gümrük Inn

In this study, stone deterioration in the Historical Customs Inn located in Şekeroğlu Neighborhood of Gaziantep was investigated. The deterioration was visually analyzed and recorded by photographs. The two-story and single courtyard inn serves as a museum today. The building, which does not have a proper position due to the location of the building, was built of black and white cut stone. In this study, the deterioration of the inner courtyard and facade walls of the building were examined, identified and classified [9]. According to the classification, deterioration is analyzed in four groups: physical, chemical, biological and anthropogenic [10].

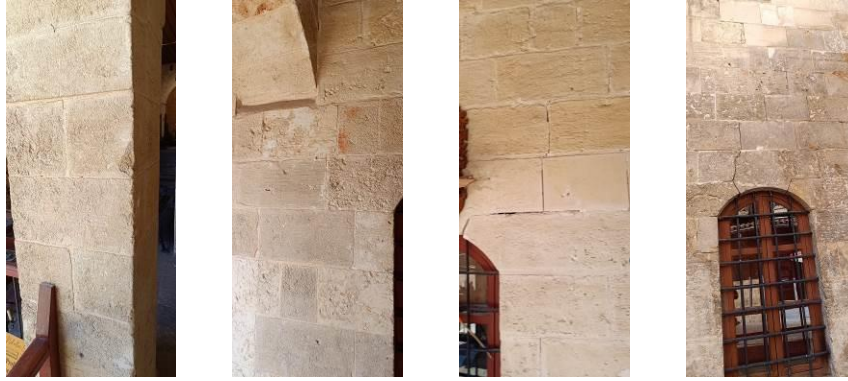
Surface losses that occur on stone surfaces as a result of changes in the petrographic properties of the stone as a result of internal and external factors are called physical deterioration. Capillary cracks, fragment breaks, surface abrasions, cuts and joint losses can be given as examples of physical deterioration [15]. The physical deterioration observed in the Historical Gümrük Inn structure is shown in Figure 1.

**Figure 1.** Physical deteriorations in Historical Gümrük Inn

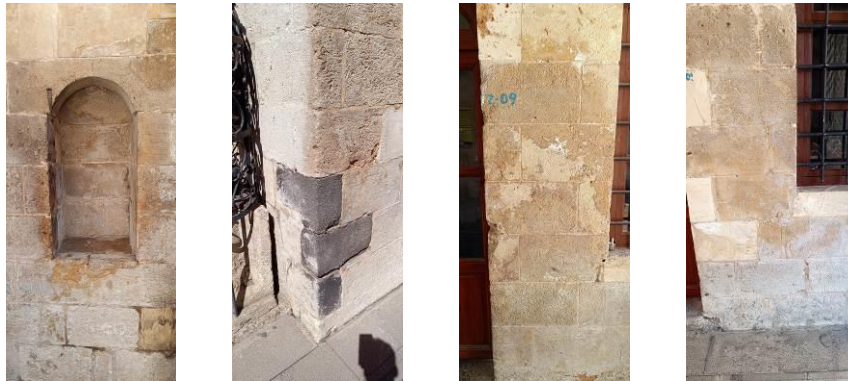
The deterioration of stone surfaces as a result of climatic and atmospheric factors such as temperature and humidity is called chemical deterioration. Crystallization, salinization, discoloration and foliation are the types of chemical deterioration [16]. The chemical deterioration of the Historical Gümrük Inn is shown in Figure 2.

**Figure 2.** Chemical deteriorations in Historical Gümrük Inn

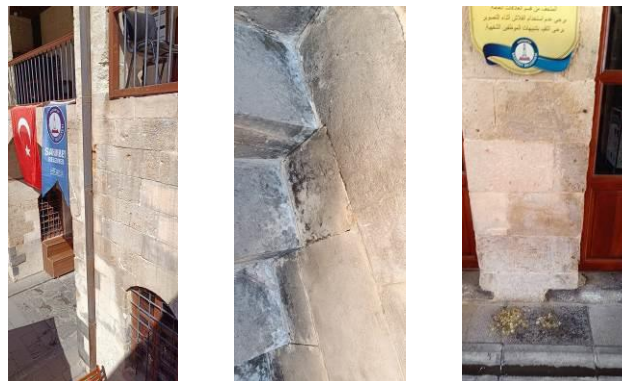
The degradation of the stone surface as a result of the reaction of biological substances with the stone surface is called biological degradation. Algae growth, plant growth, plant accumulation are types of biological degradation [17-18]. Biological degradation in the historical Gümrük Han structure is shown in Figure 3.

**Figure 3.** Biological deteriorations in Historical Gümrük Inn

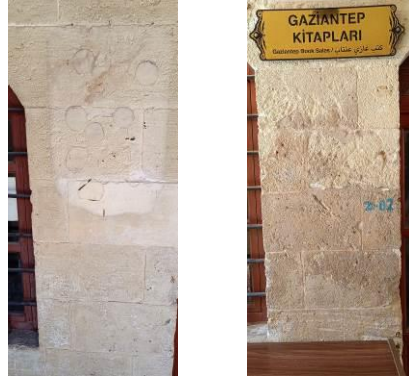
Anthropogenic deterioration is the deterioration that occurs as a result of the damage caused to traditional stone structures consciously or unconsciously by humans [19]. Incorrect restoration practices, misuse, neglect and wear and tear are the types of anthropogenic deterioration. The types of anthropogenic deterioration in the Historical Gümrük Inn structure are shown in Figure 4.

**Figure 4.** Anthropogenic deteriorations in Historical Gümrük Inn
