### Investigation of stone deterioration in Gaziantep Kumandan Fountain

Cite this study: Ay, İ., Dal, M. & Ergin, Ş. (2023). Investigation of stone deterioration in Gaziantep Kumandan Fountain. *Advanced Engineering Days*, 8, 56-59

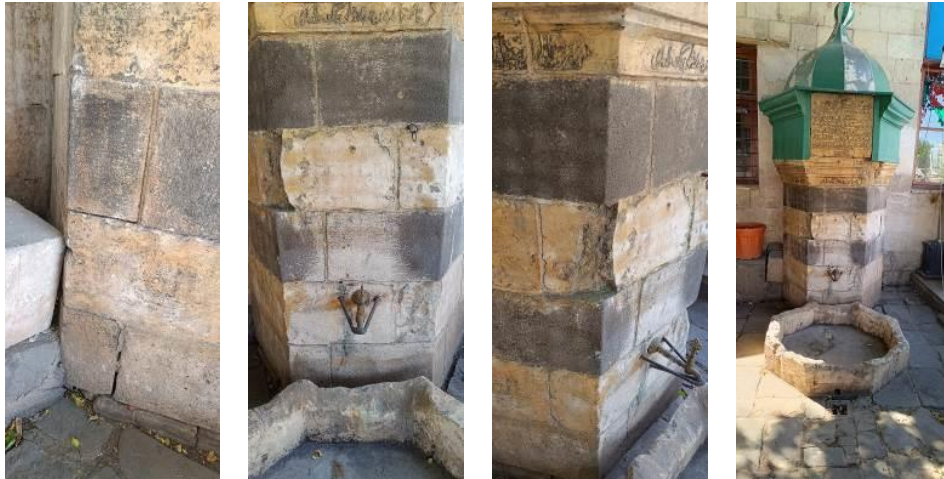
Surface losses on stone surfaces as a result of internal and external factors are called physical deterioration. Capillary cracks, fragment breaks, surface abrasions, cuts and joint losses are examples of physical deterioration [15]. The physical deterioration observed in the structure of the Kumandan Fountain is shown in Figure 1.

**Figure 1.** Physical deteriorations in Kumandan Fountain

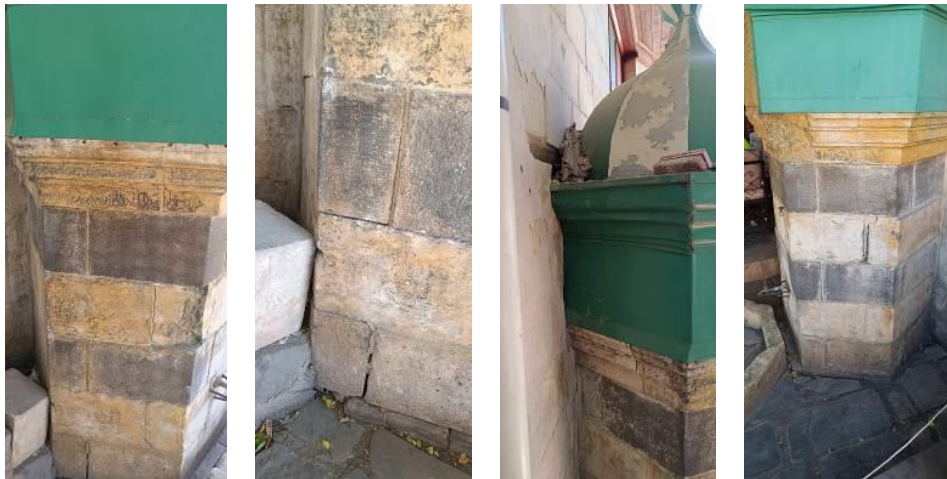
The deterioration that occurs on the stone surface as a result of atmospheric events and climatic factors is called chemical deterioration. Color change, crystallization, salinization, crusting and foliation are the types of chemical deterioration [16]. Chemical deterioration occurring in the structure is shown in Figure 2.

**Figure 2.** Chemical deteriorations in Kumandan Fountain

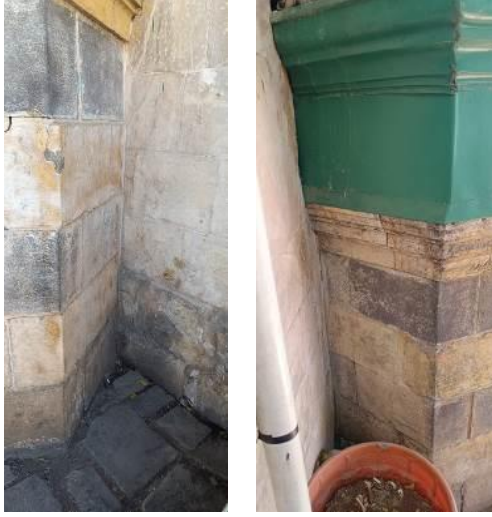
The deterioration of organic substances on the stone surface is called biological deterioration. Algae growth, plant growth, bioaccumulation are the types of biological deterioration [17, 18]. Biological deterioration in the structure is shown in Figure 3.

**Figure 3.** Biological deteriorations in Kumandan Fountain

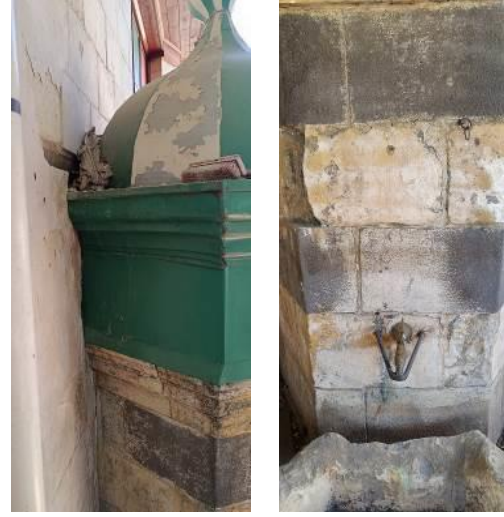
Anthropogenic deterioration is the deterioration of traditional historic stone buildings caused by the conscious or unconscious damage caused by humans [19]. Destructions such as misapplication, misuse and periodic wear and tear are types of anthropogenic deterioration. Anthropogenic deteriorations in the structure are given in Figure 4.

**Figure 4.** Anthropogenic deteriorations in Kumandan Fountain
