Advanced Engineering Days

Mardin historical Eski Demirciler (Old Blacksmiths) and Kunduracılar (Shoemakers') Bazaar architectural features

Lale Karataş^{*1}, Aydın Alptekin², Murat Yakar³

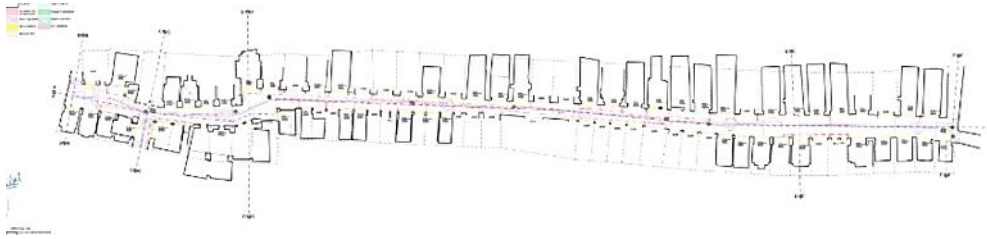
Figure 2. Floor Plan of Eski Demirciler and Kunduracılar Bazaar

Contrary to the traditional Mardin housing structure, a simpler orientation is observed in the buildings where the economic activities of the city are located. The architectural features of the bazaar are simple and generally consist of multi-storey houses built over the shops. The apartments built on the north and south wings of the bazaar were built so close to each other that they could close the street crossing distance. The inner filling stones of the original shops of the bazaar, located just south of the 1st Street, are made of coarsely cut limestone, and the outer walls are made of locally cut and finely cut limestone. The shop entrances of the bazaar are designed as pointed and semicircular arches with wide openings. Due to the topographic structure of the bazaar, it slopes from north to south and extends in the east-west direction, forming a small area by breaking in the west of the street bazaar. At the end of this area, the street narrows again and opens to the 1st Street in a sloping way. Near the western end of the street, it passes to the Yemenciler and Kaçakçılar Bazaar with a small street. The street floor is paved with masculine basalt stone pavements. The shops of the open-top bazaar are next to each other, facing each other on the north and south sides of the street. The original shops have a rectangular plan with pointed or semi-circular arches, cross and barrel vaults from the inside, and flat roofs from the outside, and they face the street. Today, however, a significant part of the south-facing shops has been converted to reinforced concrete (Figure 2).

The building was built in the masonry construction system as in the traditional Mardin architecture. The main construction material is limestone, which is processed from the quarries in the region. The main construction material of the elements such as the walls, cover and flooring of the building is the same stone. The sections between the inner and outer faces of the walls and the interior of the vaults are rubble fill. The outer walls are

made of rubble masonry and thick joints. However, the wall of the interior and the walls of the sections where the vaults are located are thin. Wooden materials are used in the door, window joinery and wings.

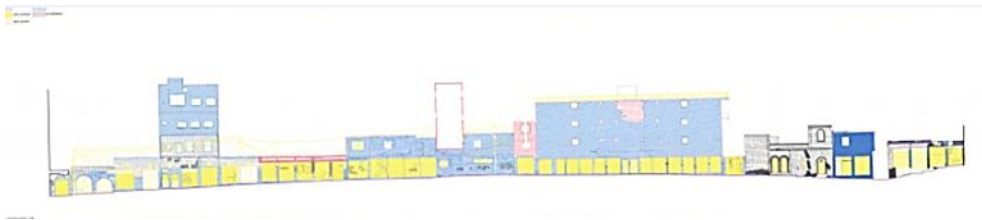
Figure 4. Eski Demirciler and Kunduracılar Bazaar South Wing View

The arcaded shop entrances in the south wing of the bazaar have been converted into reinforced concrete lintels and are single storey. While the street façade of the south wing preserves its structural originality, interventions contrary to the original texture are observed on the façade surface. The fact that the facade surfaces were plastered in places, the original entrances were damaged, and the original wooden doors were replaced by iron doors or shed shutters caused significant changes in the authenticity of the street facade of the bazaar. The southern wing of the Ayakkabıcılar Bazaar was completely demolished before 1950, and instead, reinforced concrete shops and a three-storey reinforced concrete apartment building were built on the same plots. In the west direction of the south wing, there are shops with the original texture but whose entrances have been converted into reinforced concrete lintels (Figure 4).
