Detection of materials and material deterioration in historical buildings by spectroscopic and petrographic methods: The example of Mardin Tamir Evi

Lale Karataş¹, Aydın Alptekin², Murat Yakar³

Within the scope of the "Mardin House Conservation and Restoration Project" carried out by the Cultural Heritage Preservation Association and the Mardin Archeology Museum, 3 wood samples, 12 stone samples, and from the deep between knitting stones 12 mortar samples, were taken from the Mardin House from a building in the Artuklu District of Mardin Province. The following analyzes were carried out in the Restoration-Conservation and Analysis Laboratory of the Mardin Museum.

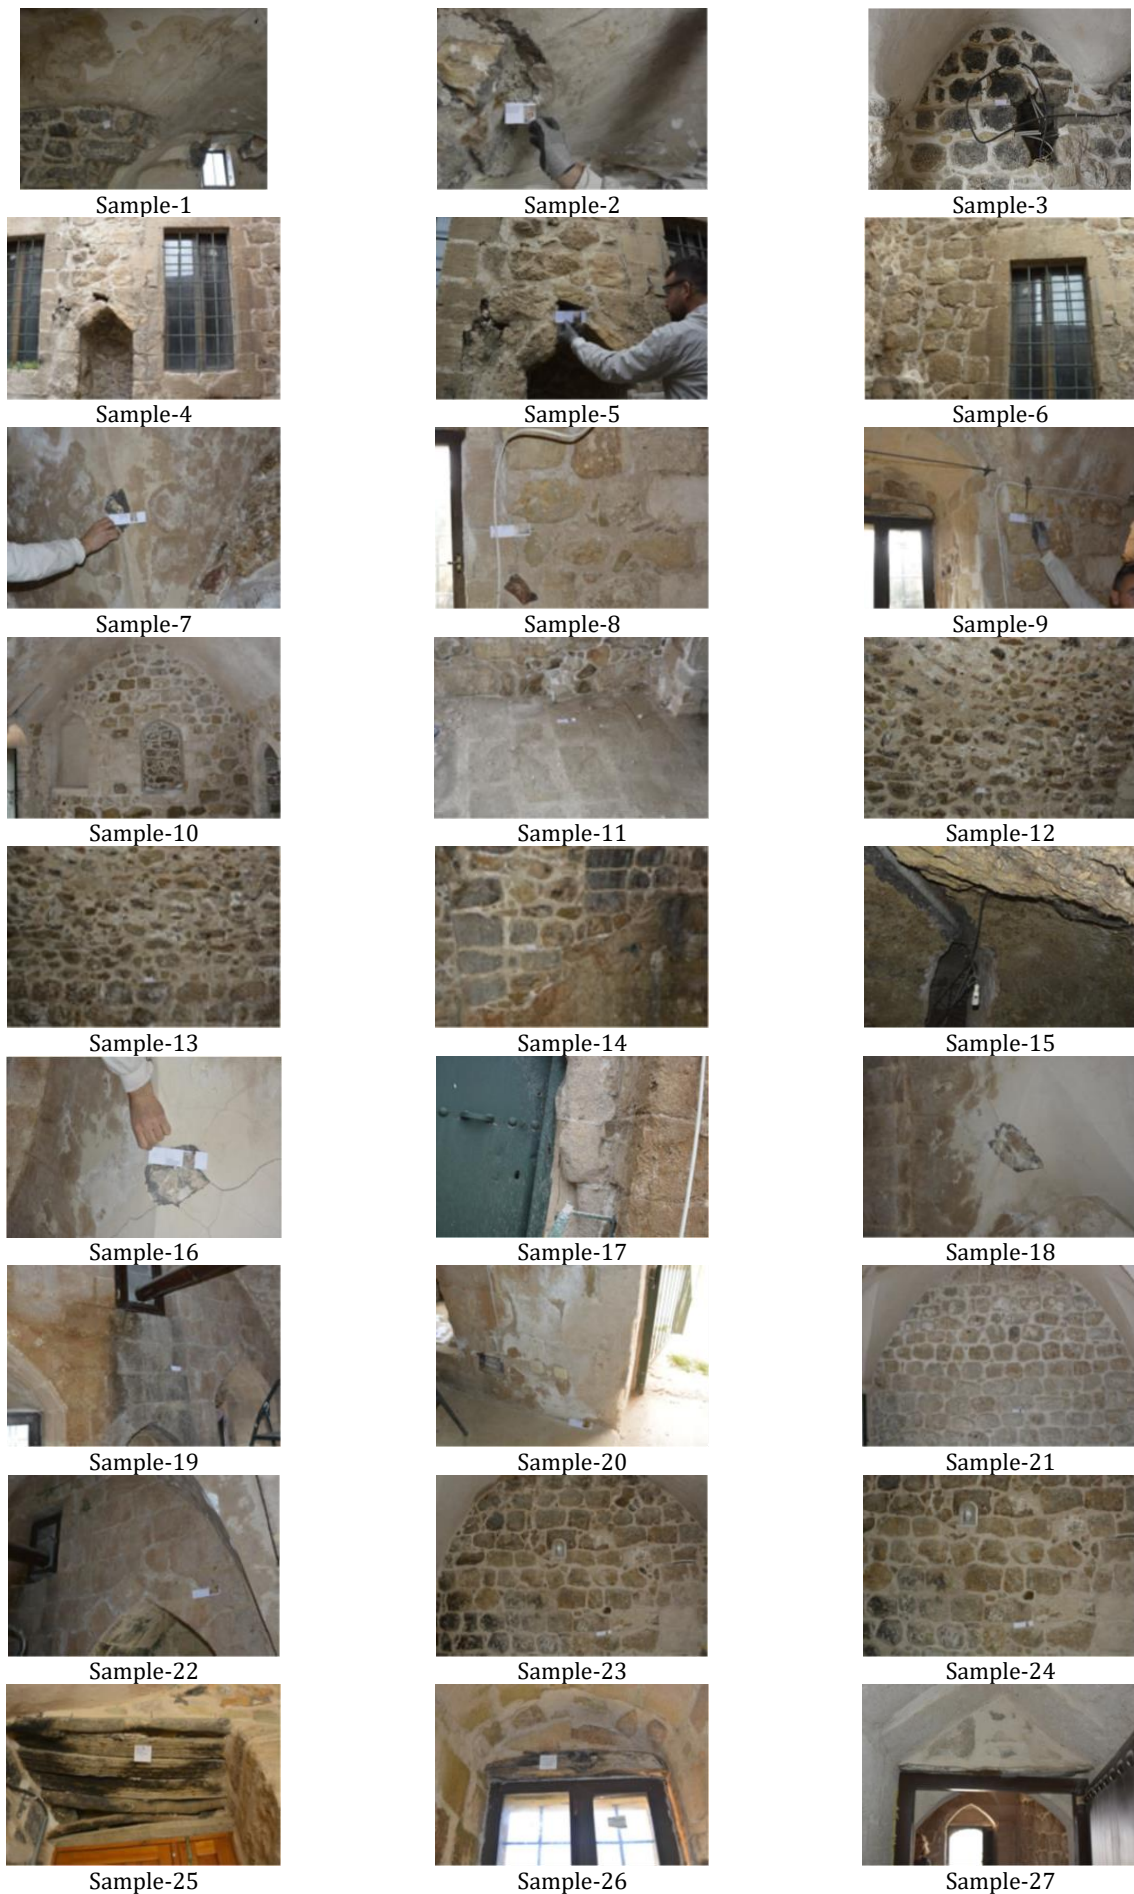
Figure 1. Samples taken from Tamir Evi

Sample No	Explanation
1-Z01 (Stone)	It is a solid example of a yellowish light brown colored stone with black deposited dirt on its surface, taken from the damaged part of the vault of the semi-open courtyard section of the house.
2-Z01 Ton. (Mortar)	It is a sample of brownish gray mortar, with white masses up to 4 mm in size, at least 4-8 mm in size, taken from among the masonry stones in the damaged part of the vault of the semi-open courtyard section of the house, which disintegrates while it is intact.
3-Z01 D.D. (Mortar)	It is a relatively solid sample of brownish gray mortar with white masses up to 2 mm in size, 3-5 mm in spatter, and taken from the wall of the semi-open courtyard section of the house.
4-Z02 K.C.D. (Mortar)	It is a sample of brown-colored mortar containing aggregates up to 10 mm in size, relatively solid in place, and dispersed when taken, taken from the south exterior (courtyard) façade of the house.

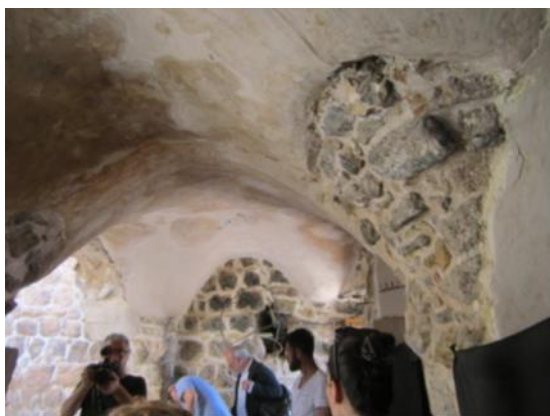
(a)

Mortar No. 2, 3, 14 and 24, which is classified as the second main group, is a sample binder, Portland cement with 10-15% lime added, varying between 100-200 doses, and its aggregates are 5 mm in average under sieve size and 3-5% volcanic fracture of limestone, which is rock particles and quartz. In the 3rd sample of this group, approximately 5% ash was added additionally. It has been understood that the mortars of this group, depending on their binding nature, were used in the extensive and/or individual repairs made in the middle or the second half of the 20th century. It has been visually determined that all of the plasters applied on the vaults of the house, which did not need to be taken as samples, were recent plasters with portland cement binder (Figure 1,2).

Figure 1a. In the vault of the space in the semi-open courtyard of the house
Figure 1b. Upstairs, recent repair plasters with portland cement binder in the kitchen vault

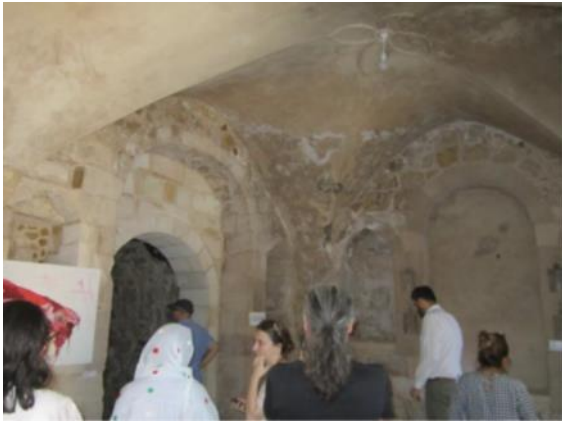
(a)

Figure 2a. Upstairs of the house, recent repair plaster with portland cement binder in the vault of the entrance room

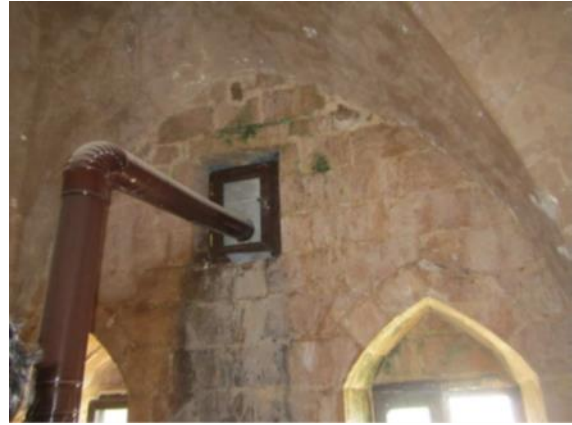
(b)

Figure 2b. Plant formations and stains caused by water on the inner surface of the south wall

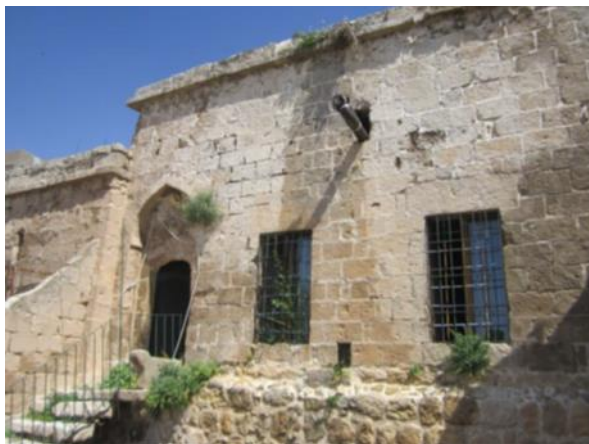
(a)

The stones in the ground floor of the house and the rock-cut section were found to be micritic limestone with plenty of cracks, which has not yet completed its petrification, looks like greywacke and has plenty of clay. It has been determined that there are surface erosions on the inner and outer surfaces of the walls of the house, especially in the areas of water evaporation, there are chloride and nitrate salts from the repair mortars and plasters with portland cement binder in general, and from the sewage in places, from the water leaking from the walls and roof (roof) of these salts, from the flowering cycle of these salts. In addition to these surface problems, as a result of the overflow of the water tank on the roof of the house, wetting on the outer surface of the south wall of the house, accordingly the formation of herbaceous plants on the exterior, woody plant formations on the garden wall, as well as the moisture problem in the entire building has been seen. As a result of these wetting and drying cycles, there has been an increase in flowering and surface erosion of the mesh stones (Figure 3,4).

Figure 3a. On the outer wall surface of the house, with herbaceous plant formations due to wetting

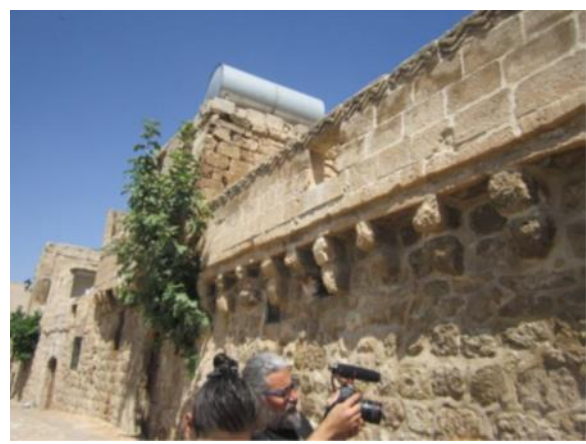
(b)

Figure 3b. General views of the woody plant formation on the garden wall

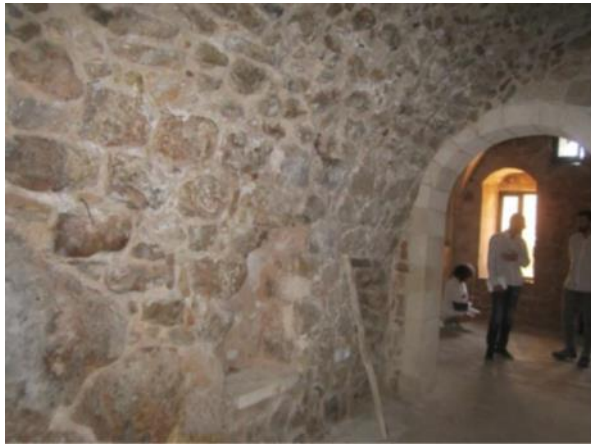
(a)

Figure 4a. General view of efflorescence (salt deposits) occurring in the evaporation zone on the interior wall surfaces of the house

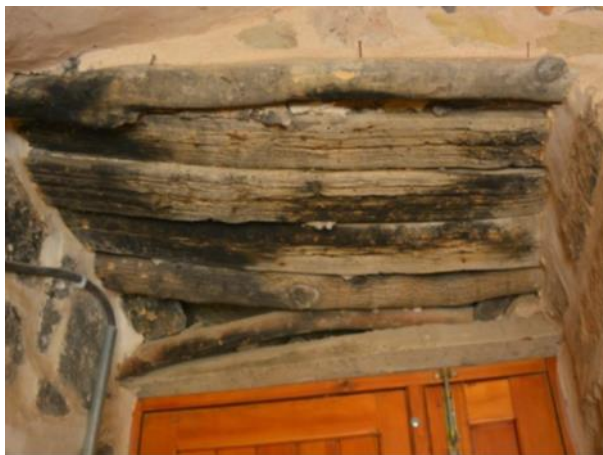
(a)

In addition, poplar (*Papulus Nigra L.*) wooden elements were used on the beams on the doors and windows on the lower floor of the house, while oak (*Queras SPP.*) wooden elements were used on the beams on the doors and windows of the upper floor ([Figure 5](#)).

Figure 5a. General view of the wooden elements used on the door tops and the damage caused by rot and insect infection on these wooden elements

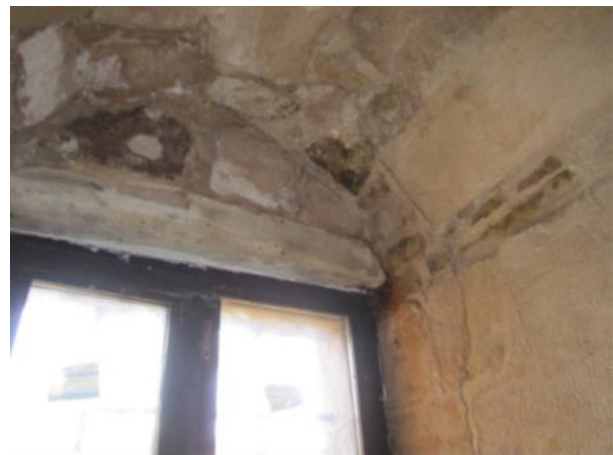
(b)

Figure 5b. General view of the wooden elements used on the window tops and the rot and insect infection damage on these wooden elements

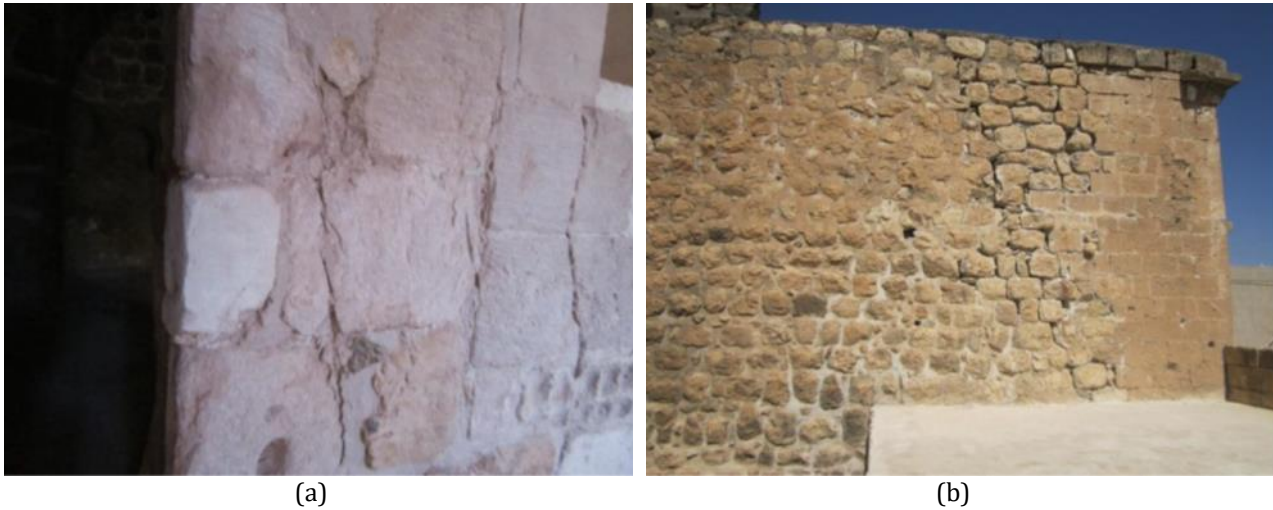
In addition, according to the gallery type, *Anobium Punctatum* (Furniture Beetle) is used on the wooden main carriers that carry the wooden elements, which are exposed to brown-colored rot in various intensities due to humidity and individual wetting in general, and which carry the connecting wall of the place between the bagdadi laths and the Z02 space of the Observatory and the connection corridor.) were found to be infected by insects, which are understood to be of the genus. In addition to the problems in the building materials of the house, it has been visually determined that there are structural static problems in the walls and rock-carved vaults of the house, although not much. In addition, it is seen that there is a very serious structural crack in the wall of the neighboring house, which is understood to have been partially destroyed and repaired before ([Figure 6](#)).

Figure 6a. General view of static problems on the interior wall of the house
Figure 6b. General view of static problems on the wall of the neighboring house
