Advanced Geomatics

Erdem, N. & Gdl, R. (2022). Road-Parcel Situations and Property Analysis of Neighborhoods in Çukurova Regional Airport Project after Land Consolidation Projects. *Advanced Geomatics*, 2(2), 30-36.

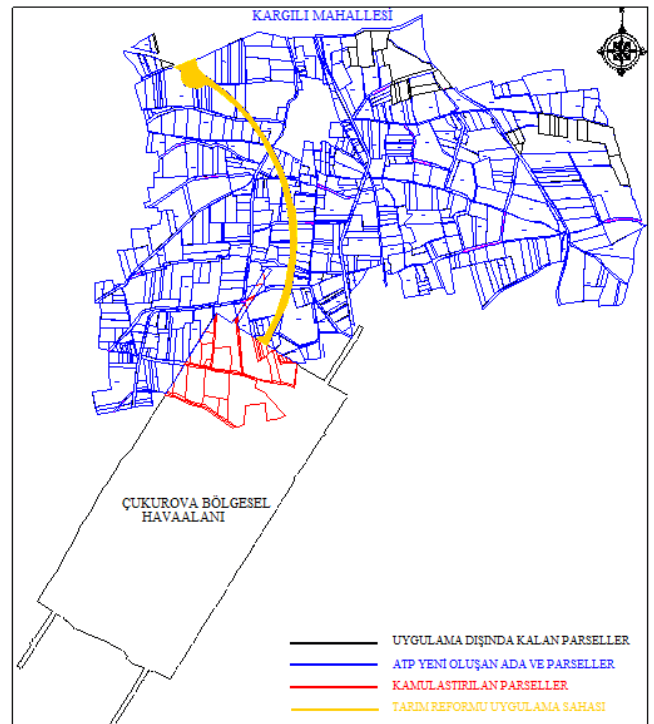
**Figure 6.** Kargılı District newly formed island-parcel and expropriated parcels.

While the parcel information of Kargılı Neighborhood, whose consolidation has been completed, was in the suspension announcement, it was subjected to re-examination by the Consolidation Administration as a result of the objections made by the owners. Therefore, its registration has not been completed and the net area cannot be specified. According to the approximate value obtained from the TKGM parcel query system, the total area of Kargılı District is 1931.93 hectares (Figure 6).

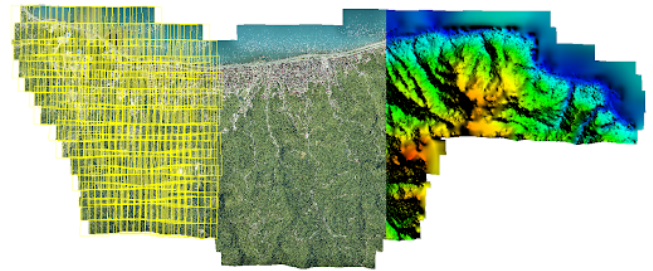
**Figure 2.** Photogrammetric Data Processing Steps.

By using photogrammetric methods, Point Cloud at 26 Point/m<sup>2</sup> density, 8cm resolution Digital Surface and Terrain Model (DSM and DTM), 8cm Resolution True-Orthophoto Generation data were used. The Digital Terrain Model was produced at 8cm resolution. All structures were automatically obtained from 3D vector data and dense point cloud. Buildings are automatically mapped (Buyukdemircioglu et al 2018).

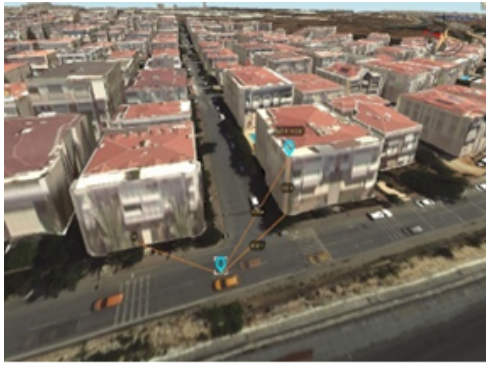
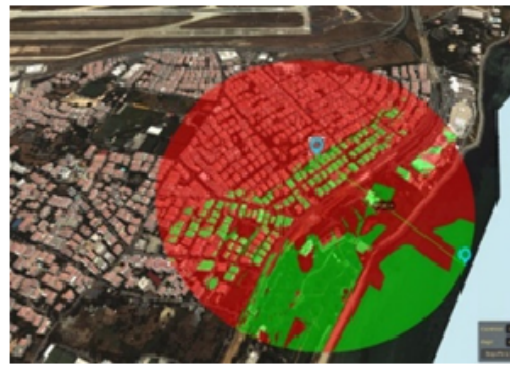
**Figure 8.** (a) and (b) are spatial analysis using CityGenius software on 3D model.

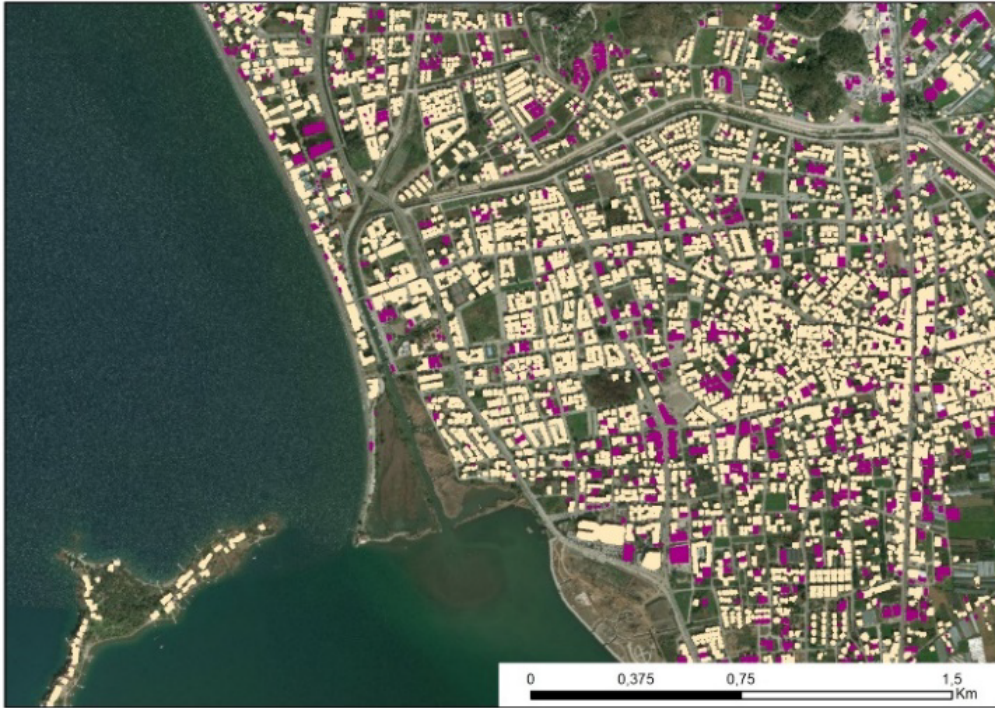
**Figure 11.** Between 2005 and 2020, buildings area in the PA increased by 20%.

By land use change analysis in greenhouse areas, greenhouse areas decreased by 5% between 2005 and 2020. Most of the greenhouse areas have turned into residential area in the last 15 years. There may be many different reasons for the reduction in greenhouse areas between 2005 and 2020. The areas that were greenhouse areas in 2005, which have now turned into residential, were investigated. According to this analysis, 7% of the existing buildings in 2020 had greenhouses in 2005. Most of these greenhouse areas, which have been converted into building, are designated as "Agricultural Area" according to the 1/25000 Environmental Master Plan.

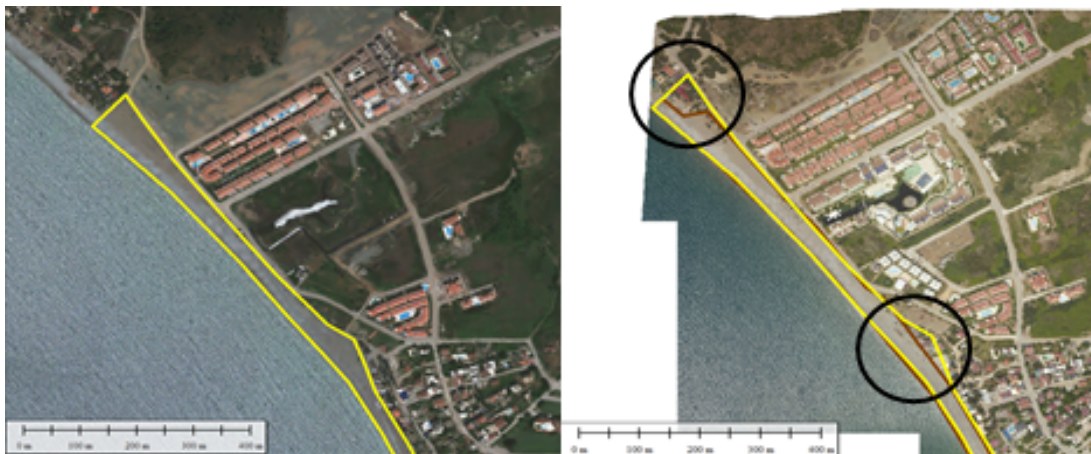
**Figure 12.** Between 2005 and 2020, coastal area changes in the PA.

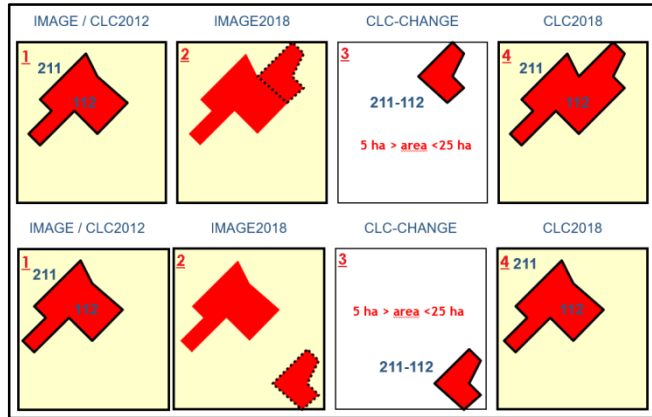
Figure 2. Consistent mapping of CLC Change

The aim of CLC-Change creating is to produce a map of real land cover changes describing an evolution process taking place in the environment (e.g. urban sprawl, forest clearcut). Changes should be interpreted regardless of their position (Fig. 2). Change polygons should: have size at least 50 da, have width at least 100 m, describe a real evolution process that occurred between yearold and yearnew, and be detectable on satellite images.

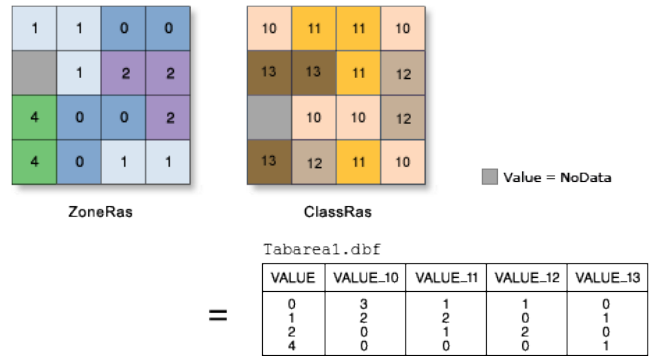
Figure 3. Tabulate Area Illustration

Geographic Information System(GIS) is important for collecting and processing geographic data of objects. Transforming data into geographic information with geographic analysis and viewing geographic data helps to plan activities (Başara et al. 2021). GIS software was used as a method in examining the land cover change. “Zonal toolset” and “Tabulate Area” analysis was performed from the “Spatial Analyst toolbox” menu of ArcGIS software. Calculates cross-tabulated areas between two datasets and outputs a table (Fig. 3).

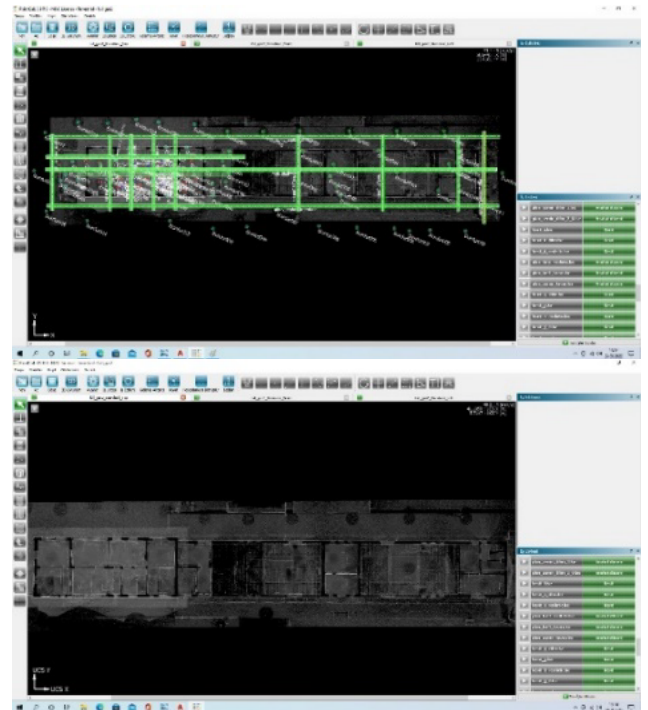
**Figure 2.** Scene of creating orthophotographs from the point cloud obtained from Terrestrial Laser Scanning, using the programme named PointCab Origins 3.9

In this stage, orthophotograph images of the building were acquired from the point clouds obtained in the laser scanning procedure in the software named PointCab Origins 3.9 (“Fig. 2-7”).

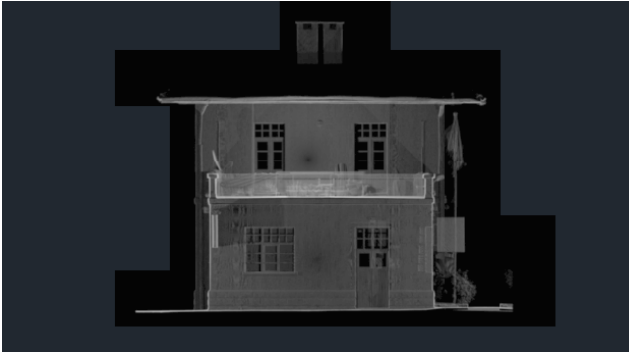
Figure 4. Orthophoto of west frontage

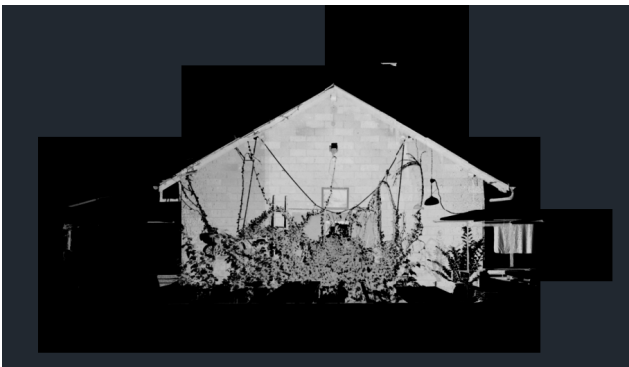
Figure 5. Orthophoto of east frontage

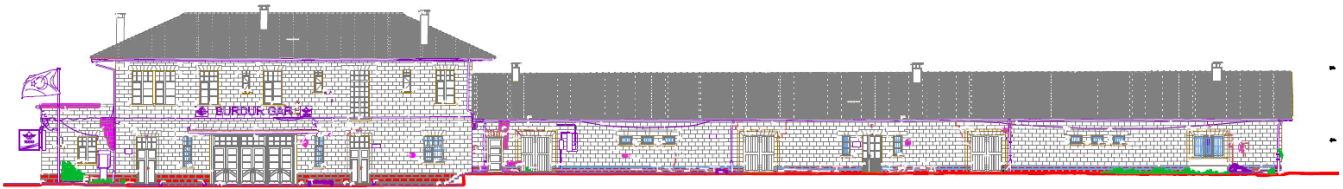
**Figure 10.** The south frontage

Besides, there are numerous jerry-built attachments are present on the facade (“Fig. 10”).

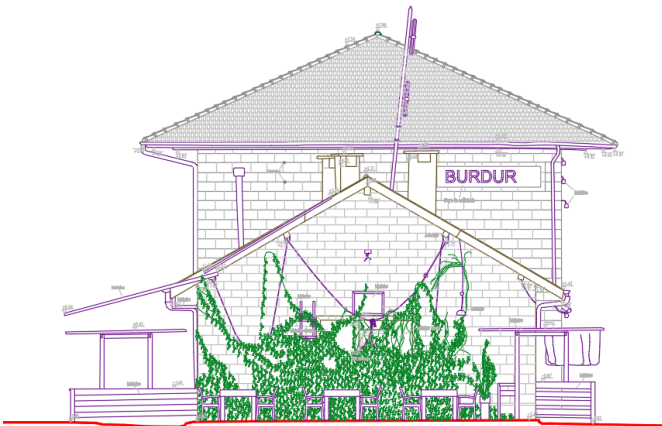
**Figure 11.** The east frontage

Majority of the east frontage is covered with ivy plant, and it is seen that the front of the facade is utilized as a cafe. Jerry-built attachments and deteriorations such as the surface contamination were observed ("Fig. 11").

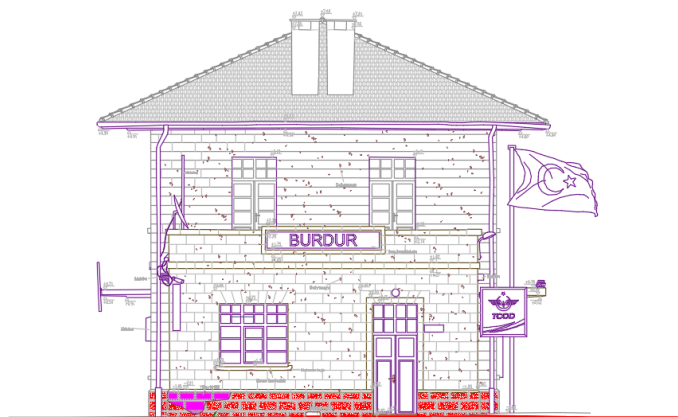
**Figure 12.** The west frontage

It is seen that intervention has been made on the sign plate within the rectangular frame created by cut stones with paint on the west frontage. Deformation and surface contamination, and various jerry-built attachments such as cables and antenna are seen on the surface of the cut stone facade ("Fig. 12").
