6th Intercontinental Geoinformation Days

The 3D virtual restitution of historical buildings using photogrammetry: A case study of the Dungeon-Cistern structure in the Ancient City of Dara (Anastasiopolis), Mardin

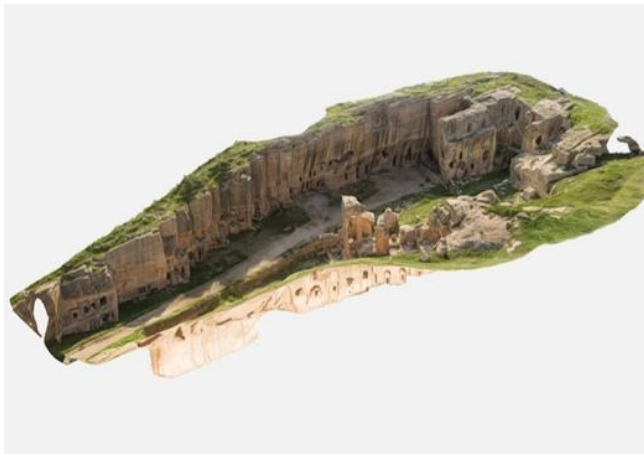
Figure 2. 3D model of the Dara Necropolis Area.

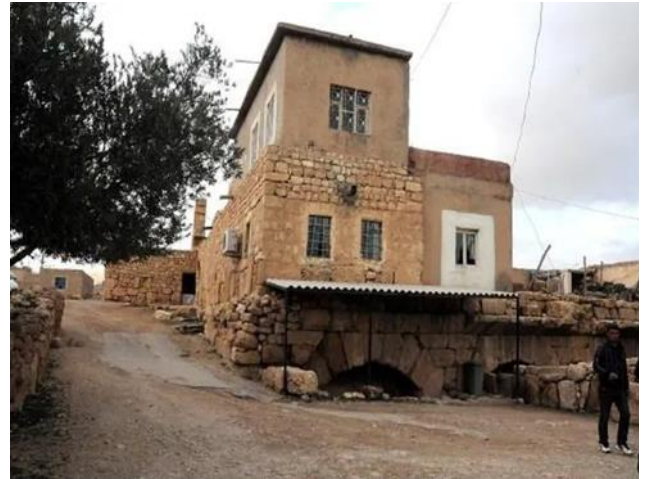
Figure 3. Dara (Anastasiopolis) ancient city Zindan-Cistern structure: (a) Exterior appearance (b) Interior space

The archaeological remains of Dara, including the city walls, public structures, private residential areas, necropolis, and stone quarries, are among the important features that make Dara city significant (Karataş, 2016). The Zindan-Cistern structure, belonging to the ancient city of Dara/Anastasiopolis, is one of the notable structures in the area (Figure 3).

The Dungeon-Cistern structure of the ancient city of Dara (Anastasiopolis) is located approximately 100 meters northwest of Agora Street. It is a large cistern with well-cut stone walls, and its original entrance is on the eastern facade. Despite the fact that the connected structures and adjacent spaces are still underground and a house has been built on top of the structure at a later date, the structure still retains its grandeur. Above the two-story structure, the city's cathedral (great church) is located, of which only one wall remains standing today in the western part. According to the historian Procopius, there are two significant churches in Dara. One of them is the 'Great Church,' and the other is the Bartholomew Church. According to the historian Theodoros Lector, Saint Bartholomew appeared in the dream of Anastasius and asked for the protection of the city. In response to this, Anastasius had Bartholomew's bones brought from Cyprus to Dara. Until the 14th century, there was a Syriac metropolitanate in Dara (Gabriel, 1940; Abdulgani Efendi, 1999).

water. In the ancient city of Dara, outside the city walls, another cistern, dating back to the 6th century and known as the "zindan" among the locals, was identified. The interior of the cistern, which had its upper covering collapsed, was filled with 18 meters of soil. Through excavation, the soil filling inside the cistern, which was used as a stable, was emptied, and its vaulted upper covering was restored using its original stones without the use of any new stones (Gabriel, 1940; Abdulgani Efendi, 1999; Akyüz, 1988). The interior of the structure is a symmetrical rectangle approximately 23x16 meters in size, extending in the east-west direction. Its height is approximately 15 meters (Figure 4).

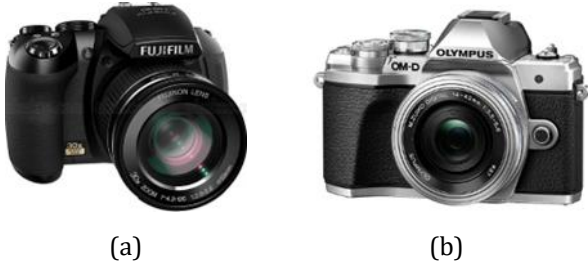
Figure 4. a) A professional digital camera, Fuji FinePix HS10 model, with 30X optical zoom, panoramic shooting feature, and a resolution of 10.3 megapixels.

b) A semi-professional digital camera, Olympus SP-550UZ model, with 18X optical zoom and a resolution of 7.1 megapixels.

In the second stage of the study, the documentation of the original state of the structure revealed through archival research was carried out using a 3D model. For this purpose, the Zindan-Sarnıç structure of Dara/Anastasiopolis ancient city was examined on-site and photographed. During these fieldwork activities, two cameras were used: a Fuji FinePix HS10 model with 30X optical zoom, panoramic shooting feature, and 10.3-megapixel resolution, and an Olympus SP-550UZ model with 18X optical zoom and 7.1-megapixel resolution, both operated with tripod stands. Numerous photographs were taken from different perspectives to thoroughly and comprehensively document all parts of the structure, capturing both general views and detailed components (Figure 4).
