6th Intercontinental Geoinformation Days

Stone material damage detection in restoration using Virtual Reality: The case of Virgin Mary Church and Patriarchate in Midyat, Türkiye

Karataş, L., Dal, M., Alptekin, A., & Yakar, M. (2023). Stone material damage detection in restoration using Virtual Reality: The case of Virgin Mary Church and Patriarchate in Midyat, Türkiye. *Intercontinental Geoinformation Days (IGD)*, 6, 9-12, Baku, Azerbaijan

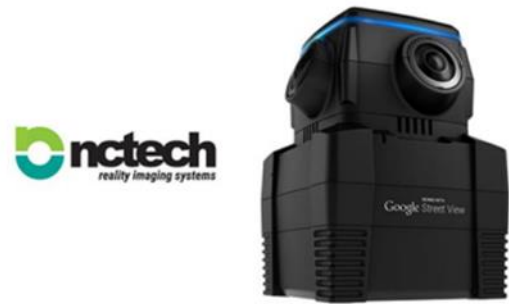
Figure 2. The NCTech iris360° Model is a panoramic imaging device used for capturing 360-degree panoramic images. (TMMOB Jeoloji Mühendisleri Odası, 2023).

To capture 360-degree panoramic images that encompass the entire surroundings of the historical building, special equipment such as dedicated 360-degree cameras, cameras with a 360-degree shooting mode, or smartphones with 360-degree capabilities can be used. It is important to carefully capture the shots to obtain high-resolution and sharp images. Sufficient photographs should be taken to capture all the details, both indoors and outdoors of the building (Karatas, 2022a; b; c). In this study, the selected structures were visited, and panoramic images of the buildings were captured using a panoramic imaging device (NCTech iris360° Model) (Figure 2) for the creation of three-dimensional virtual environments (Figure 3).

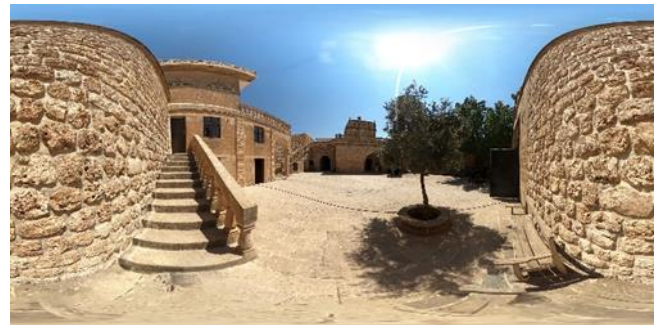
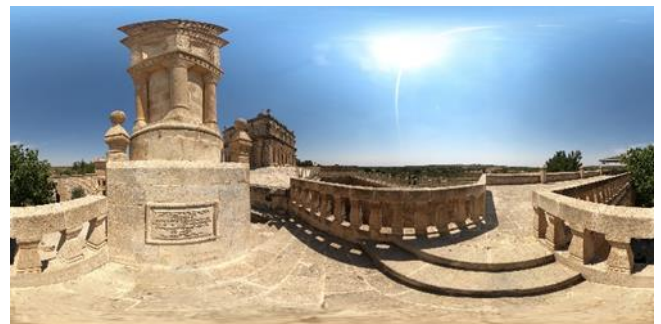
Figure 3. 360-degree panoramic images of the Virgin Mary Church and Patriarchate taken by the NCTech iris360°

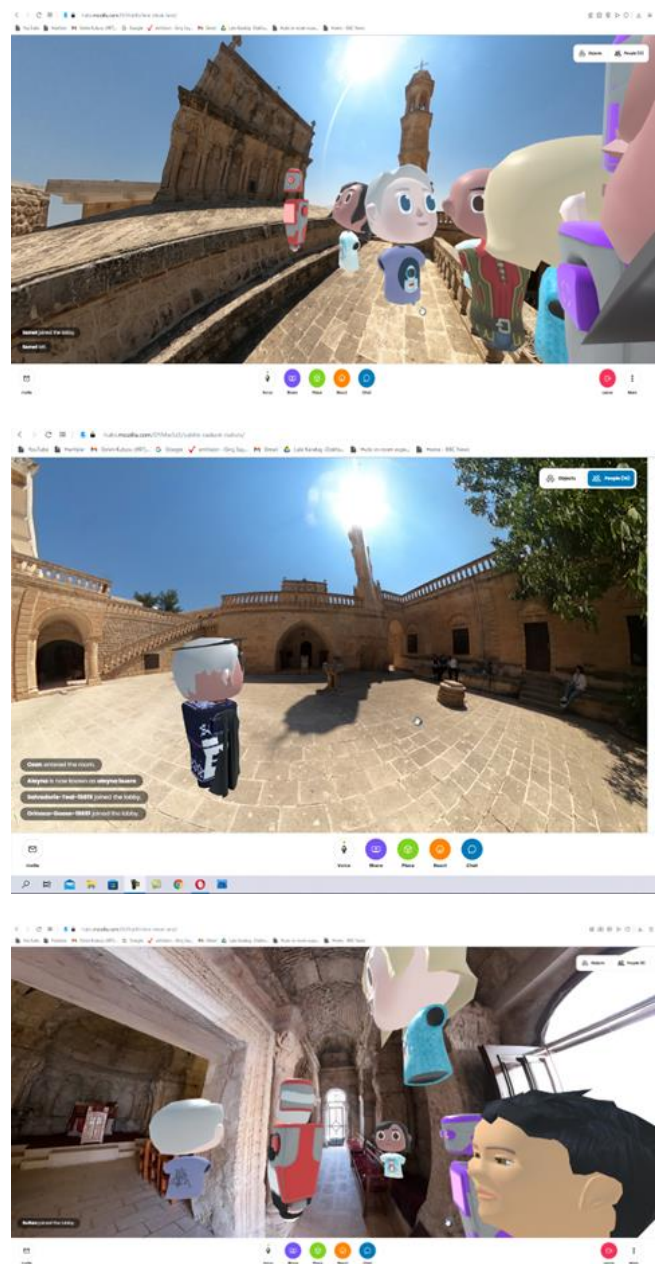
Figure 4. Examples of virtual tours for damage assessment

Within the scope of the study, a 3D virtual environment was created based on the 360-degree panoramic photographs of the building, and the damages occurring in the structure were identified. The virtual environment of Virgin Mary Church and Patriarchate was generated using the Mozilla Hubs program from the 360-degree panoramic photos. The details of the building can be perceived clearly in the virtual environment, allowing users to navigate and zoom in or out using avatars to view detailed information about materials and material deterioration. The virtual tour images conducted through avatars for damage assessment in the virtual environment are presented as shown in the figures (Figure 4).

According to the findings, the facade walls of Virgin Mary Church and Patriarchate structure have experienced surface loss, voids, and color changes due to the damaging effects of moisture and sunlight on the stone material. Surface loss and color changes are the

Based on these results, it can be concluded that the material issues identified in Virgin Mary Church and Patriarchate located in Midyat, a district of Mardin, are similar to historical structures in Mardin. Improper material repairs are partially present due to the failure to use original materials resulting from the deterioration of the original material. Plant growth and moss formation have been detected in the flat courtyard. Wear and tear are observed on the stairs. Cracks, deformations, wear, and color changes are found in the frames and wings of the wooden windows. Wear is observed on the thresholds. No material deterioration has been detected in the arches. Decorative elements on the building facade show loss of form and surface contamination.
