6th Intercontinental Geoinformation Days

Architectural documentation with terrestrial laser scanning (TLS) data: Case study of Lutfu Pasa caravanserai (Mathius Caravanserai), Izmir

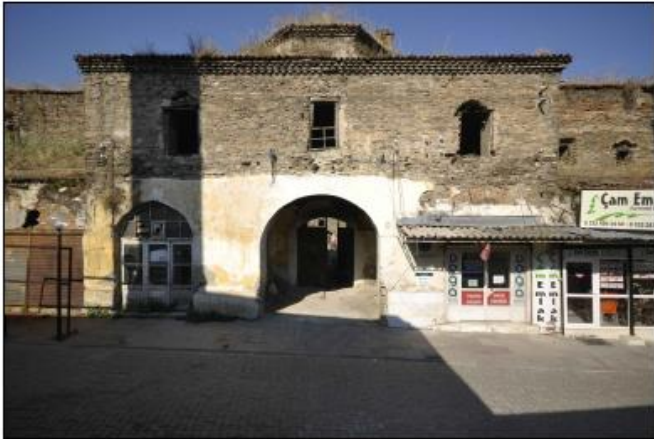
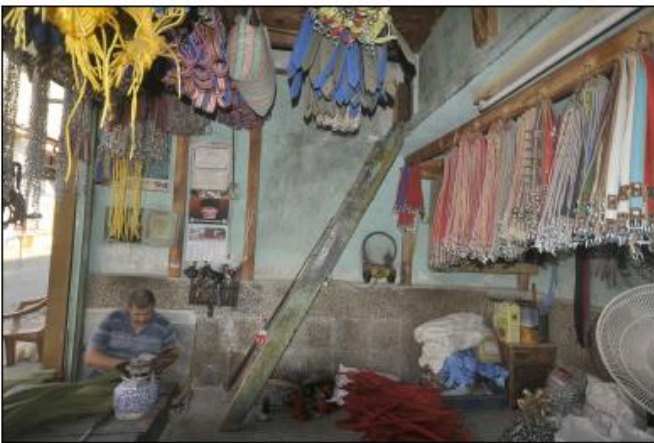
Figure 1. Lutfu Pasa Caravanserai, located in Tire, Izmir, features a captivating entrance section. a) Entrance section, b) View from a shop inside the caravanserai

the Grand Vizier Lütü Pasha in Tire. The building is also known as Mathius Caravanserai, named after a Greek man who operated the han for a period of time. Currently, the han is in a neglected state and privately owned (Figure 1).

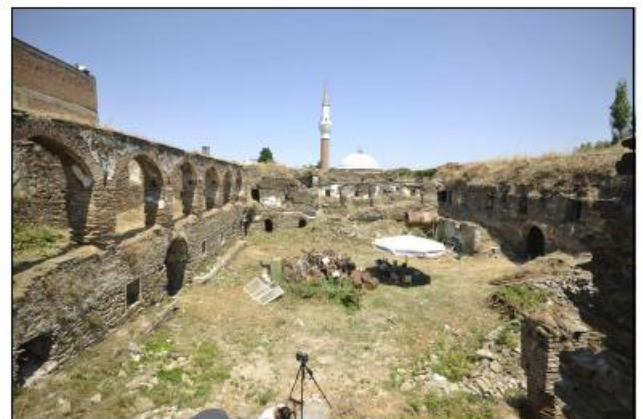
Figure 3. Lutfu Pasa Hami during laser scanning of the inner courtyard

The structure was scanned using a terrestrial laser scanning device (Leica Geosystems brand, ScanStation C10 model, 3D laser scanner) (Figure 3). Point clouds were obtained during the scanning process.

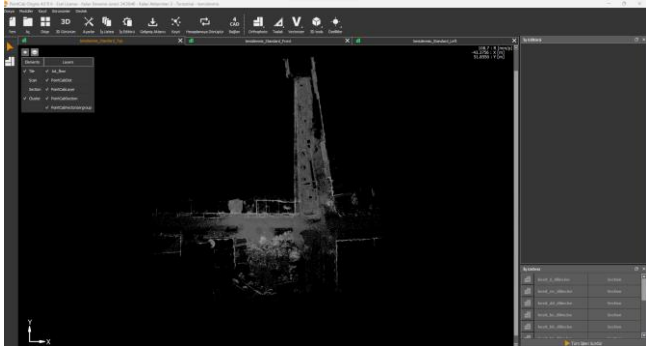
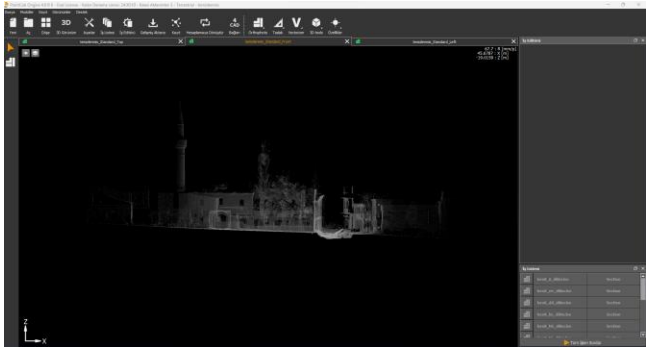
Figure 4. In PointCab Origins 4.0 program, scaled orthophotos of the structure's floor plans can be obtained. a) Floor plan orthophoto; b) Section orthophoto; c) Elevation orthophoto

Origins 4.0, cross-sections were taken from desired locations on the 3D visualizations of the structure to produce orthophotos (Figure 4).

In the next stage, the AutoCAD software was used to generate architectural drawings. Before the drawing process, the orthophoto images produced in PointCab Origins 4.0 software were transferred to the AutoCAD environment (Karataş et al., 2022a,b,c; Karataş et al., 2023a,b,c; Karataş & Alptekin, 2022). The AutoCAD software supports the common data format of .tif or .tiff files, which allowed for the transfer of orthophoto images to the AutoCAD environment (Karataş & Mentese, 2022). Using the obtained scaled orthophoto images, elevation drawings of the structure were created using the AutoCAD program.
