6th Intercontinental Geoinformation Days

3D visualization of pavement distress using terrestrial LIDAR data

Riyaz Khan Noordeen Haroon Rashid¹, Vasantha Kumar Selvaraj¹

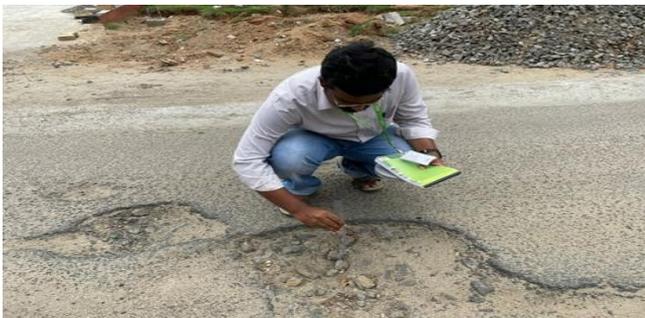
A pilot study was carried out to explore the feasibility of using laser point clouds to visualize the pothole in a three-dimensional way. For this, a 110 m long stretch of a flexible pavement near our Vellore Institute of Technology (VIT) campus was selected. A pothole of considerable dimension was found on this stretch as seen from Fig.1.

Figure 1. Pothole in the study stretch

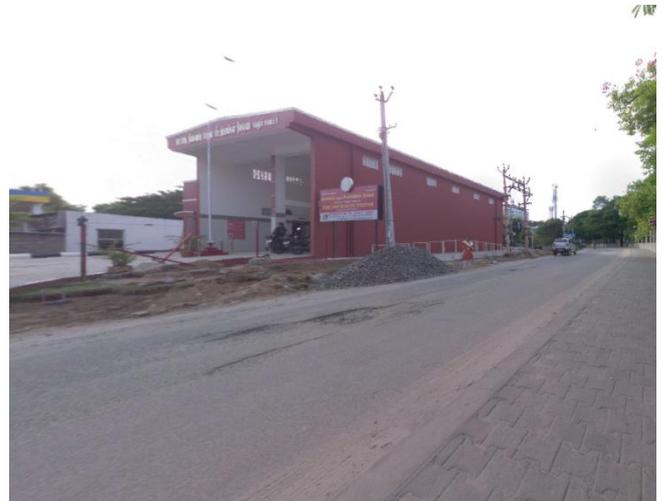
sensing technique of Light Detection and Ranging (LIDAR), where the scanner emits 360,000 laser pulses per second and thus can produce a point cloud of millions of data points of X, Y, Z values finally. The scanner can scan up to a range of 60m and it is placed on the footpath of the roadway so that it can cover the entire pavement width along with the pothole. Two scans were taken on April 12, 2022 during high noon and Fig. 2 shows the HD photo of the study stretch taken by the BLK 360 scanner.

Figure 2. High-definition photo taken by the laser scanner showing the pavement with potholes
