7th Intercontinental Geoinformation Days

Examination of earthquake effects in closed reinforced concrete structures

Muhammed Emin Işık¹, Nuri Erdem^{*2}

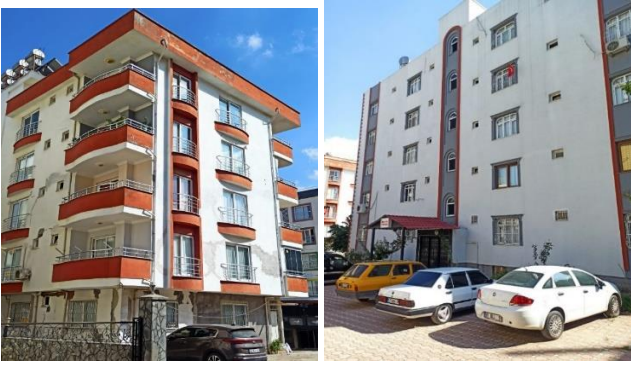
Figure 1. Buildings with and without Canopy (Archive).

Approximately 80 percent of the housing stock in our country has covered exits (URL_2). It has been observed in the damage assessment studies in the field that buildings with closed cantilevers received more damage in most earthquakes, especially during the February 6 Kahramanmaraş-centered earthquake, than buildings with regular structures (without closed cantilevers or consoles). Figure 1 shows examples of buildings built with a closed cantilever on the left and without a cantilever on the right. According to the figure, of the two buildings located on the same street opposite each other

in Fakuşağı District of Osmaniye, on island 248, parcel 6 (building on the left) and island 247, parcel 9 (building on the right), the building with a closed exit was damaged, while the building without a closed exit survived the earthquake without any damage. Of course, it would be incomplete information to say that the damaged buildings were damaged only due to closures. In addition, soft storey irregularity, short column effect, ground liquefaction, inadequacy of ground improvement works, lack of engineering services and workmanship in structures, material quality, technological impossibilities, inadequacy of regulation and inspection mechanism, etc., which are generally examined under the disciplines of civil and geotechnical engineering. Many different factors can be considered.

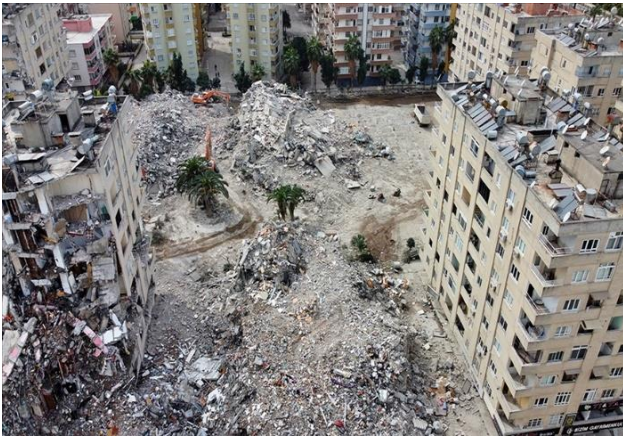
Figure 2: Image of Osmaniye Province 6 February Earthquakes (URL_3).

Figure 2 shows the earthquake-affected view of the site, which consists of 14 blocks and 9 floors, all with closed exits, located on island 2955, parcel 1, in Adnan Menderes District, Adnan Menderes District, Osmaniye Province. In case of a closed exit along with many different factors mentioned above, it is necessary to consider the earthquake effect as a whole. Therefore, if the buildings had been designed and built with a frame system that met the load-bearing system requirements from the ground up, rather than with a closed cantilever, they would have been less affected. Of course, for this purpose, a detailed scan should be made and the existing building data should be processed into the computer environment, earthquake performance analysis should be carried out in the same structure without a closed exit and the results should be compared. Only in this way can
