## Intercontinental Geoinformation Days

### Documentation of centennial structures in Istanbul via Terrestrial Laser Scanning technology

Onur Yılmaz<sup>\*1</sup>, Maryna Batur<sup>1</sup>, Haluk Özener<sup>1</sup>

<sup>1</sup>Boğaziçi University, Kandilli Observatory and Earthquake Research Institute, Department of Geodesy, Istanbul, Turkey

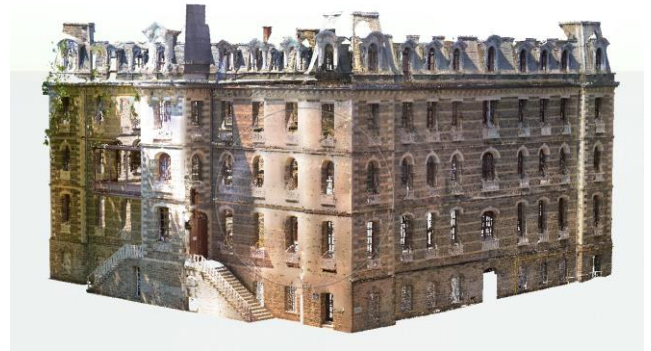
**Figure 5.** 3D point cloud model of the 1<sup>st</sup> Men's Dormitory buildings

As the results of this study, a 3D point cloud model with more than 400,000,000 points was obtained which is shown in Fig. 5.

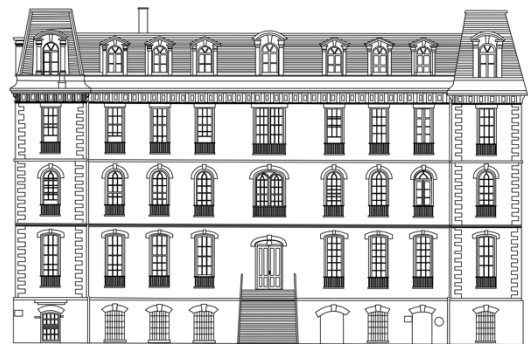
**Figure 6.** The deliverables of the TLS surveying: (a) an orthophoto of façade of the 1<sup>st</sup> Men's Dormitory building; (b) an architectural drawing of the 1<sup>st</sup> Men's Dormitory building drawn over the orthophoto

Orthophoto images of building façade served as a base for architectural drawings, which were done in AutoCAD software and can be seen in Fig. 6.

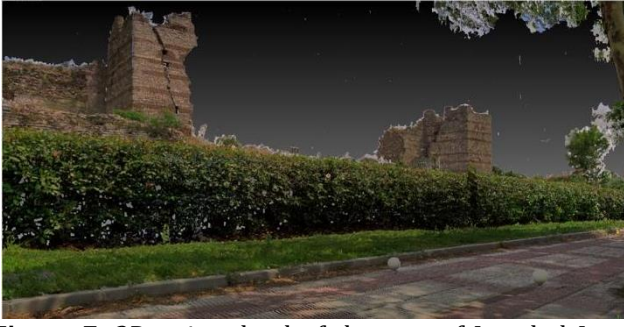
**Figure 7.** 3D point cloud of the part of Istanbul Land Walls

In total, more than 500,000,000 points were involved in the 3D point cloud model, which is shown in Fig. 7.
