Advanced LiDAR

Analytical Documentation of Stone Material Deteriorations on Facades with Terrestrial Laser Scanning and Photogrammetric Methods: Case Study of Şanlıurfa Kışla Mosque

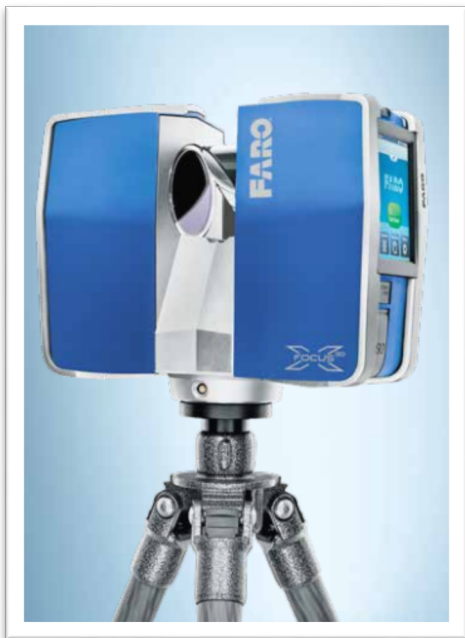
Figure 2. Laser Scanner (The Focus3D X 330)

In the next stage of the study, a laser scanning device (Faro Focus Laser Scanner) was used in the part of the building's facades in order to obtain images of the facades of the building and point clouds were obtained during the scanning. Objects up to 330 meters away can be scanned with the device used (see Figure 2).

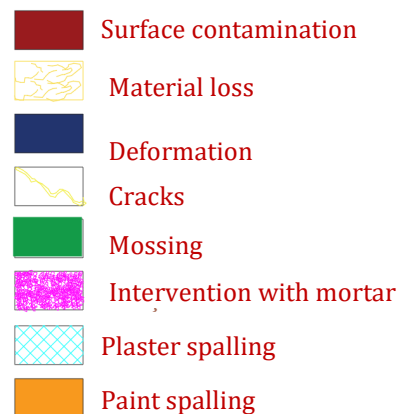
Figure 12. Legend regarding the material damage layouts

When the facades are investigated, it is seen that the most frequent material deterioration seen is the surface contamination depending on the air pollution. This problem is followed by intervention with mortar, mossing, material loss, deformation, plaster and paint spalling, and cracks respectively from most to least (“Fig. 12”).
