Advanced LiDAR

Survey Process of Gesi Pigeonry with Ground Laser by (Point Cloud) Scanning Method

The pigeons, which are accepted as the symbol of peace and love, are one of the first domesticated birds by people. Pigeons have been bred up for 6000 years since they are used in postal services, feeding as a hobby, benefiting from meat, manure, and egg for different purposes. There are special pigeon nests made for pigeons in the world. The nests in the Kayseri Gesi Region, which are described as a dovecote, are special structures that are unique in the world and are designed to obtain the pigeon manure used in agriculture. The unique feature of the gothic cavern is that the main nest is made of carved chambers under the ground and on the ground a dovetail chimney, a dovecote or a dovecote tower. As it is seen in this study which is related to dovecotes, it has the function, form, and organization of each other with its unique local artifacts. However, in the globalizing world, the necessity of adding the original identity of the dovecotes to the world cultural heritage is determined. Preserving cultural heritage is an imperative task for all civilizations in the world. In order to

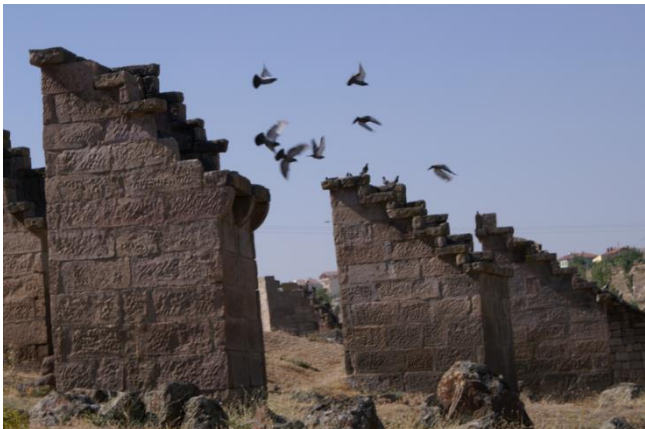
Figure 3. Bushes and birds (Albayrak, 2019)

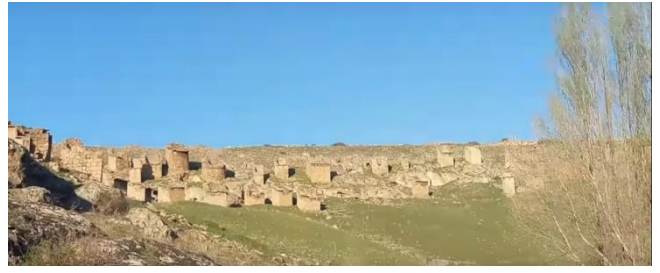
Figure 4. Harmony of the valley and the dovecotes (Albayrak, 2019)

Along the roads leading from Gesi to Kayabağ (Darsiyak) and Güzelköy (Nize), dovecote bastions can be seen in different forms, first sporadically and intermittently, then lined up one after the other. These bastions, which are positioned according to the slope of the land and sprinkled on both sides of the valley, on the right and left, under the roads, exhibit an impressive appearance. The visible upper part of the pigeonry is called a chimney/bush or tower, and it is kept high in order to protect the pigeons from the environment factors (the chimneys are kept high to protect the pigeons from reptiles and insects that can harm the pigeons (Büyükmihci, 2006) and that can harm the birds (marten, fox, wolf, bear) is the part that protects from all kinds of creatures. Pigeon house chimneys are the mouth part that sits on these nests and allows the birds to enter and leave their nests (Büyükmihci, 2006) (Figure 3). The dovecotes, whose nest part is not perceived from the outside, have only towers in the landscape, and the towers are in harmony with the slope of the valley (Özkuş & Özkuş, 2021; Alptekin et al., 2019) (Figure 4).

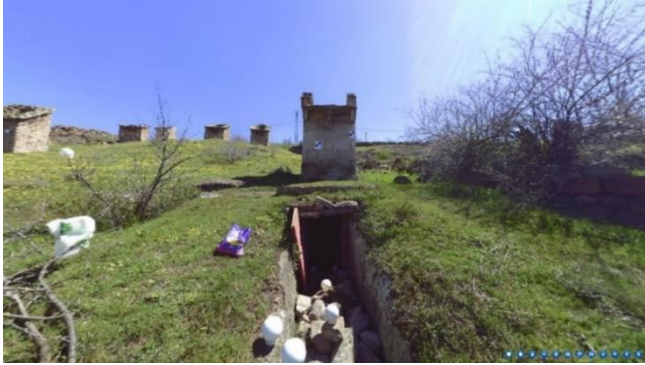
Figure 6. Nest entrance tunnel (Albayrak,2019)

Although these nests are used for laying and sheltering pigeons, the main purpose of the building is to collect pigeon manure, which is very valuable for the commercial conditions of the period. When we examine the nest structure, the association of this geometric chain and its design were made in accordance with this purpose. Pigeon manure is collected on the platform that surrounds the building. The relationship between the people who enter the building and collect these fertilizers in necessary periods is provided through a narrow tunnel (Büyükmihci, 2006)(Figure 6).

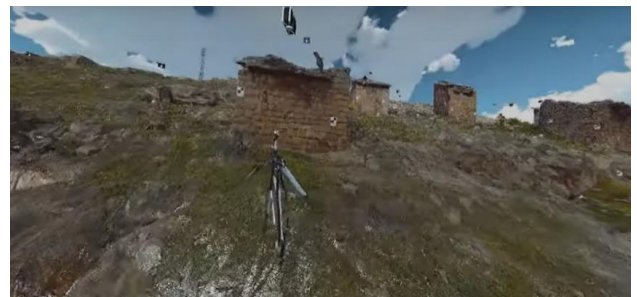
Figure 9. Pigeon houses and established stations (Albayrak,2021)

The device was installed in 815 different stations in the building area and the structure was scanned with the Faro Focus 3d laser scanning device. Device measurements took 32 days with simultaneous use of two laser scanners. In these measurements, the laser scanner also took the photograph. The bastions of all 147 dovecotes were scanned, and about 20 nests were entered and scanned. Other slots could not be entered. (Gesi Kayabağ Pigeonry repair and Valley Arrangement Project was carried out by Demirhanlı Agricultural Products Tec. Project Service Industry and Trade Ltd.
