## Advanced LiDAR

## Creating Architectural Surveys of Traditional Buildings with the Help of Terrestrial Laser Scanning Method (TLS) and Orthophotos: Historical Diyarbakır Sur Mansion

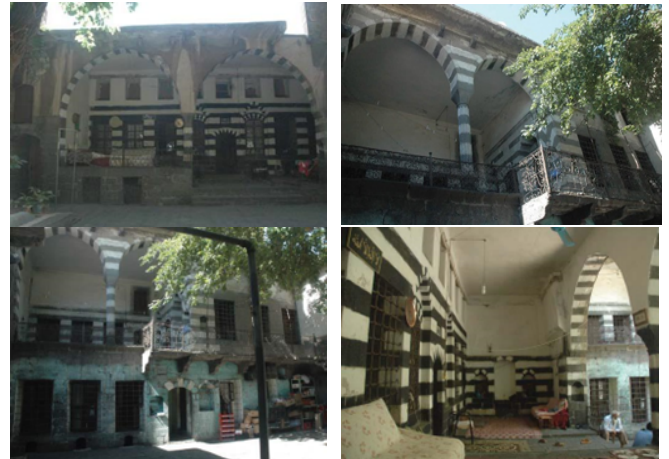
**Figure 3.** The original state of the building

Şemu Ef Foundation. Another document is the aerial photograph published by the Diyarbakir Promotion, Culture and Solidarity Foundation in 1966. In addition, photographs taken from the Diyarbakir Cultural

Inventory show the state of the building before it was destroyed (Figure 3).

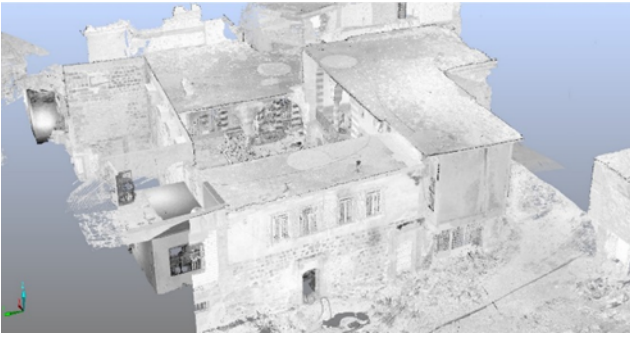
**Figure 4.** Obtained point cloud of the structure

In the next stage of the study, a laser scanning device (Faro Focus Laser Scanner) was used on some of the building facades to obtain images of the building facades and point clouds were obtained during scanning. Objects up to 330 meters can be scanned with the device used (Figure 4).

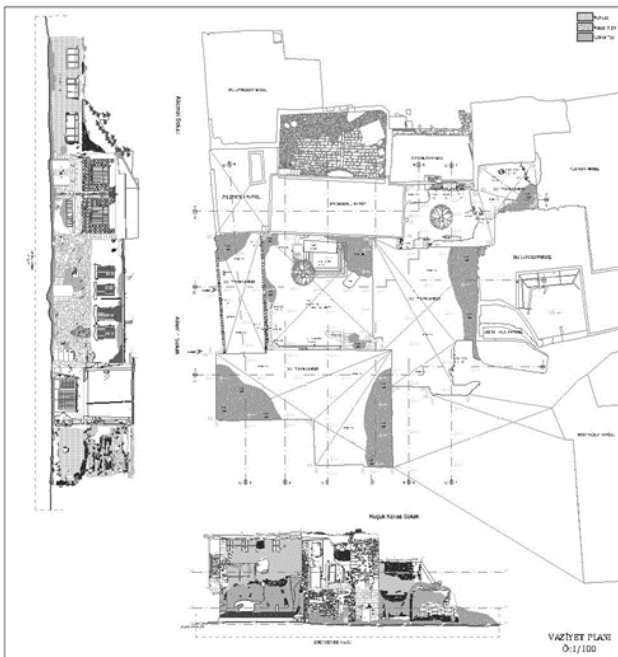
Figure 9. Building site plan survey

In the house, which was built in a "U" plan around the square planned courtyard, smooth cut basalt stone and limestone were used. Basalt stone is the main building block of historical artifacts in and around Diyarbakir province. The structure, consisting of east, west and south wings, was built of basalt stone. Basalt stone was used mainly on the courtyard facades. The spaces forming the south wing were built of basalt stone, and limestone stone and wooden beams were used. The same is true for the spaces that make up the east and west wings, but the rooms on the upper floor of the west wing are made of today's building materials. All rooms have basalt stone floors and wooden beams (Figure 9).

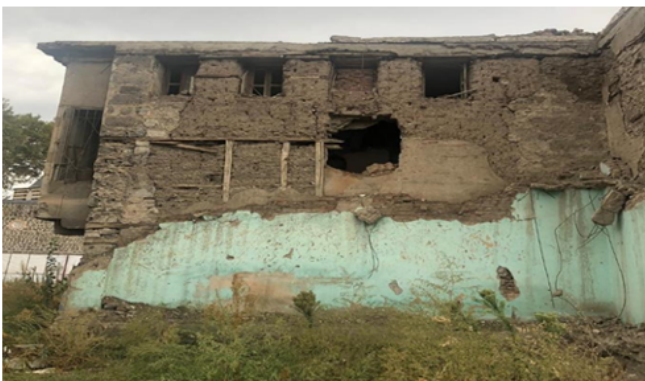
**Figure 13.** Analytical survey of the south façade of the building

The south façade wall consists of adobe, rubble stone, blend brick, basalt stone and plastered wall surfaces. The south façade wall consists of the south wing of the building and the south wall of the west wing. The façade wall is more clearly observed by the demolition of the building on the neighboring parcel. Intense deterioration is observed on the facade wall. Intense plaster-paint

spills, especially destructions and material loss on the wall surface, and surface contamination on stone surfaces were observed. The upper level of the façade is formed by a reinforced concrete flat roof (Figure 13).

The architectural documents obtained as a result of the study show that the building has been exposed to material damage to a large extent. Intense deterioration is observed on the facade wall. Intense plaster-paint spills, especially destructions and material loss on the wall surface, and surface contamination on stone surfaces were observed. Interventions were made with cement-added mortar on the stone wall surfaces of the façade. However, it has been determined that structural deteriorations, especially surface pollution, occur on stone surfaces.

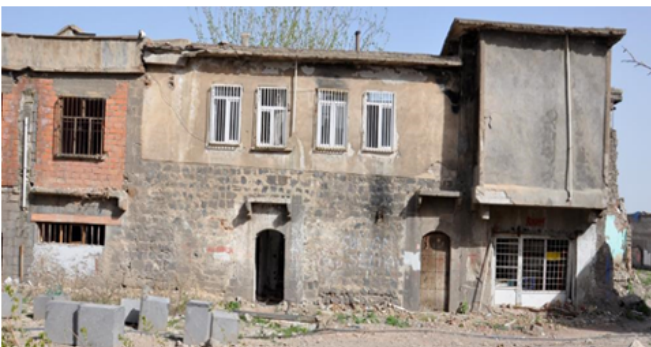
**Figure 14.** Analytical survey of the western façade of the building

The west façade wall consists of rubble stone, basalt stone and plastered wall surfaces. The facade wall consists of door and window openings and a bay window. The façade wall was built with rubble stone up to +3.62 elevation. There are two entrance doors in the area covered with rubble stone. The entrance gates built with basalt stone have a basalt stone arch measuring 1.85x0.98 m. There is also a basalt eaves resting on two basalt stone pendentives. The wooden heeled door in one of these door openings opening to the courtyard entrance hall has managed to preserve its originality. Four rectangular PVC window openings on the upper elevation of the wall have metal railings. A 2.80x2.12 m opening belonging to the shop is seen on the east of the façade wall. Above this area is a bay window. The door openings, basalt stone pendentive, eaves and wooden heeled door on the façade wall have managed to preserve their originality. Interventions were made with cement-added mortar on the stone wall surfaces of the façade. However, it has been determined that structural deteriorations, especially surface pollution, occur on stone surfaces. The upper level of the façade is formed by a reinforced concrete flat roof (Figure 14).

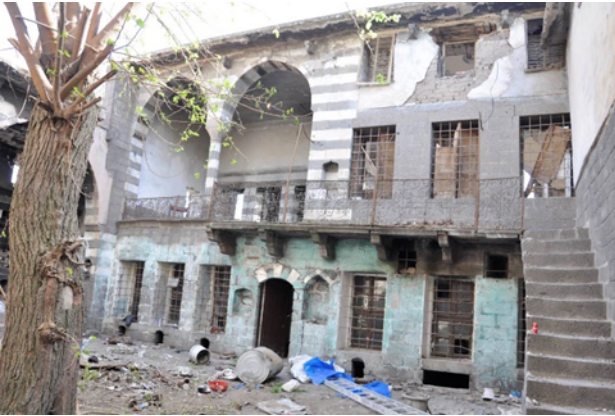
Figure 15. Analytical survey of the south façade of the building facing the courtyard

The south façade of the building in the courtyard consists of three floors. There is a door opening on the middle axis of the ground floor main wall that provides the entrance to the building. In the eastern part of the entrance door, there are three rectangular-planned three window spaces with iron bars in front, two rectangular-planned window spaces with iron railings in front, and a staircase that provides access to the upper floors of the building. On the first floor of the building, there are two iwans with a height of 6 meters on the right side of the central axis of the main wall, and three window spaces in

two rows, with a rectangular plan in front of them, on the left side. There is a section supported by buttresses on the part connecting the ground floor and the first floor on the façade (Figure 15).

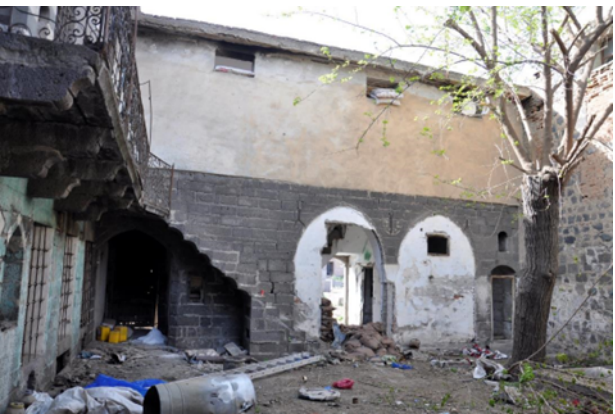
Figure 16. Analytical survey of the western façade of the building facing the courtyard

The west façade facing the courtyard consists of two floors, and two closed iwans are visible on the ground floor (Figure 16).

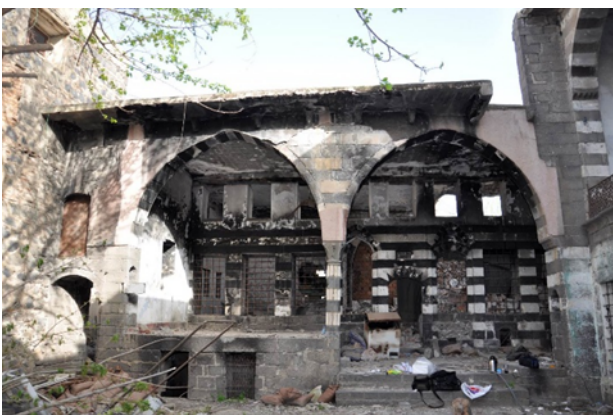
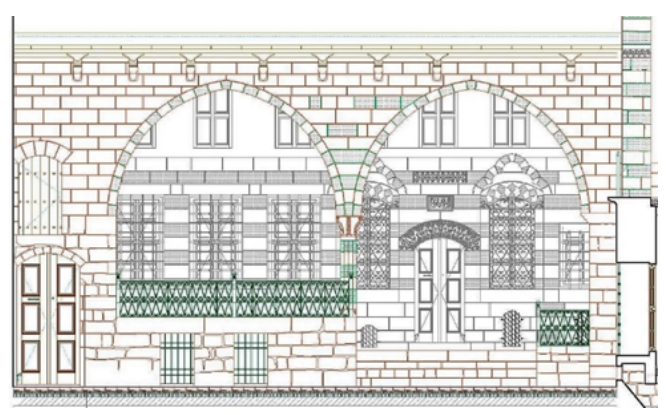
Figure 17. Analytical survey of the east façade of the building facing the courtyard

The east façade, facing the courtyard, consists of two floors, and two iwans with pointed arches forming large openings can be seen on the façade (Figure 17).
