Vol: 2
Issue: 2
September, 2022

ADVANCED LIDAR

Page No	Article Name and Author Name
31 – 35*	<i>Detection of Informal Housing and Non-Compliance with Planning Regulations from Maps Produced by Mobile Lidar Technique</i> Serhat Güneş & İsmail Şanlıoğlu
36 – 47*	<i>Analytical Documentation of Stone Material Deteriorations on Facades with Terrestrial Laser Scanning and Photogrammetric Methods: Case Study of Şanlıurfa Kışla Mosque</i> Lale Karataş, Aydın Alptekin & Murat Yakar
48 – 53*	<i>Detection of Road Distress with Mobile Phone LiDAR Sensors</i> Mustafa Zeybek & Dilay Ediz
54 – 63*	<i>Creating Architectural Surveys of Traditional Buildings with the Help of Terrestrial Laser Scanning Method (TLS) and Orthophotos: Historical Diyarbakır Sur Mansion</i> Lale Karataş , Aydın Alptekin & Murat Yakar

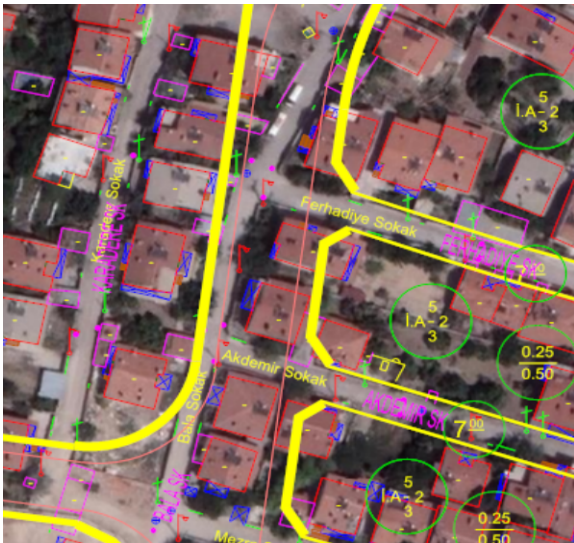
Figure 1. Example illegal structures on the zoning roads

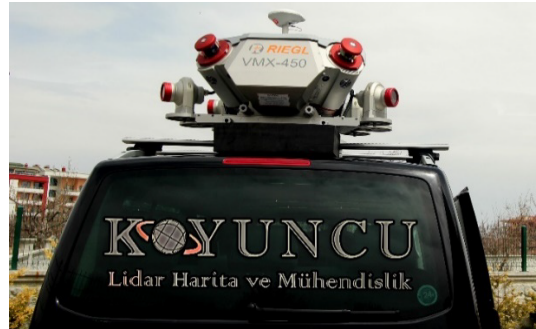
Figure 2. High Speed, High Performance & Dual Browser Mobile Mapping System RIEGL VMX-450 (courtesy Koyuncu Lidar)

elements that play a vital role in data collection and analysis are the photodetector and optics. Helicopters, UAVs and airplanes are mostly used to obtain lidar data. In this study, building data obtained from mobile lidar data were obtained from necessary persons and institutions. (Fig.2)

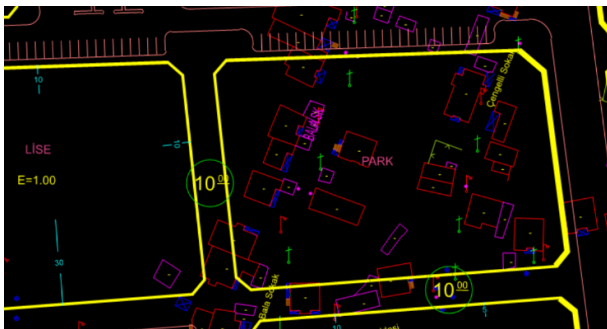
Figure 7. Merging of building data and zoning plan data.

At this stage, the building data created with the help of mobile lidar was combined with the zoning plan layer after the necessary coordinate transformation was made in the Netcad 8.5 GIS program. (Fig.7)

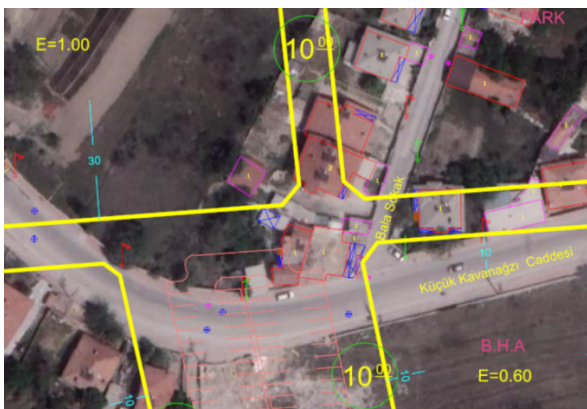
Figure 8. Illegal structures on the zoning road.

High resolution current google satellite image was added on the data seen in Figure 7 and the data were analyzed. (Fig.8-12)

In this study, as seen in Figure 8, Figure 9 and Figure 10, using lidar data and satellite images, it was revealed that some buildings in the Ladikli, Hacı İsa Efendi, Arifbilge and Batı Hadimi neighborhoods of Meram district of Konya were built against the zoning plan. However, as can be seen in figures 11 and 12, it was revealed that some of the buildings identified with the help of current satellite images used in the study were demolished by the necessary authorities and suitable structures were built in their places.

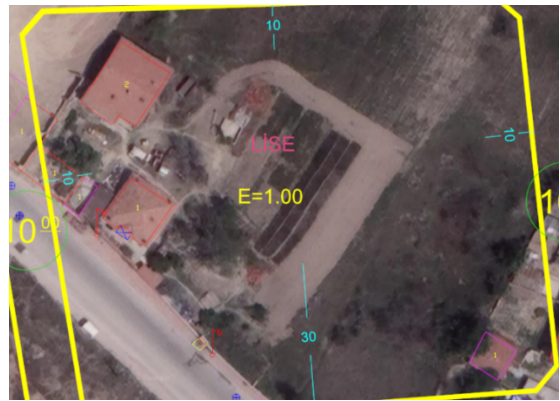
Figure 9. Buildings contrary to zoning in the school area.

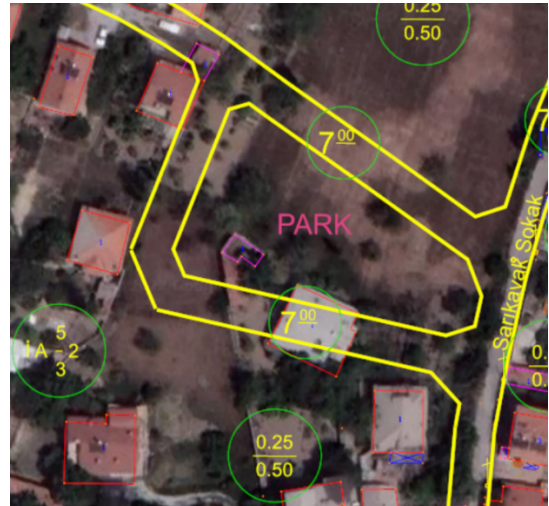
Figure 10. Illegal structures in roads and parking areas.

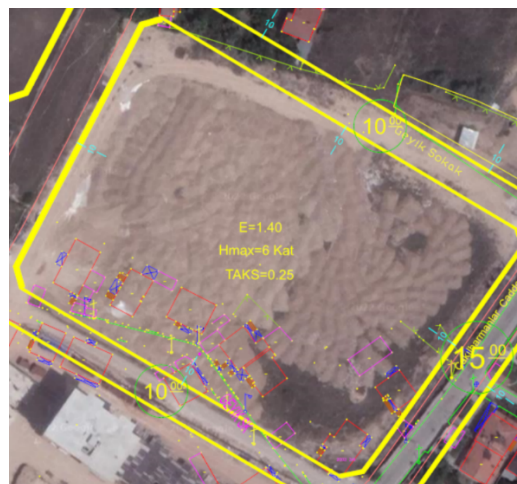
Figure 11. Demolition of illegal structures.

NOTE: Red areas represent pre-existing buildings.

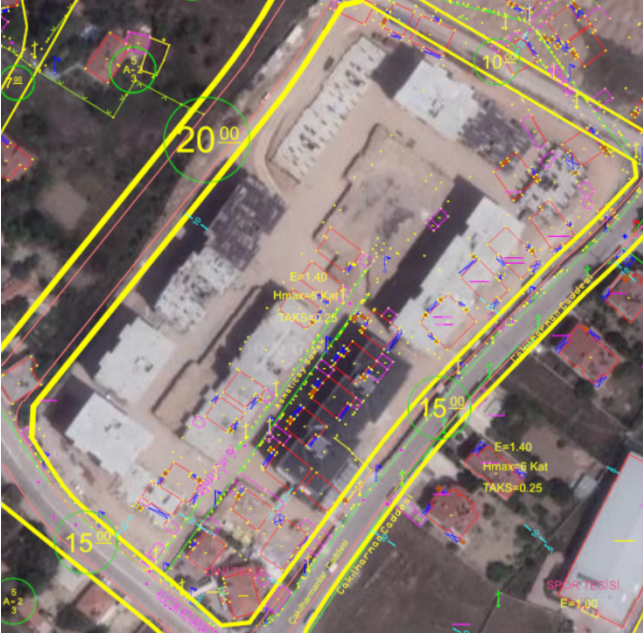
Figure 12. Buildings built in accordance with zoning instead of buildings constructed in violation of zoning.
NOTE: Red areas represent pre-existing buildings.

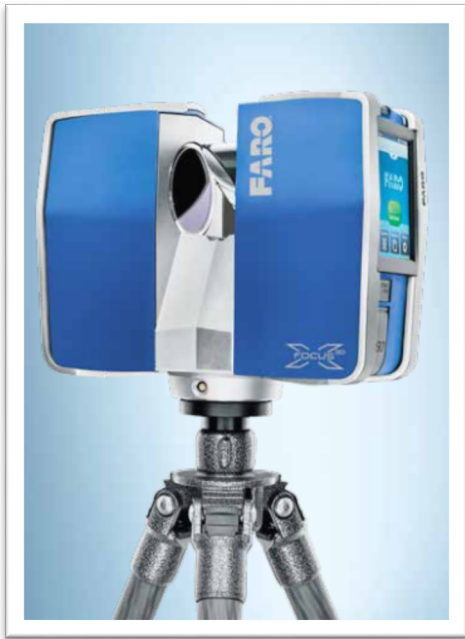
Figure 2. Laser Scanner (The Focus3D X 330)

In the next stage of the study, a laser scanning device (Faro Focus Laser Scanner) was used in the part of the building's facades in order to obtain images of the facades of the building and point clouds were obtained during the scanning. Objects up to 330 meters away can be scanned with the device used (see Figure 2).

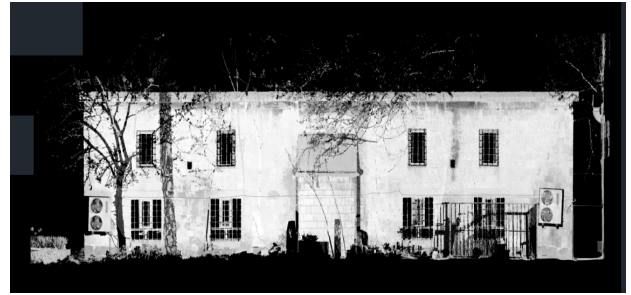
Figure 6. Orthophoto of layout plan

Figure 7. Orthophoto of ground floor plan

Figure 8. Orthophoto of west frontage

Figure 9. Orthophoto of east frontage

Figure 10. Orthophoto of south frontage

Figure 11. Orthophoto of north frontage

In this stage, orthophotograph images of the building were obtained from the point clouds obtained in the laser scanning procedure in the software named PointCab Origins 3.9 (“Fig. 5-11”).

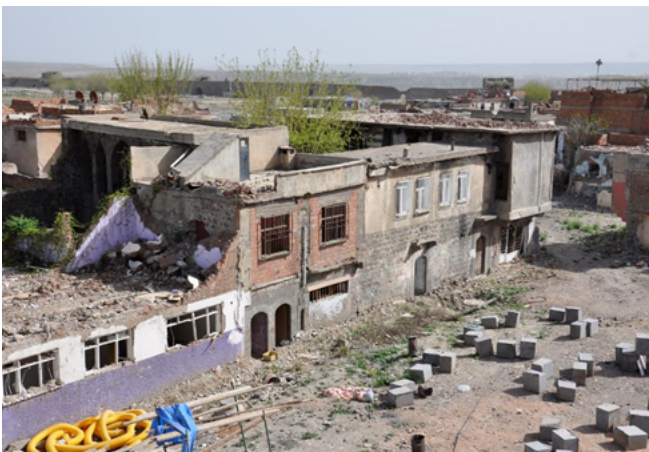
Figure 2. Current state of the building

The building has been registered as a "monumental" structure to be protected by the Council of Europe's Natural and Cultural Heritage Conservation Inventory and the General Directorate of Turkish Cultural Heritage and Museums (Figure 2). There is no information about the construction date of the building in the sources. The inscriptions in the building do not contain information about the history of the building. On the inscriptions on the eastern wall of iwan 1 and the western wall of iwan 3, "El Baki El Hallak" is written in Arabic thuluth calligraphy. Considering the plan of the house, the materials used, the construction form and the construction date of similar example houses, it is estimated that the building was built in the XIX or XX century. It is known that the house numbered 382 47 was used as a school for the deaf in the 1950s. In our research, the building served as a school for 10 years and then moved to its new location. Only written and oral sources could be reached, and no visual data could be found about the period when the building was used as a school. The oldest document belonging to the building is the measurement sketch dated 1952 taken from the archive of the cadastral directorate. There is also the Savings sketch of the building drawn in 1953. It is stated that the building shown in plot no. 27 on the savings sketch is a masonry house and it is owned by Marton Pedros Velesi

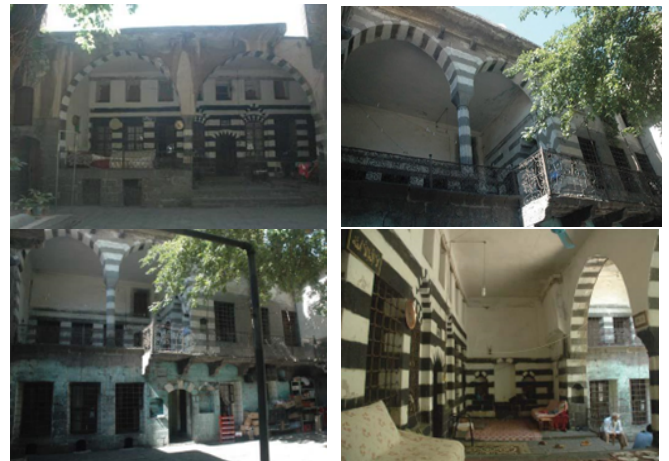
Figure 3. The original state of the building

Inventory show the state of the building before it was destroyed (Figure 3).

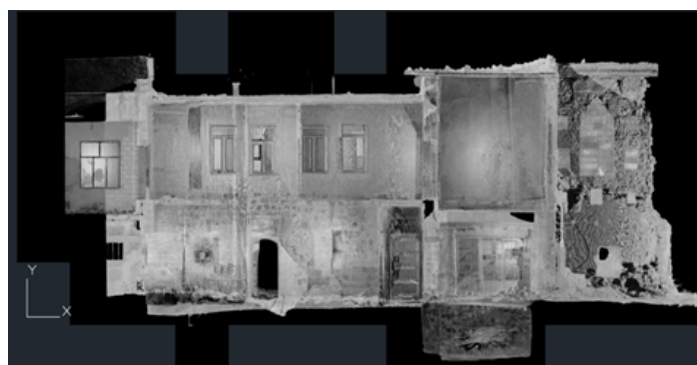
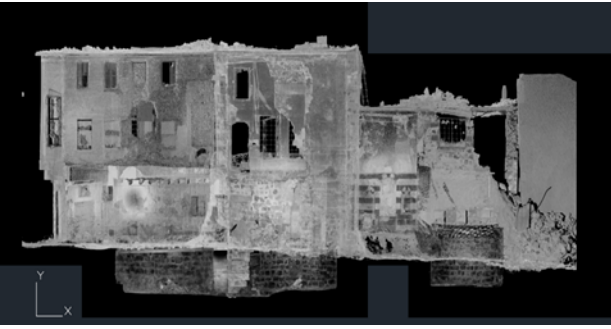
Figure 6. Orthophoto of the ground floor plan

Figure 5. Orthophoto of the basement floor plan

Figure 7. Orthophoto of the first floor plan

Figure 8. Orthophoto of the western façade

Figure 8. Orthophoto of the south façade

AutoCAD program was used in the process of creating the drawings of the facades. Before starting the drawing process, orthophoto images produced in PointCab Origins 4.0 software were transferred to the AutoCAD environment. It can be transferred to AutoCAD environment in TIF file format with .tif or .tiff extension, which is the common data format of AutoCAD software. Using the scaled orthophoto images obtained, the facade drawings of the building were obtained with the Autocad program.

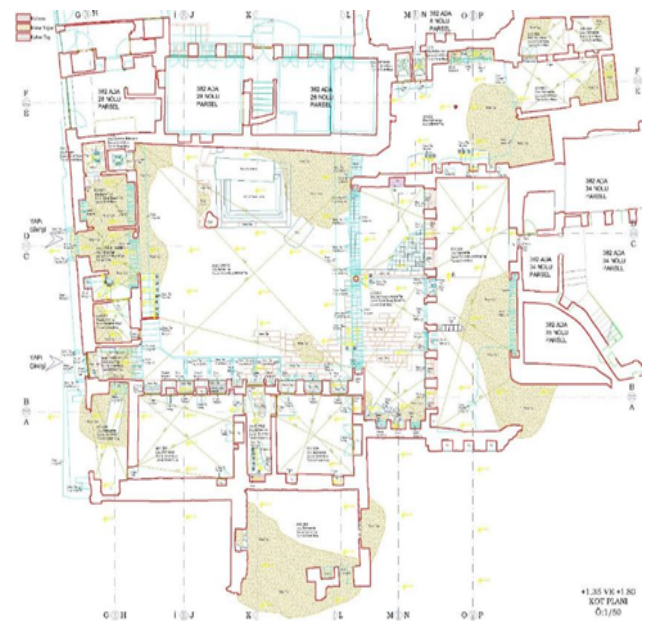
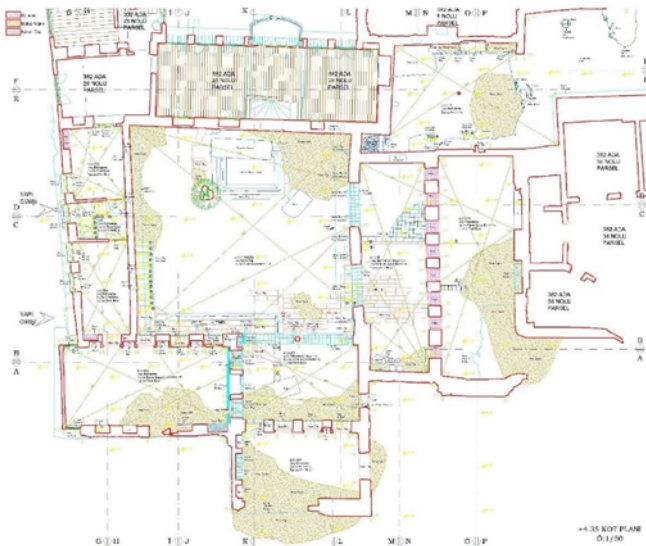
Figure 10. The basement floor survey of the building

Figure 11. The ground floor survey of the building

Figure 12. First floor survey of the building

The walls of the building have been destroyed due to material loss in the rooms. In addition, deteriorations such as plaster-paint spills, cracks and surface contamination were observed on the plastered wall surfaces.

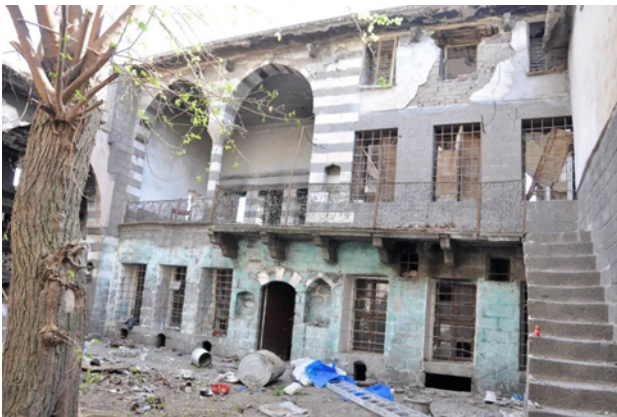
Figure 15. Analytical survey of the south façade of the building facing the courtyard

The south façade of the building in the courtyard consists of three floors. There is a door opening on the middle axis of the ground floor main wall that provides the entrance to the building. In the eastern part of the entrance door, there are three rectangular-planned three window spaces with iron bars in front, two rectangular-planned window spaces with iron railings in front, and a staircase that provides access to the upper floors of the building. On the first floor of the building, there are two iwans with a height of 6 meters on the right side of the central axis of the main wall, and three window spaces in

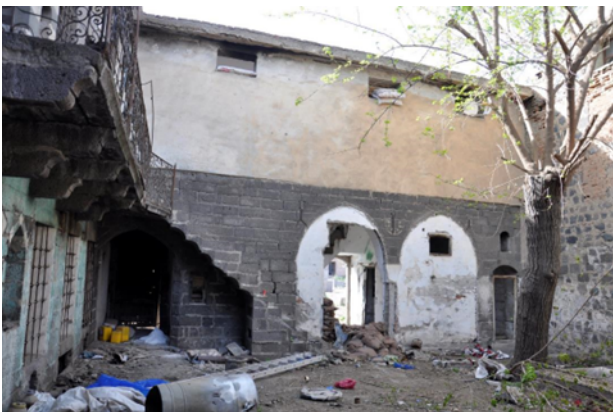
Figure 16. Analytical survey of the western façade of the building facing the courtyard

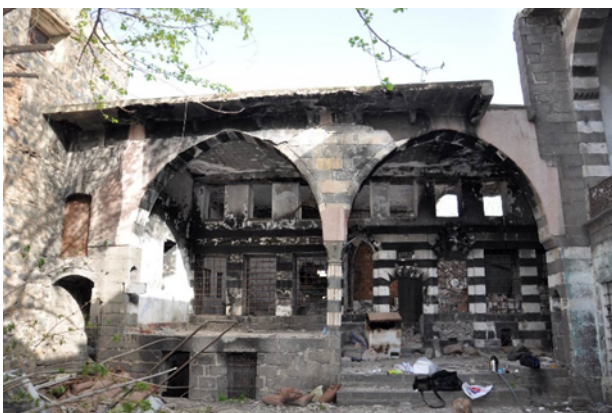
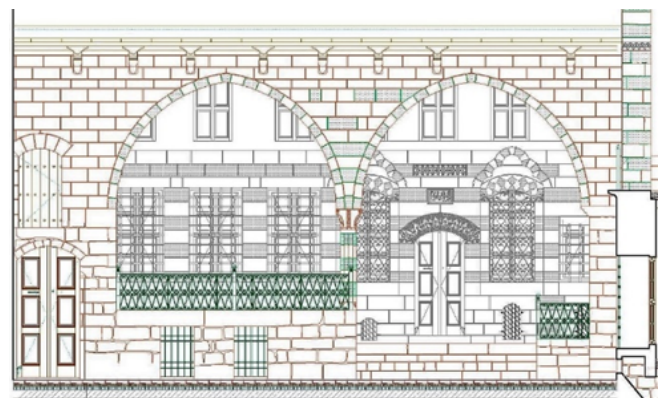
The east façade, facing the courtyard, consists of two floors, and two iwans with pointed arches forming large openings can be seen on the façade (Figure 17).

Figure 17. Analytical survey of the east façade of the building facing the courtyard
