## Investigation of the existing situation of the Surp Ağpırig (Déra Spî) Monastery

Enes Arkan\*<sup>1</sup>

, Fatih Avcil<sup>2</sup>

<sup>1</sup>Bitlis Eren University, Engineering-Architecture Faculty, Civil Engineering Department, Bitlis, Turkey, earkan@beu.edu.tr; favcil@beu.edu.tr

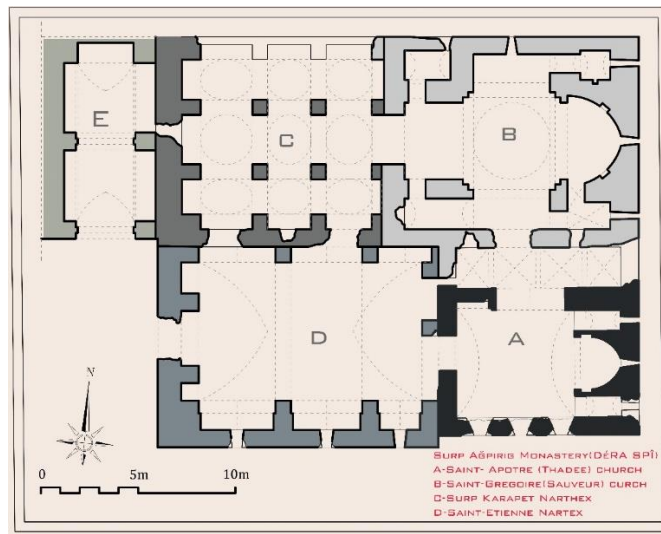
The monastery, which developed with the additions made at different times, was used as the episcopacy center of the region until the end of the 19th century. A large part of the monastery, which consists of two churches, two jamatuns, a bell tower and a large number of monks' rooms, is in ruins today. The plan we prepared for the Monastery after the survey work is shown in Figure 2.

Figure 2. The plan of the Surp Ağpırig (Déra Spî) Monastery (drawn by author)
