Advanced Geomatics

Determination of Stone Material Deteriorations on the Facades with the Combination of Terrestrial Laser Scanning and Photogrammetric Methods: Case Study of Historical Burdur Station Premises

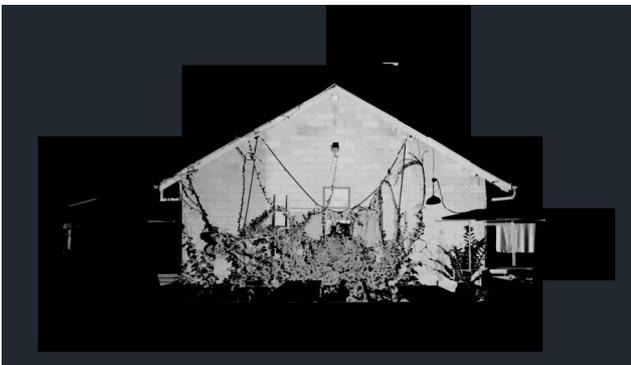
Figure 5. Orthophoto of east frontage

Majority of the east frontage is covered with ivy plant, and it is seen that the front of the facade is utilized as a cafe. Jerry-built attachments and deteriorations such as the surface contamination were observed (“Fig. 11”).
