### Documentation of stone material deterioration on the facades of historical masonry buildings by terrestrial laser scanning: A case study of a Mansion in Mardin

Lale Karataş<sup>\*1</sup>, Aydın Alptekin<sup>2</sup>, Murat Yakar<sup>3</sup>

The rich architectural heritage of our Turkey is also manifested in stone monuments. The building, which is the subject of the study, is located in the Şar Neighborhood of the Artuklu district of Mardin Province which has the characteristics of historical buildings in the region with its construction technique, plan features and materials. As in many buildings in the region as construction material, there is an intense use of stone

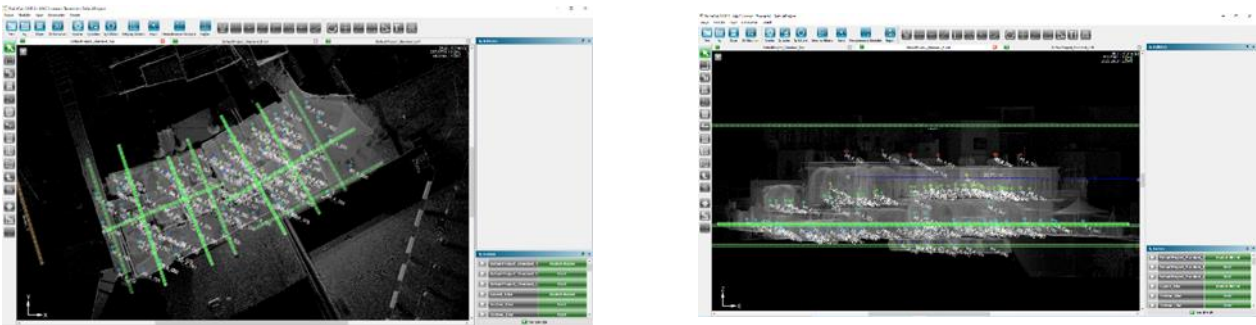
Figure 1. Stations used in scanning

In the study, literature review, archive research and terrestrial laser scanning method were used. First of all, the information about the building was compiled from the archive of the Mardin Metropolitan Municipality. Afterwards, field research was carried out and the structure was scanned with a terrestrial laser scanner (Faro Focus Laser Scanner) (Figure 1).

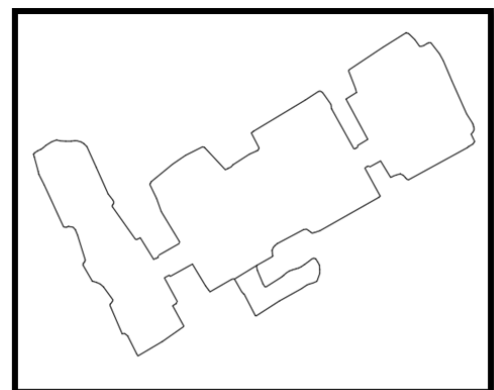
Figure 6. Basement Floor Plan

The building consists of basement, ground floor and first floor. The basement floor area is 72 m<sup>2</sup> and consists of 3 separate spaces. The spaces are made of rubble stone. The floor covering is concrete screed. The ceiling is in the form of a vault. The building consists of 5 separate sections on the ground floor and the 1st floor, and each section is functional in itself (Figure 6-8).
