Konya Aslim Wild Storage Field Rehabilitation and gains

ABSTRACT

Konya Aslım Rehabilitations Field

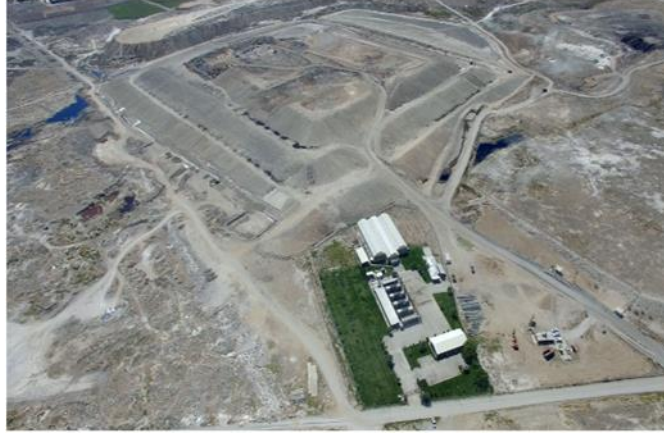
Figure 1. Rehabilitation area.

the field are completely finished, it is planned to plant vegetation in standards that will not damage the top cover. The rehabilitation area is shown in Figure 1.
