Advanced Engineering Days

Restitution suggestion for Mardin TatlıDede Mansion

Lale Karataş¹, Aydın Alptekin², Murat Yakar³

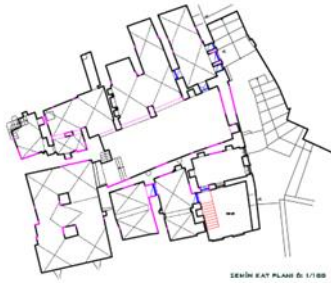
Figure 1. Plan of ground floor

As a result of the Ground Floor Plan examination, areas, of which its location, trace and materials are clear and completed with the information from the building, were determined as the arcaded areas, floor covering, niche, and feeder. There are wooden doors and windows known as a result of the comparative studies. There are stone stairs and iron railings completed as a result of the architectural requirement (Fig. 1). As a result of examination of the first floor plan there are parapet, walls, ground flooring, and stone wall, of which the location, trace and materials are clear and are completed with the information from the building. There are wooden doors and windows known as a result of the comparative studies (Fig. 2). As a result of second floor examination, there are parapet wall, ground flooring, stone wall, groined vault and stone arch, of which its location, trace and materials are clear and completed with the information from the building. There are wooden doors and windows known as a result of the comparative studies (Fig. 3). As a result of mezzanine floor examination, there is ground flooring, of which its location, trace and materials are clear and completed with the information from the building. There are wooden doors and windows known as a result of the comparative studies (Fig. 4) (Fig. 5).

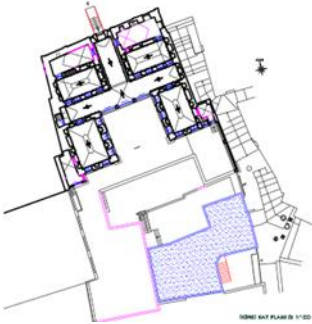
Figure 3. Plan of the second floor
